PRELIMINARY
ENGINEERING
REPORT

BEAVER LAKE DAM STUDY

LOGAN COUNTY, NORTH DAKOTA

SWC PROJECT NO. 390

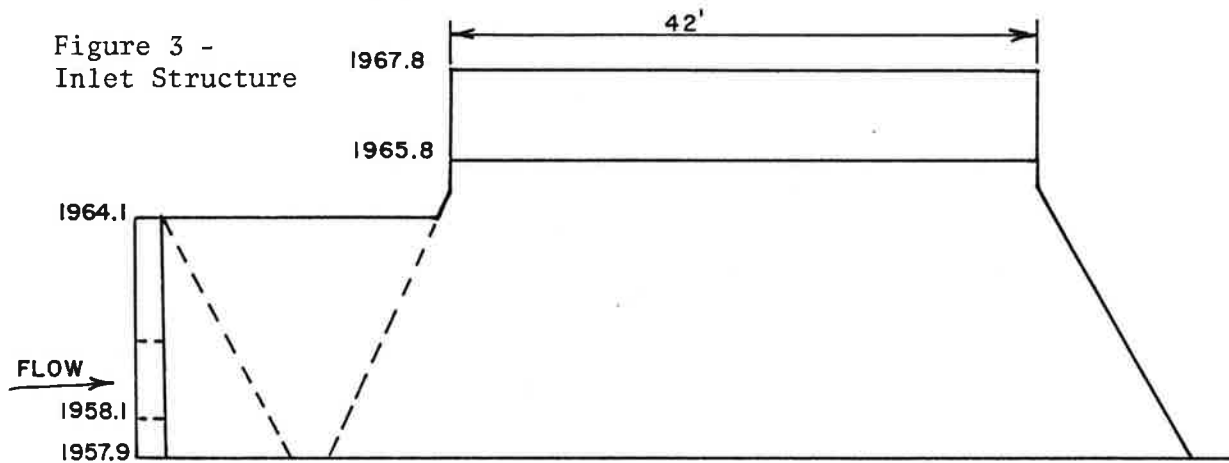
There is a control on the main inlet of Beaver Lake in the NW $\frac{1}{4}$ Section 34, Township 134 North, Range 71 West (Figure 3). The bridge structure is a quad 8 by 11 by 42-foot, reinforced concrete, box culvert. A 6 foot high weir has been placed on the southeast end and is intended to control wind tides coming from the lake. The weir has two 24-inch openings with flapgates to allow low flows into the lake. Improvements to the outlet structure should not have significant impacts on water levels upstream of Beaver Lake.

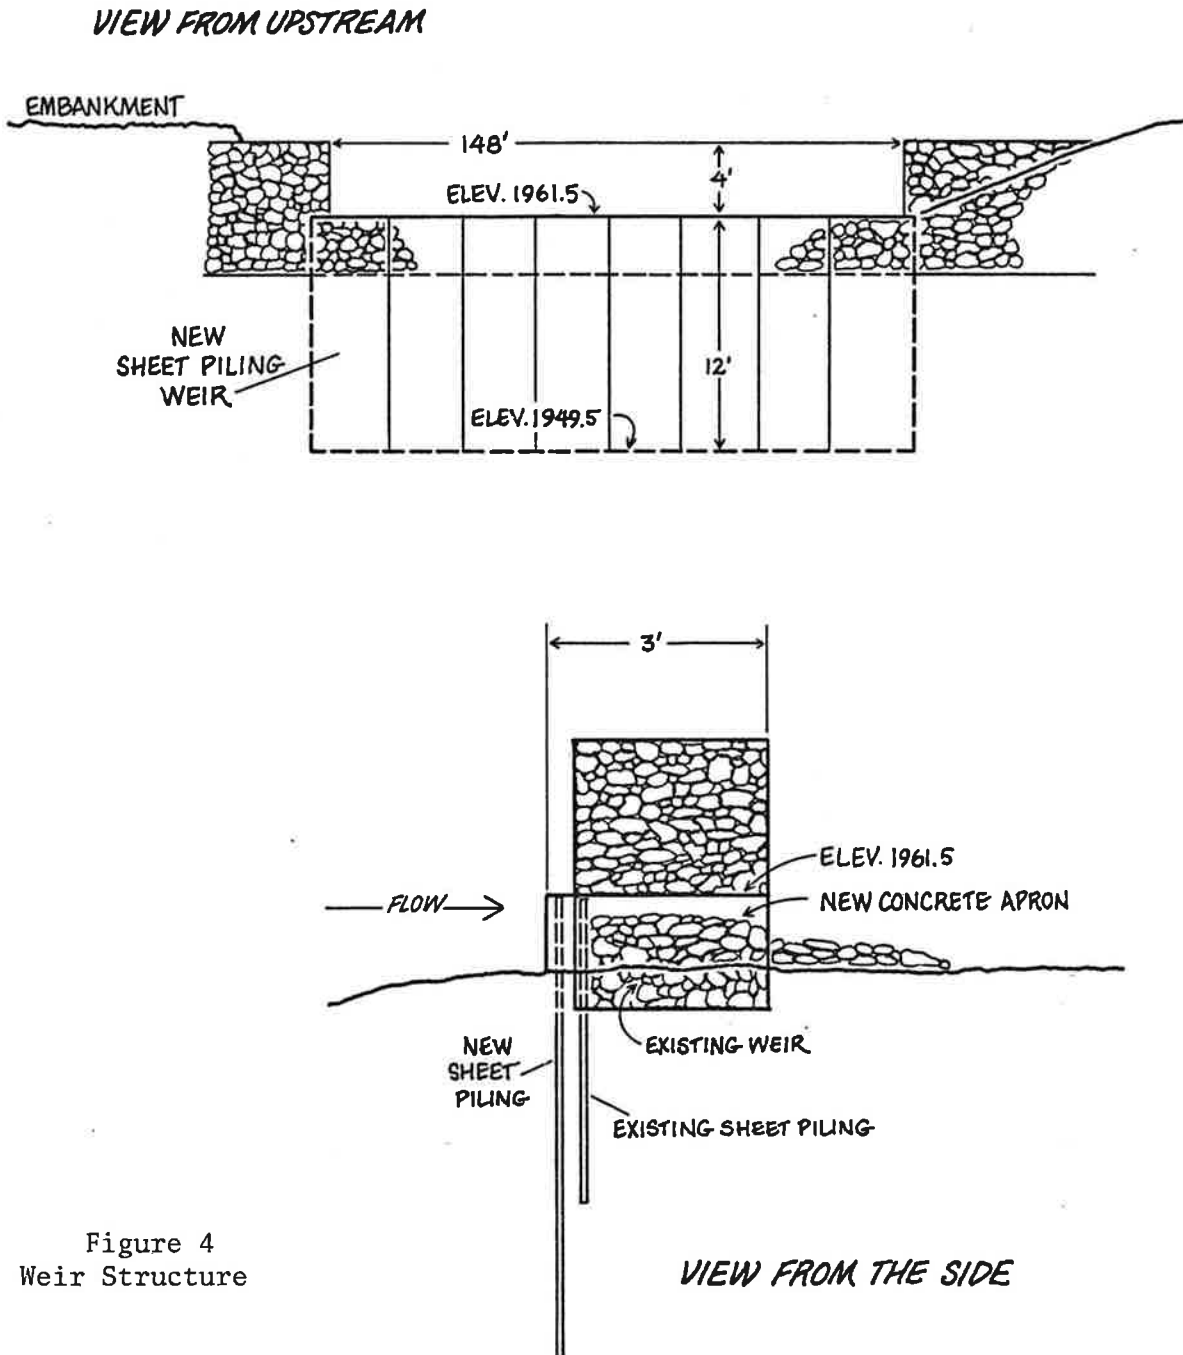
Figure 4
Weir Structure

Several repairs have been made to the weir including adding a sheet piling cutoff wall, a layer of mortar, and rock riprap on the downstream side of the weir. Even with the repairs, the weir no longer performs in an acceptable manner. Approximately one-half of the sheet piling is two feet higher than the weir. Local residents have also noticed leaks along the weir. The end abutments for the weir are in satisfactory condition, with the northwest side having a portion broken off.

The modification of the weir in Beaver Lake Dam would consist of installing a new sheet piling cutoff wall on the upstream side of the existing weir and placing a concrete apron over the sheet piling at elevation 1961.5 (Figure 4). The existing end abutments will be

used and the existing 148 foot width will not be changed.

A coffer dam will be constructed to prevent flows through the dam during the repair period. It is proposed to bury the existing structure in its present location as the existing piling is not reuseable. If problems develop, the existing structure may have to be removed.

The preliminary engineering report contains the results of a feasibility study for reconstructing Beaver Lake outlet. A new concrete apron would be constructed along with a sheet piling cutoff wall. The weir would be set at the current outlet elevation of 1961.5 msl and current weir length of 148 feet. The Logan County Water Management Board members recommended that the existing outlet elevation not be changed.
