# Silver Lake Embankment Seepage Investigation

## Sargent County, North Dakota

Investigation Report - SWC Project #391

February 2016

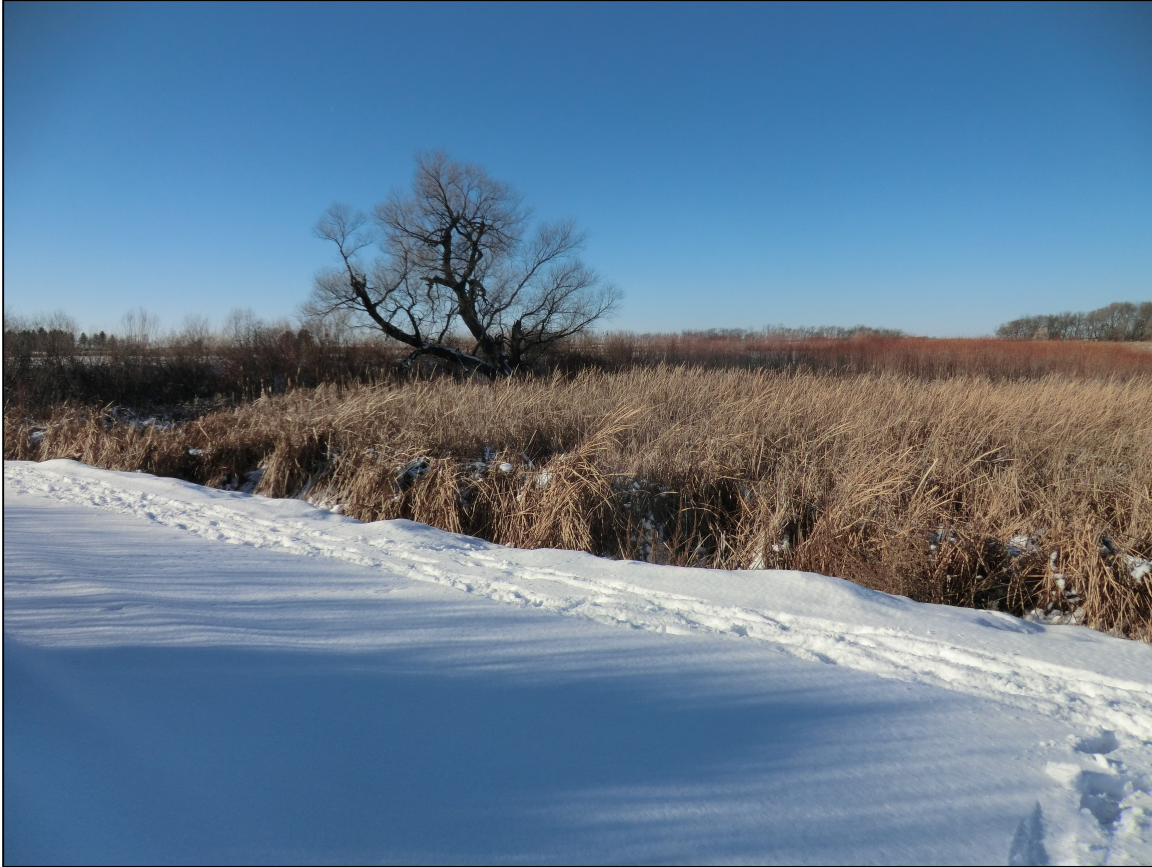
On December 4<sup>th</sup> of 2015, water resource engineers David Nyhus, Joon Hee Lee, and Chris Korkowski visited the site to examine the conditions of the embankment and evaluate design alternatives to mitigate the embankments seepage. One large tree and many small diameter willows were seen growing out of the embankment (**Figure 3**). Large amounts of cattails were observed on the downstream side of the embankment and they appear to be flourishing.

**Figure 3.** Silver Lake Dam, right embankment (photograph taken from downstream side).

The large tree growing in the right embankment presents a hazard to the dam and should be removed regardless of which alternative is chosen. Removal of this tree will require excavation to remove its root system which could lead to the failure of the embankment if proper construction methods aren't used. FEMA details several inspection and evaluation zones in an earthen embankment and the significance of having woody vegetation in each zone. **Figure 6**, from FEMA's "Technical Manual for Dam Owners", details the inspection and evaluation zones. The large tree located on Silver Lake's embankment is located in Zone 4. "Zone 4 is one of the two most critical zones relative to dam safety issues associated with tree and woody vegetation growth as well as other potential dam safety issues. This zone typically contains the interceptions of both the zone of saturation and the seepage line with the downstream slope. The

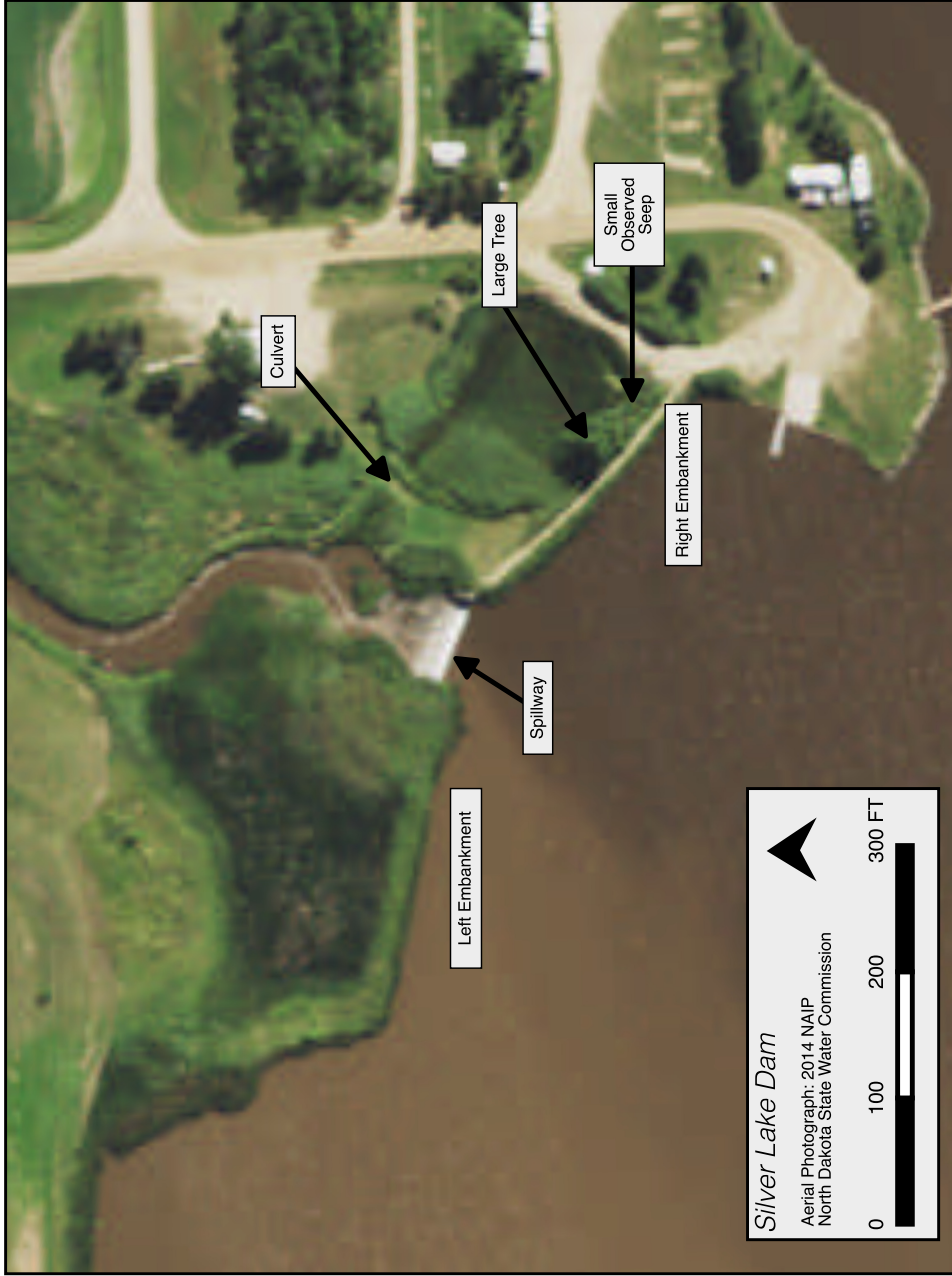
A culvert was found downstream of the right embankment, discharging into the Wild Rice River. The culvert was in a road providing access to the spillway. This 30-inch culvert had nearly an inch of water flowing through it, towards the river. Due to the seasonal conditions at the time of the visit, existing snowpack and freezing temperatures, this flow indicates considerable seepage through the right embankment. After viewing the flow through the culvert, the toe of the embankment was investigated to determine whether the seepage was coming through or under the embankment.

A small seep was located several yards east of the large tree in **Figure 3**. **Figure 4** shows the small seep in location to the culvert, and **Figure 5** is a photograph of the seep. The seep does not appear to produce the amount of flow observed at the culvert.

**Figure 4.** Shows the small observed seep in location to the culvert and the embankments.

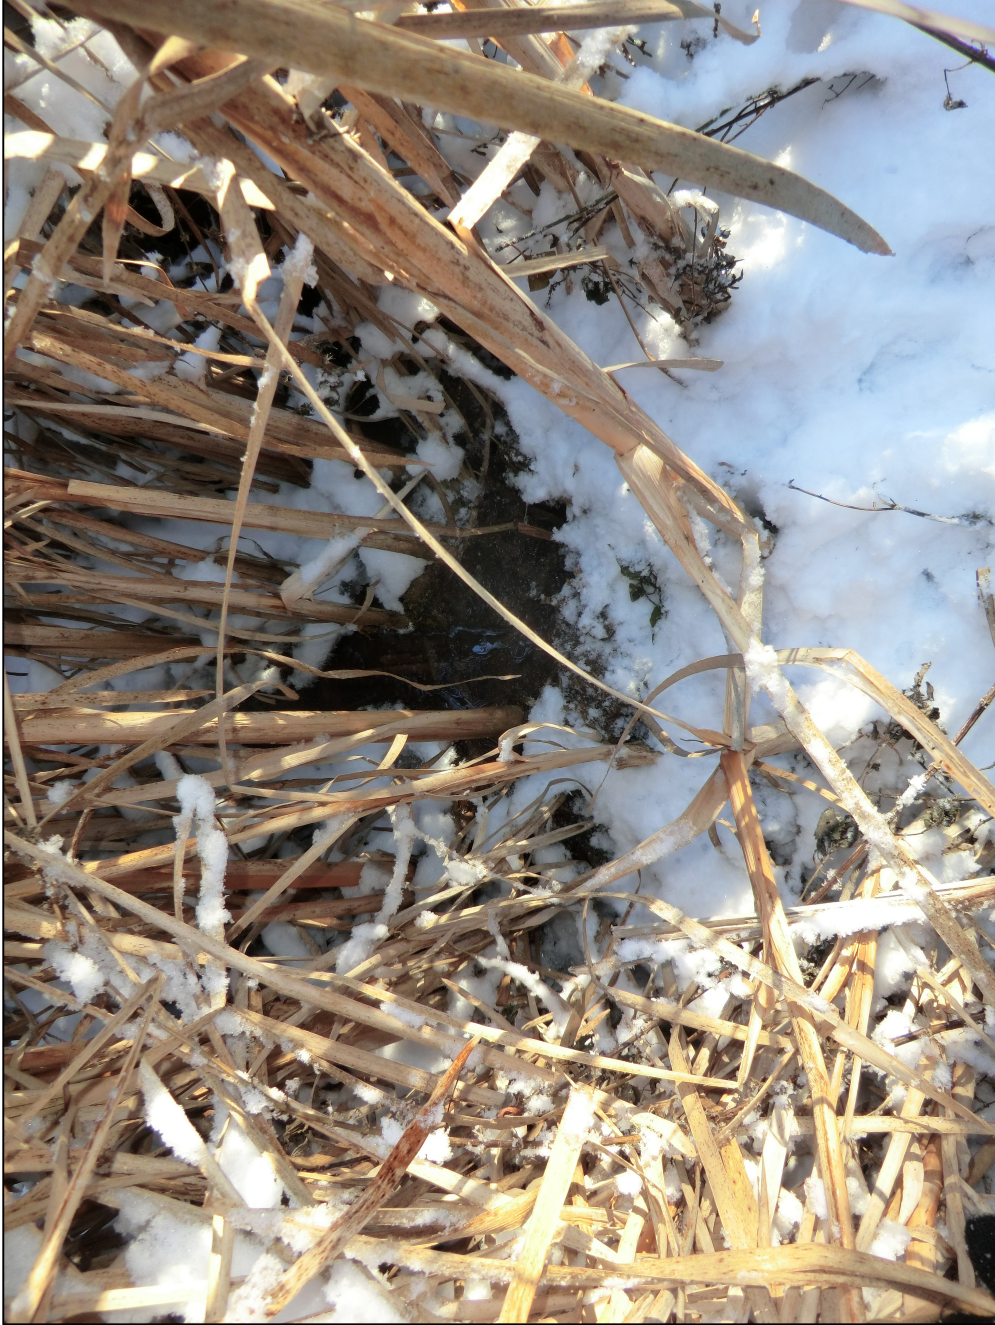
**Figure 5.** Seep on the right embankment east of the large tree.

After observing a discrepancy in flows between these points, it is apparent that another flow source is contributing to the flow at the culvert. This source could be from flow moving from the east edge of the embankment below the stagnant surface water or from flow under the embankment through a permeable seam flowing into the cattails to the north of the right embankment.

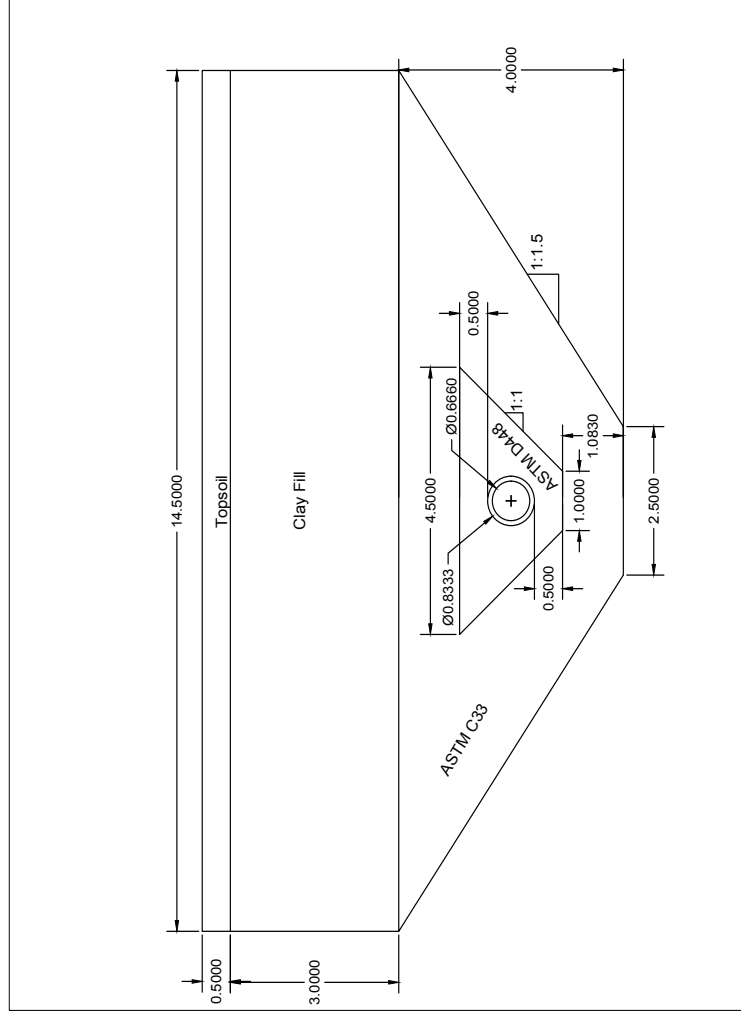
**Figure 8.** Silver Lake proposed toe drain design (dimensions in feet).

objectives. **Figure 8** is a preliminary cross section view of the toe drain designed for Silver Lake's right embankment and **Figure 9** is the approximate footprint of the toe drain. Approximate quantities for construction materials to complete the toe drain are in **Table 5** below. Volumes were calculated using the geometry in Figure 6 and given a 15 percent buffer to account for compaction.

We recommend the SCWRD proceed with Alternative 2.

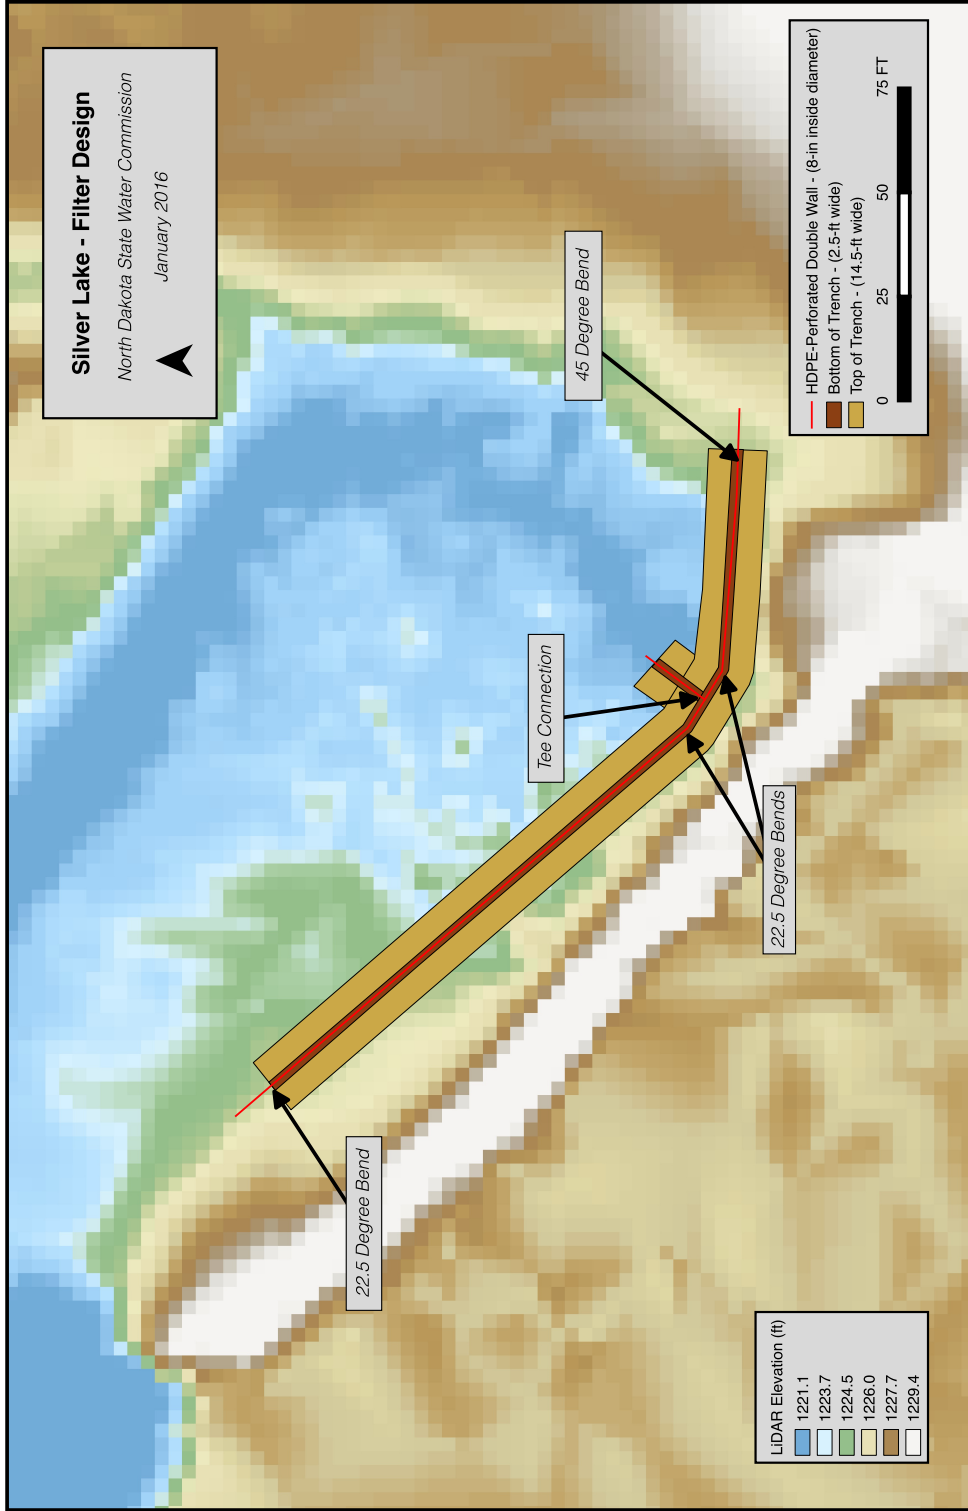
Figure 9. Silver Lake proposed toe drain footprint.
