# Upper Missouri River Bank Erosion

# Montana and North Dakota April 1991

#### UPPER MISSOURI RIVER

#### BANK EROSION

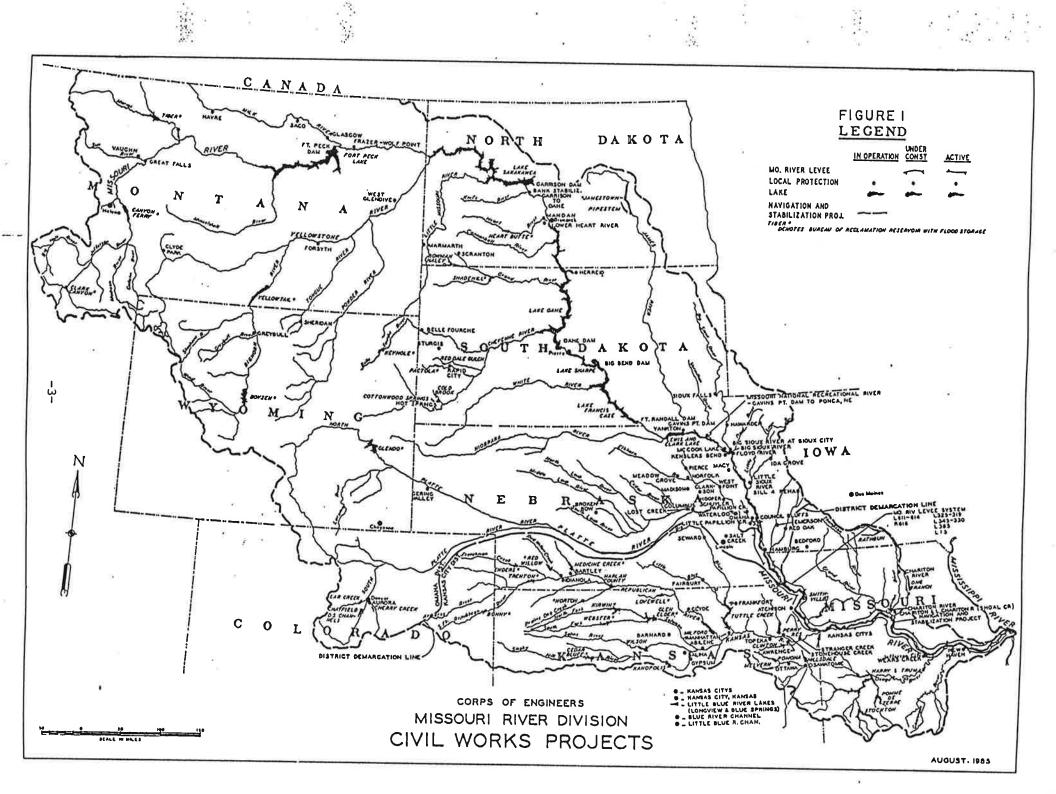
The Missouri River drainage basin consists of 529,000 square miles and includes all or parts of ten states, Figure 1. There are six main stem dams located along the thousand mile reach of the Missouri River extending from Yankton, South Dakota to Glasgow, Montana. Open reaches of river exist between Fort Peck and Lake Sakakawea (204 miles), Garrison and Lake Oahe (87 miles), Oahe and Lake Sharpe (5 miles), Fort Randall and Lewis and Clark Lake (44 miles), and downstream of Gavins Point Dam (58 miles). The area upstream of the point 58 miles downstream of Gavins Point is referred to as the upper basin, Figure 2. The five open reaches are the focus of this report with emphasis given to the reaches between Fort Peck and Lake Sakakawea and between Garrison and Lake Oahe.

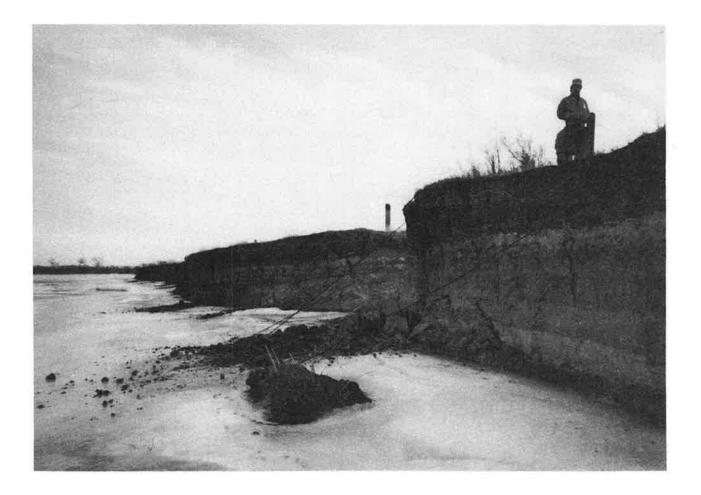
Recent mass wasting is evident as freshly fallen soils accumulate on the river ice (February, 1990). The cables are remnants of previous attempts to stabilize the banks. The landowner at this location noted that the local power company had moved power lines along this reach, and the bank recedes at an average rate of about 5 feet per year. This erosion site is about 9000 feet long.

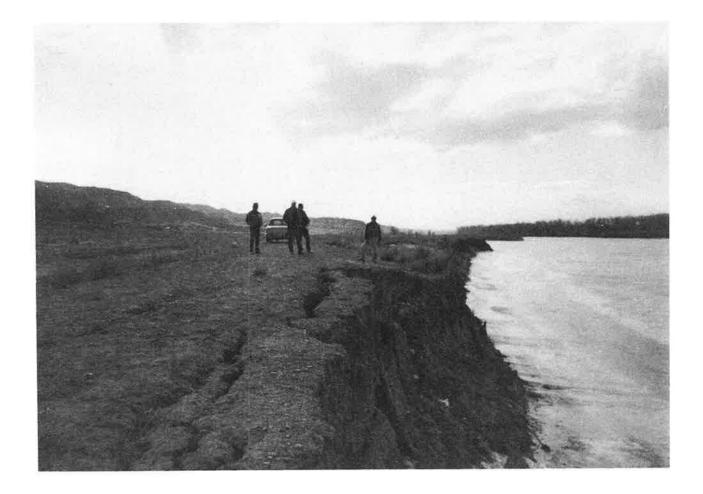
Looking west along the south side of the Missouri River in Richland County, Montana. These individuals are standing on a former county road, which has since been moved to the south.

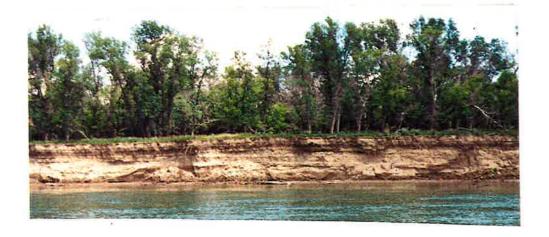
## Garrison to Oahe Reach Erosion Site #18

The left bank of the Missouri River at approximately river mile 1352. Part of approximately 4000 feet of eroding bank.

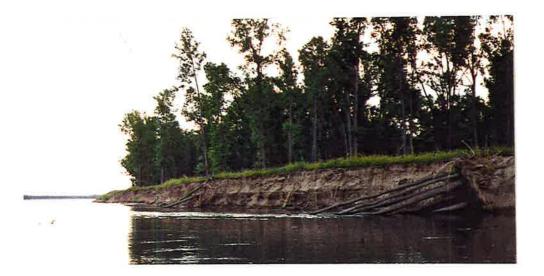
#### Garrison to Oahe Reach Erosion Site #30

The right bank of the Missouri River at approximately river mile 1343. This is part of approximately 4000 feet of bank which is eroding.

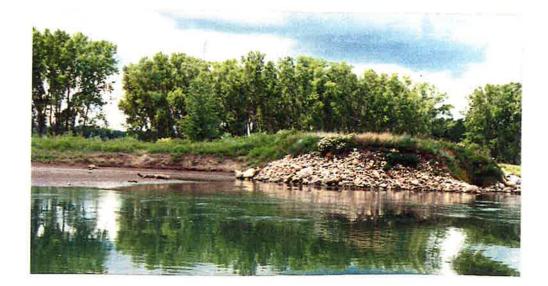
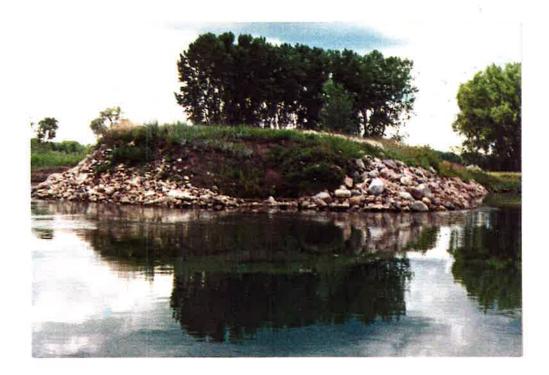
The dike is protecting the bank downstream, the photo above shows sediments deposited downstream of the dike. However, the photo below shows a scour hole on the upstream side of the dike. If the damage is not repaired, the entire dike may erode, allowing the river to began attacking the bank once again.
