# Technical Manual: Outlet Works Energy Dissipators

Best Practices for Design, Construction, Problem Identification  
and Evaluation, Inspection, Maintenance, Renovation, and Repair

FEMA P-679/ June 2010

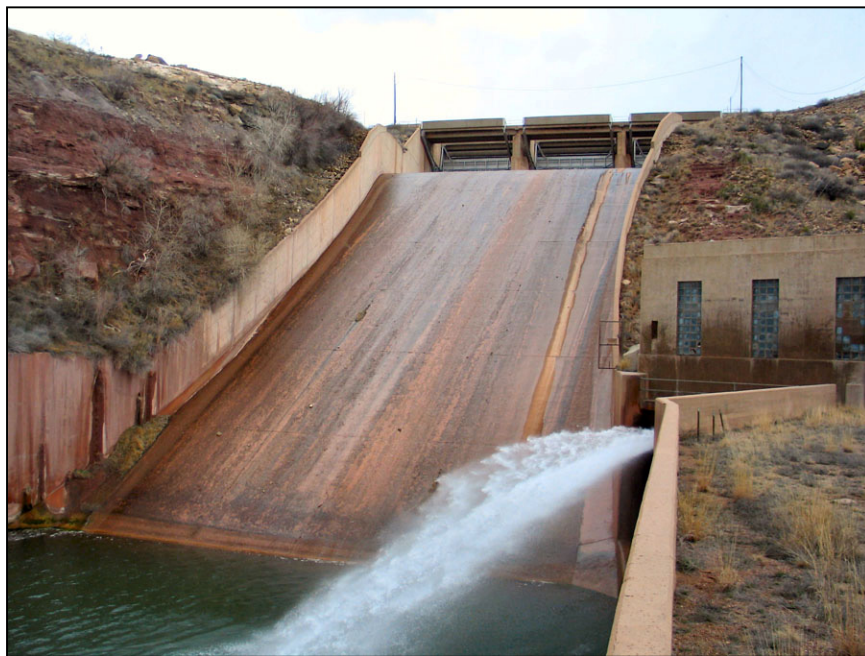
Figure 3.—An outlet works discharging into a spillway stilling basin.

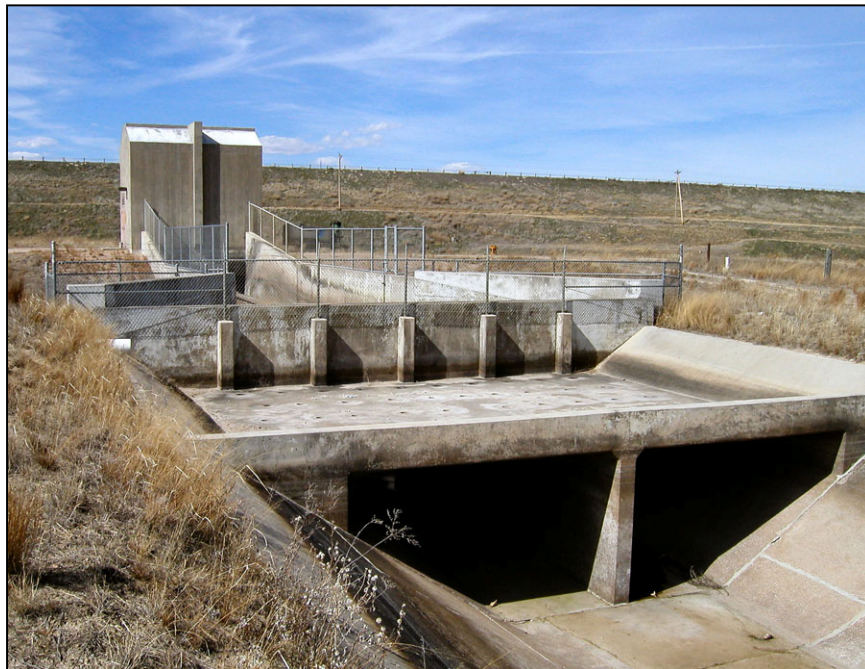
**Figure 34.**—This wave suppressor (also known as an underpass-type) was constructed after completion of the stilling basin to prevent unanticipated waves exiting the basin from overtopping the downstream canal lining. Overtopping could result in either undermining of the soil supporting the canal lining or introduction of uplift pressures beneath the canal lining. Note the formed openings through the deck of the wave suppressor.

The type IV basin is typically used for outlet works, canal structures, and diversion dams. Two separate type IV basins have been developed and have proved relatively effective for dissipating the bulk of the energy of the flow. However, the wave action propagated by the oscillating flow cannot be entirely dampened. Auxiliary wave dampeners or wave suppressors must sometimes be used to provide a smooth flow surface downstream. Figure 34 shows an example of a wave suppressor at the

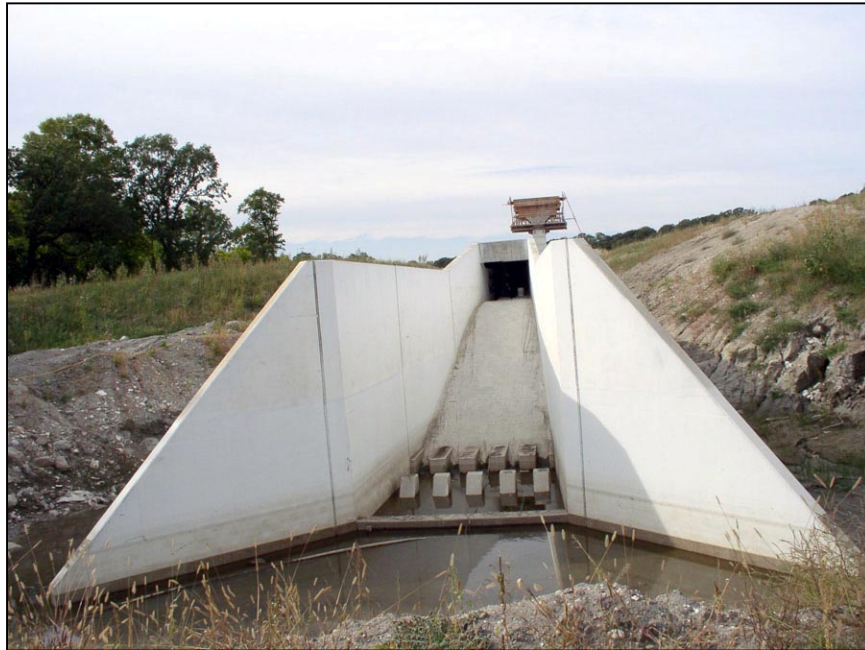
Figure 46.—SAF stilling basin.

The SAF stilling basin uses chute blocks at the entrance of the basin to increase the inflow depth and break up the high velocity flow into a number of small streams.

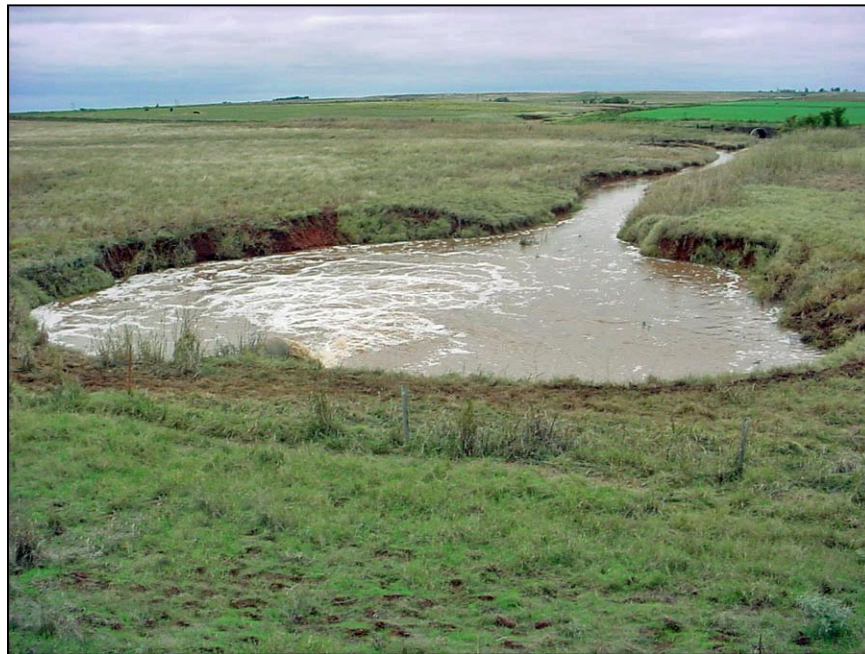
**Figure 58.**—Unlined plunge basin (view is looking downstream). This basin has been allowed to scour over time.

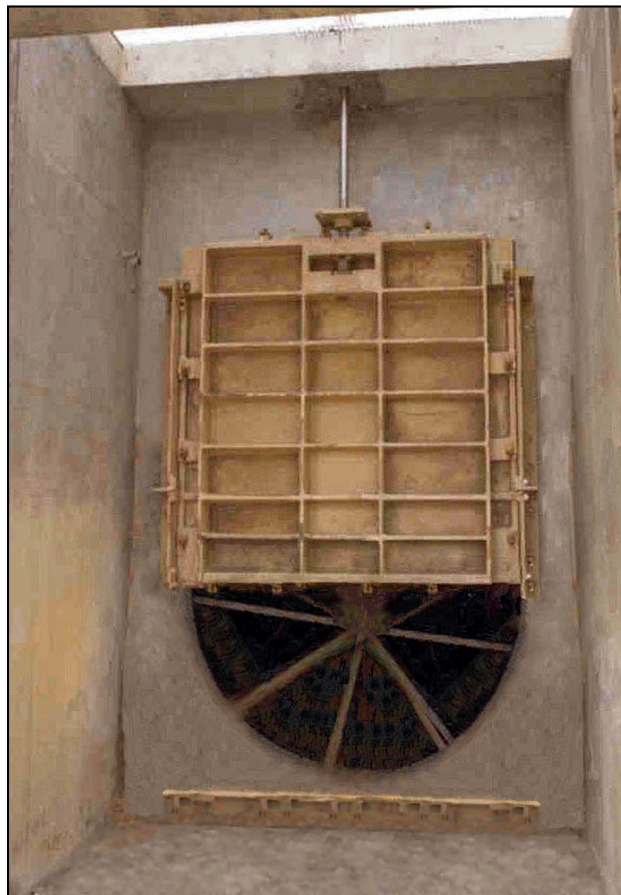
Figure 104.—Unbonneted slide gate.

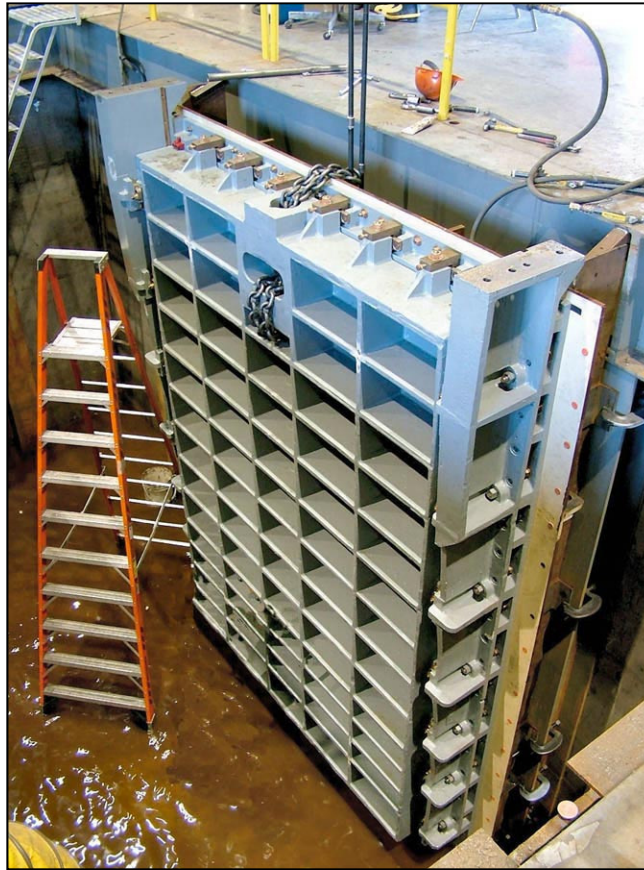
**Figure 105.**—Shop testing of cast-iron slide gate. Photo courtesy of Rodney Hunt Corporation.

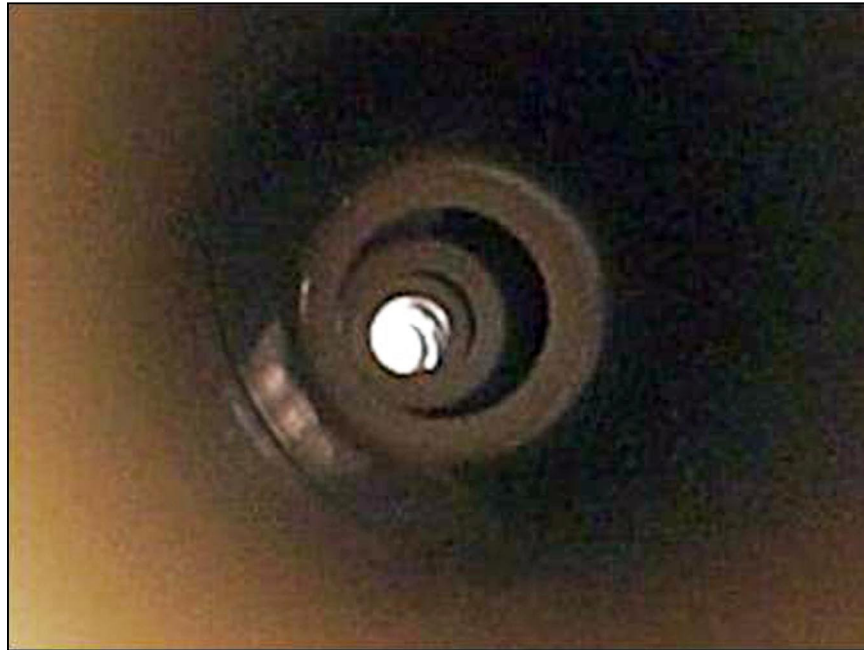
Figure 116.—Looking upstream at inline orifices within a 36-inch outside diameter pipe.

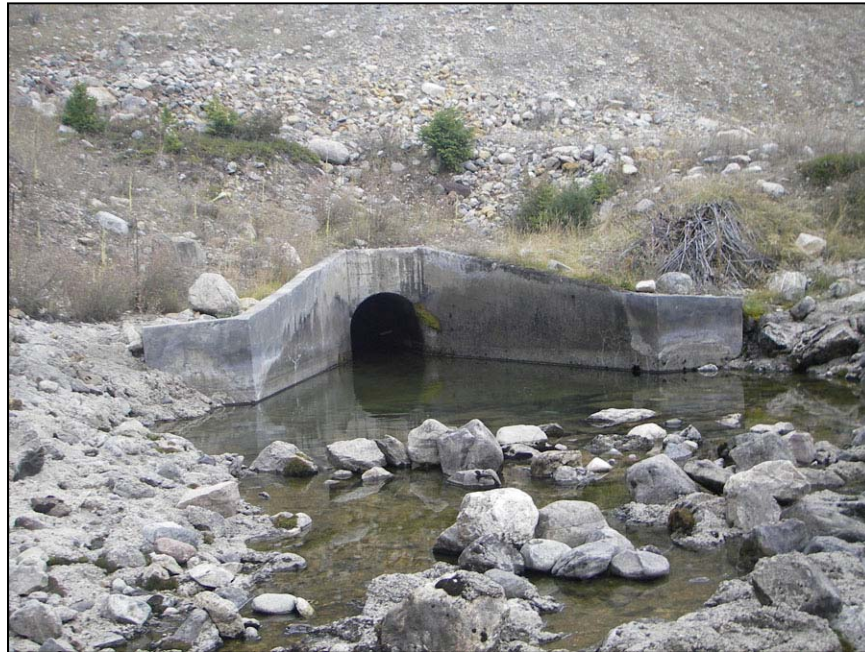
**Figure 126.**—The grouted riprap has performed well although some of the larger rocks in the foreground are displaced immediately downstream of the concrete apron.

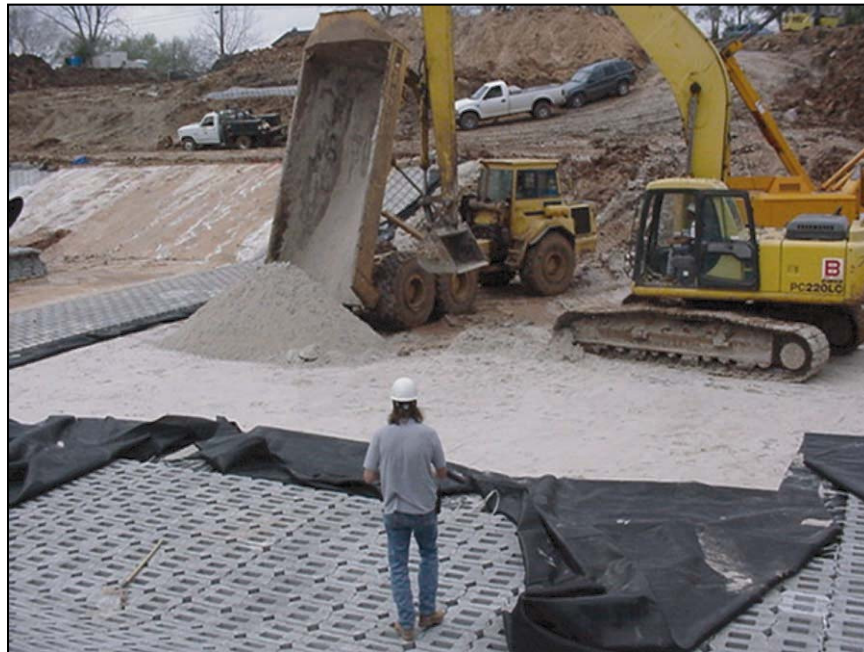
**Figure 133.**—An ACB system using a combination granular and geotextile filter.

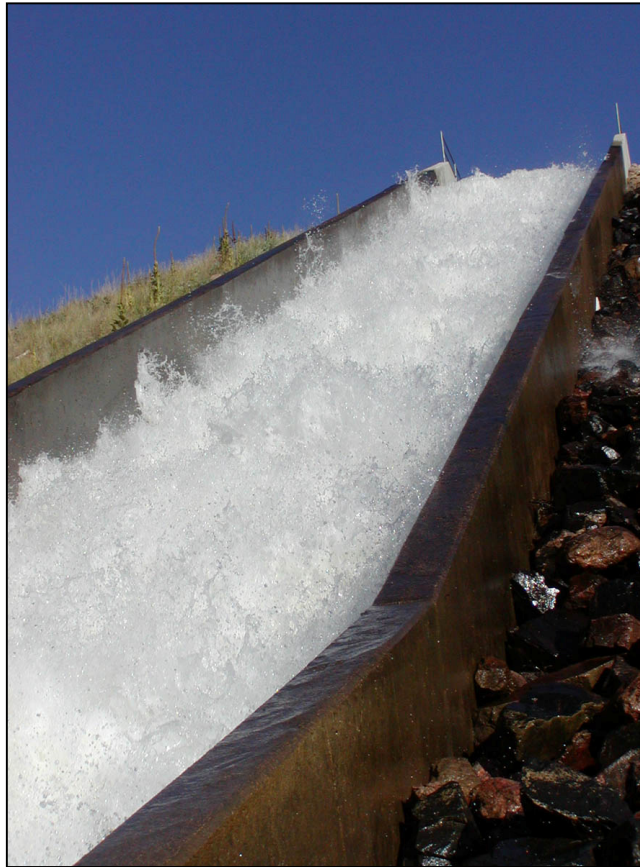
**Figure 140.**—Baffled drop aerating the flow so that it becomes saturated.

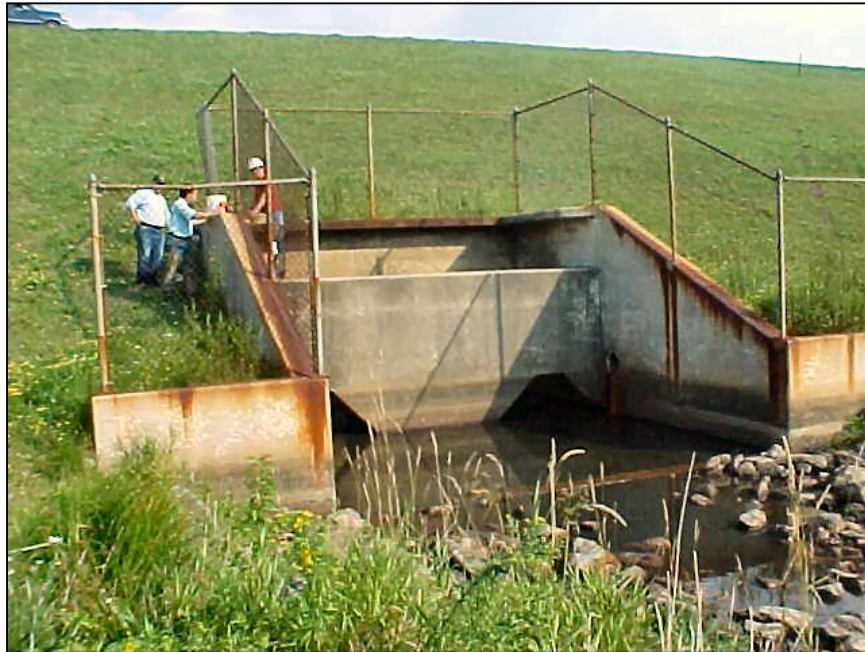
**Figure 144.**—A periodic inspection being performed at an impact basin.

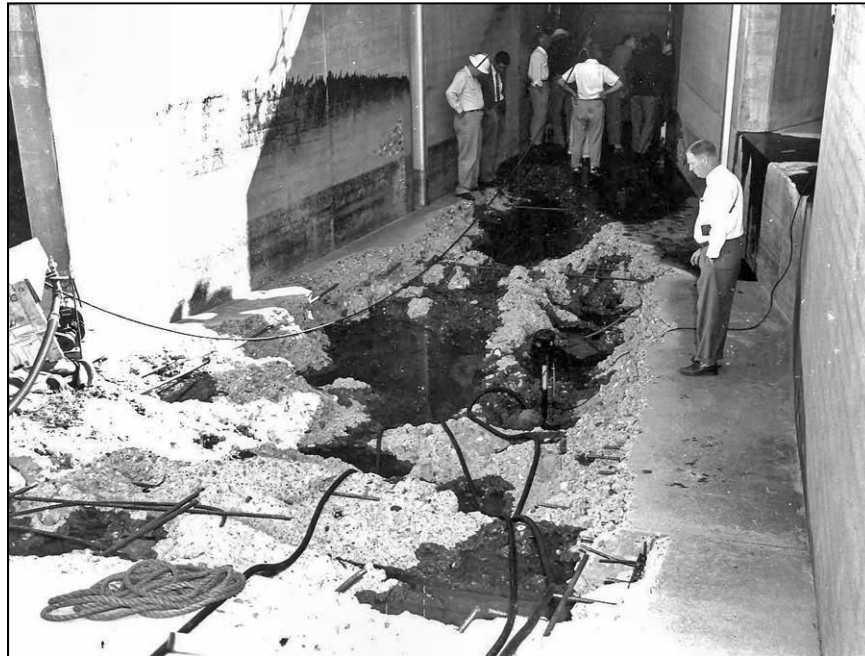
**Figure 145.**—The invert of this flip bucket sustained significant cavitation damage during operation.

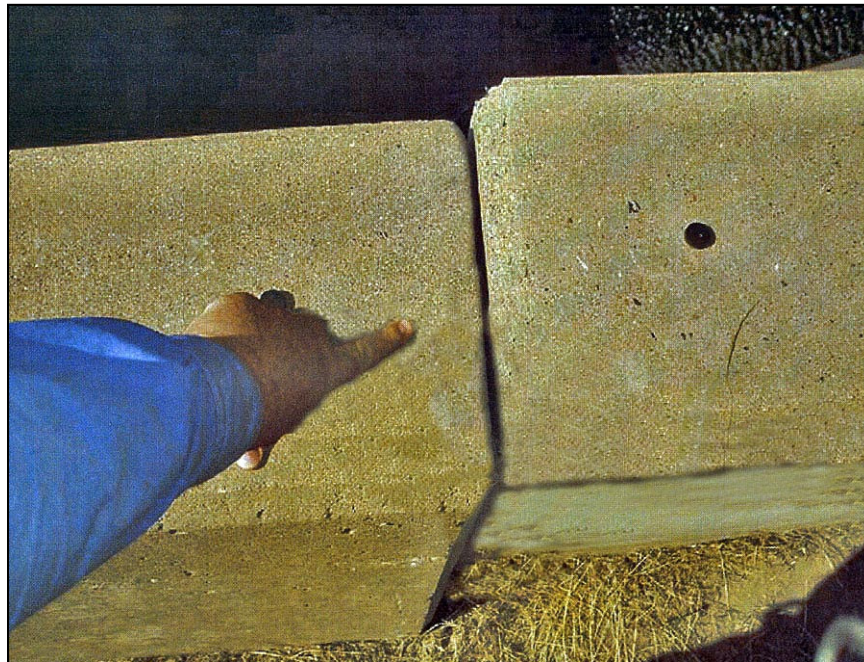
**Figure 152.**—This vertical wall joint has experienced a 2-inch offset.

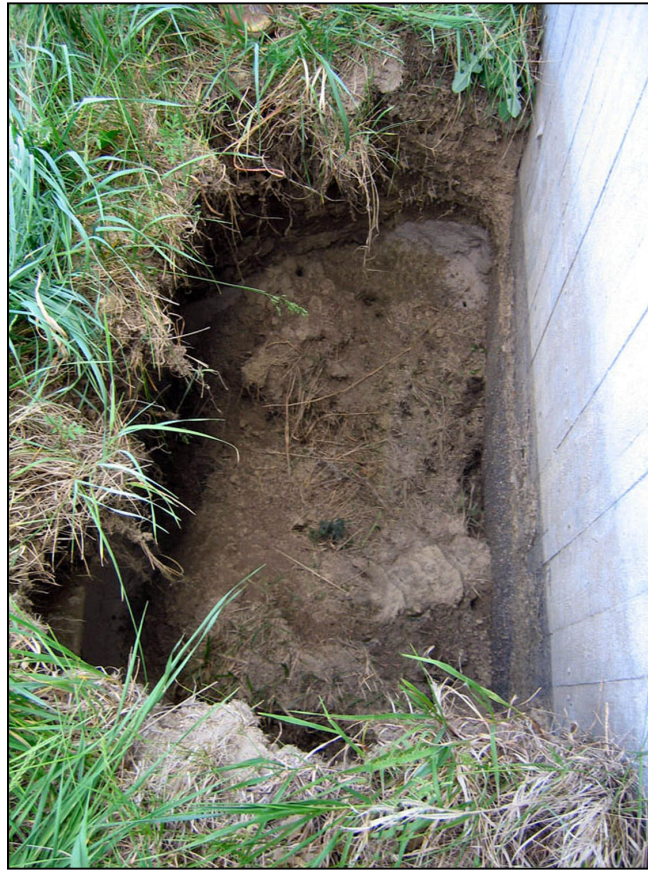
**Figure 154.**—A sinkhole developed next to this basin wall indicating internal erosion of foundation materials was occurring.

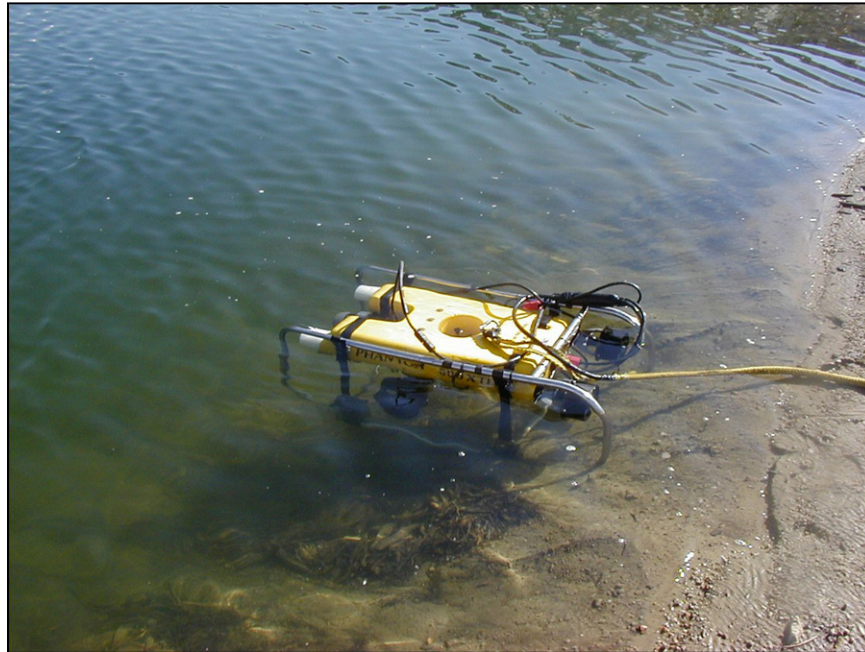
**Figure 159.**—An observation-class ROV entering the water to begin an inspection.

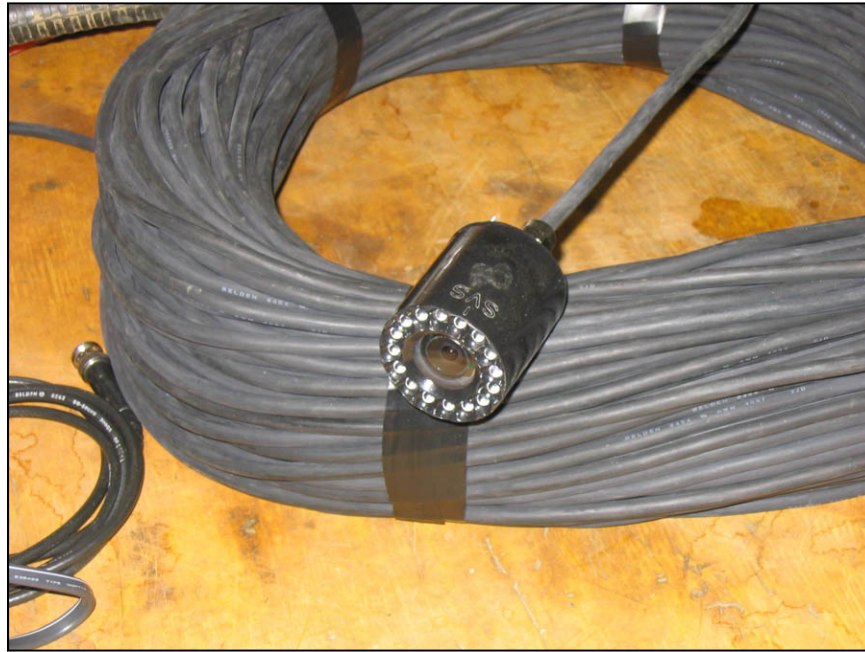
**Figure 161.**—Small video camera that can be attached to PVC or metal poles and manually pushed into underdrain pipes.

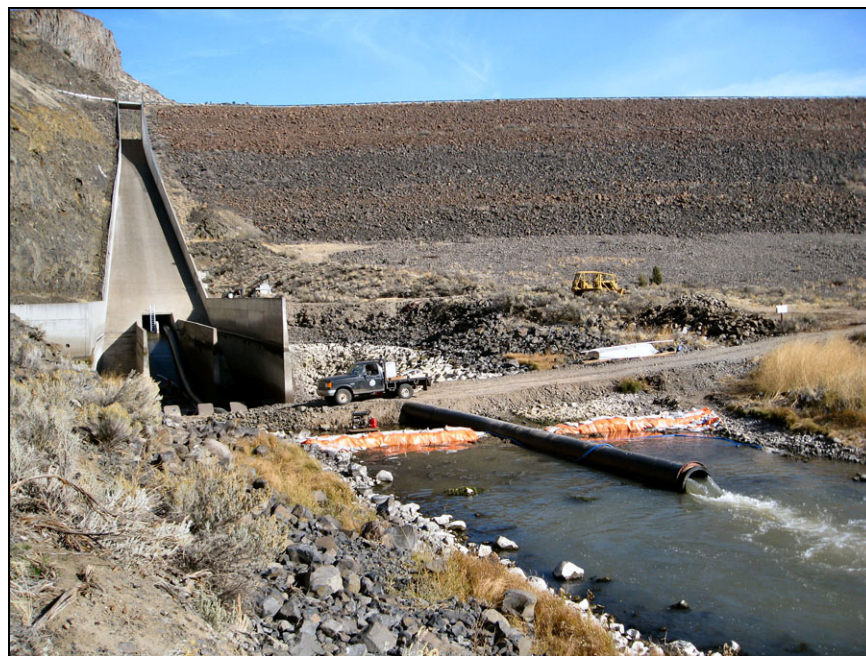
**Figure 166.**—Cofferdam constructed to keep the basin area dry for repairs.

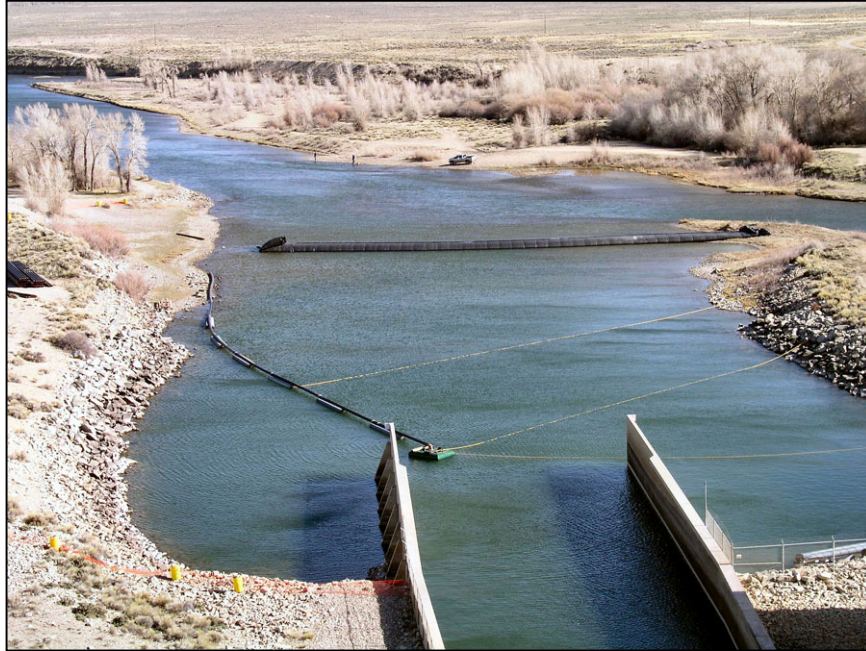
**Figure 167.**—A polyethylene baffled bladder dam is being placed downstream from a stilling basin. The dam is 250 feet long by 19 feet wide by 8 feet high. The dam weighs 2,600 pounds (dry). Two 3-inch pumps (8 hp) and two 3-inch pumps (4.5 hp) were used to fill the dam with 150,000 gallons of water. The dam took about four hours to deploy (watering up and rolling out the dam). Upon removal, the dam took 2 hours of dewatering and 2½ hours to roll up and remove. Removal of the dam required the rental and use of two track-hoes for rolling up the dam on a log.

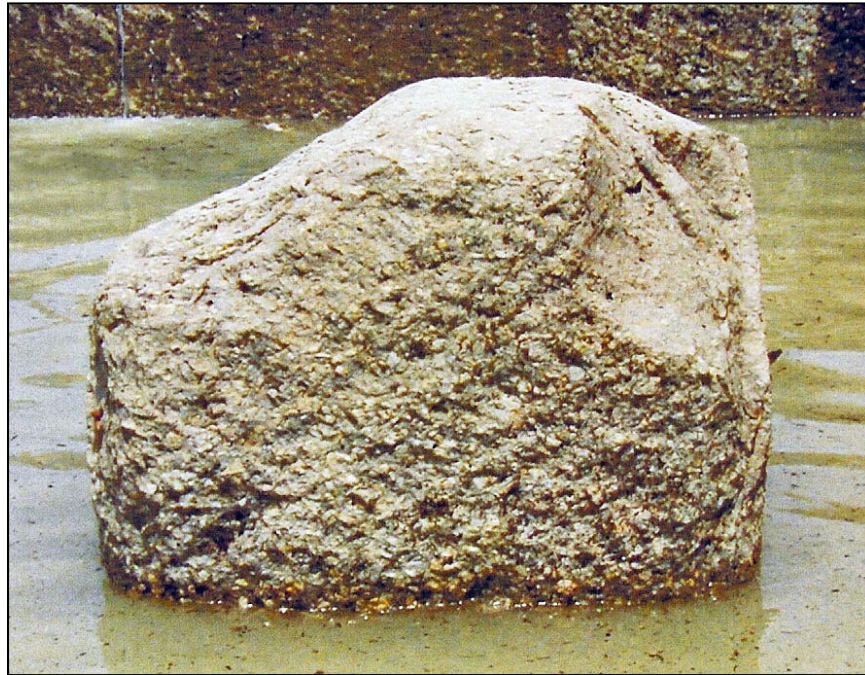
**Figure 169.**—This baffle block has experienced impact damage resulting from an object in the flow.

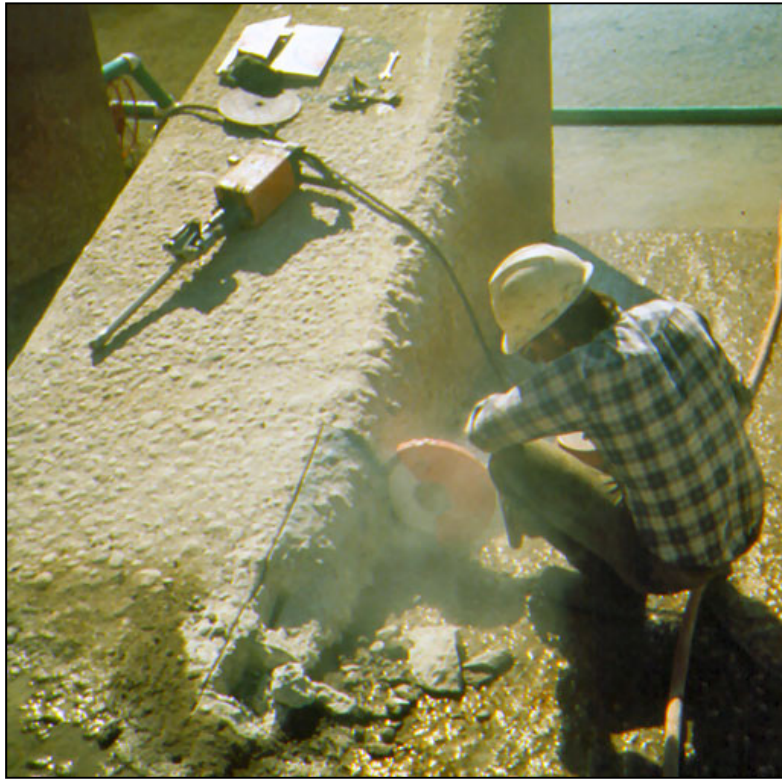
**Figure 171.**—Sawcutting the perimeter of spalled concrete prior to removal of concrete.

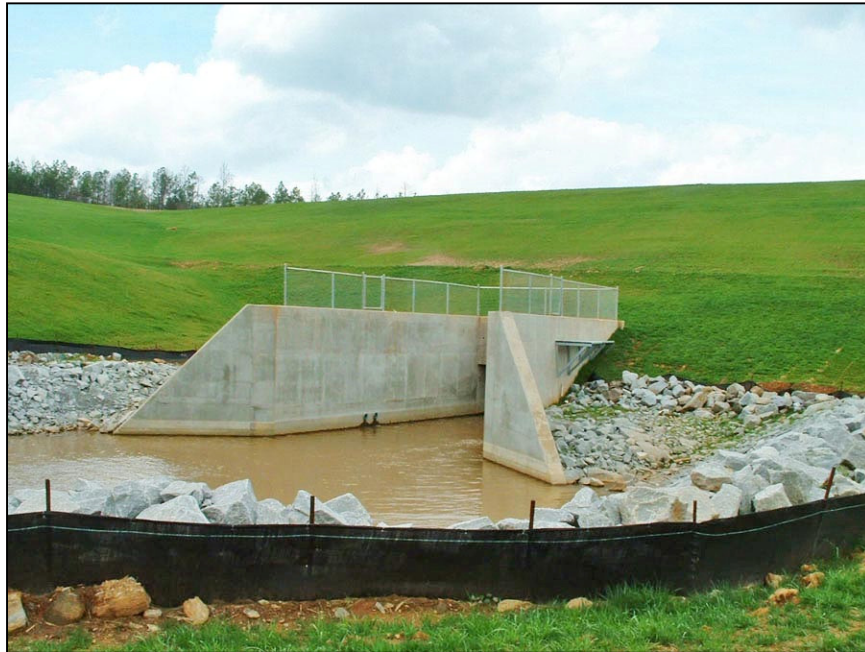
**Figure 175.**—Fencing installed along the tops of the stilling basin walls.

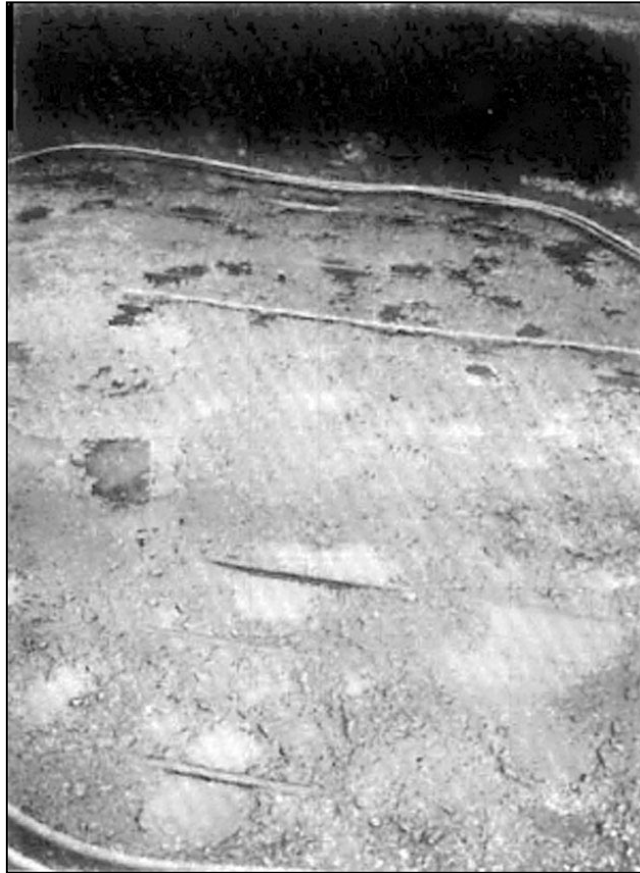
**Figure A-8.**—Exposed reinforcement in the stilling basin downstream of the baffles.

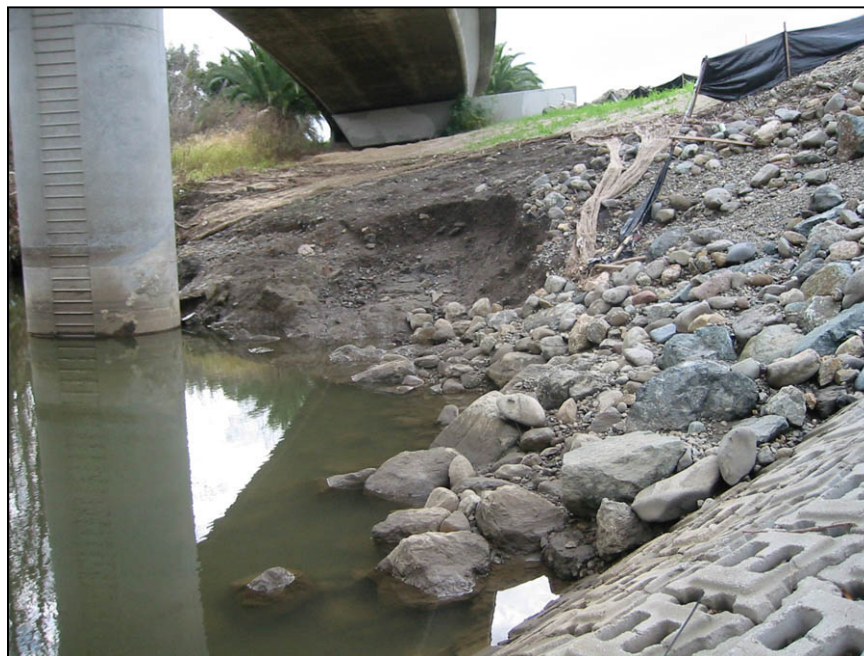
Figure A-31.—Uplifted CCM mats near the bridge pier.

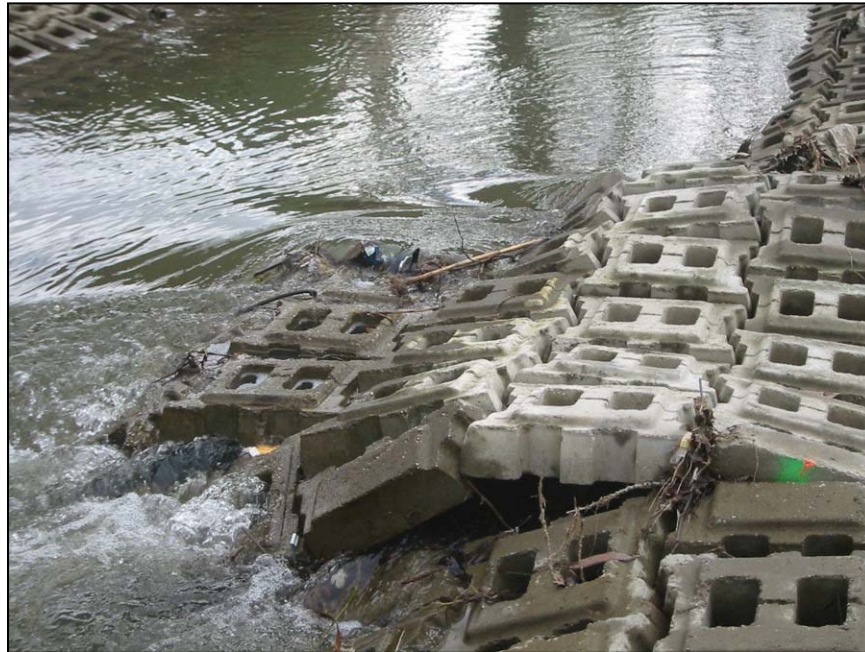
Figure A-32.—Uplifted blocks with loss of granular filter material.

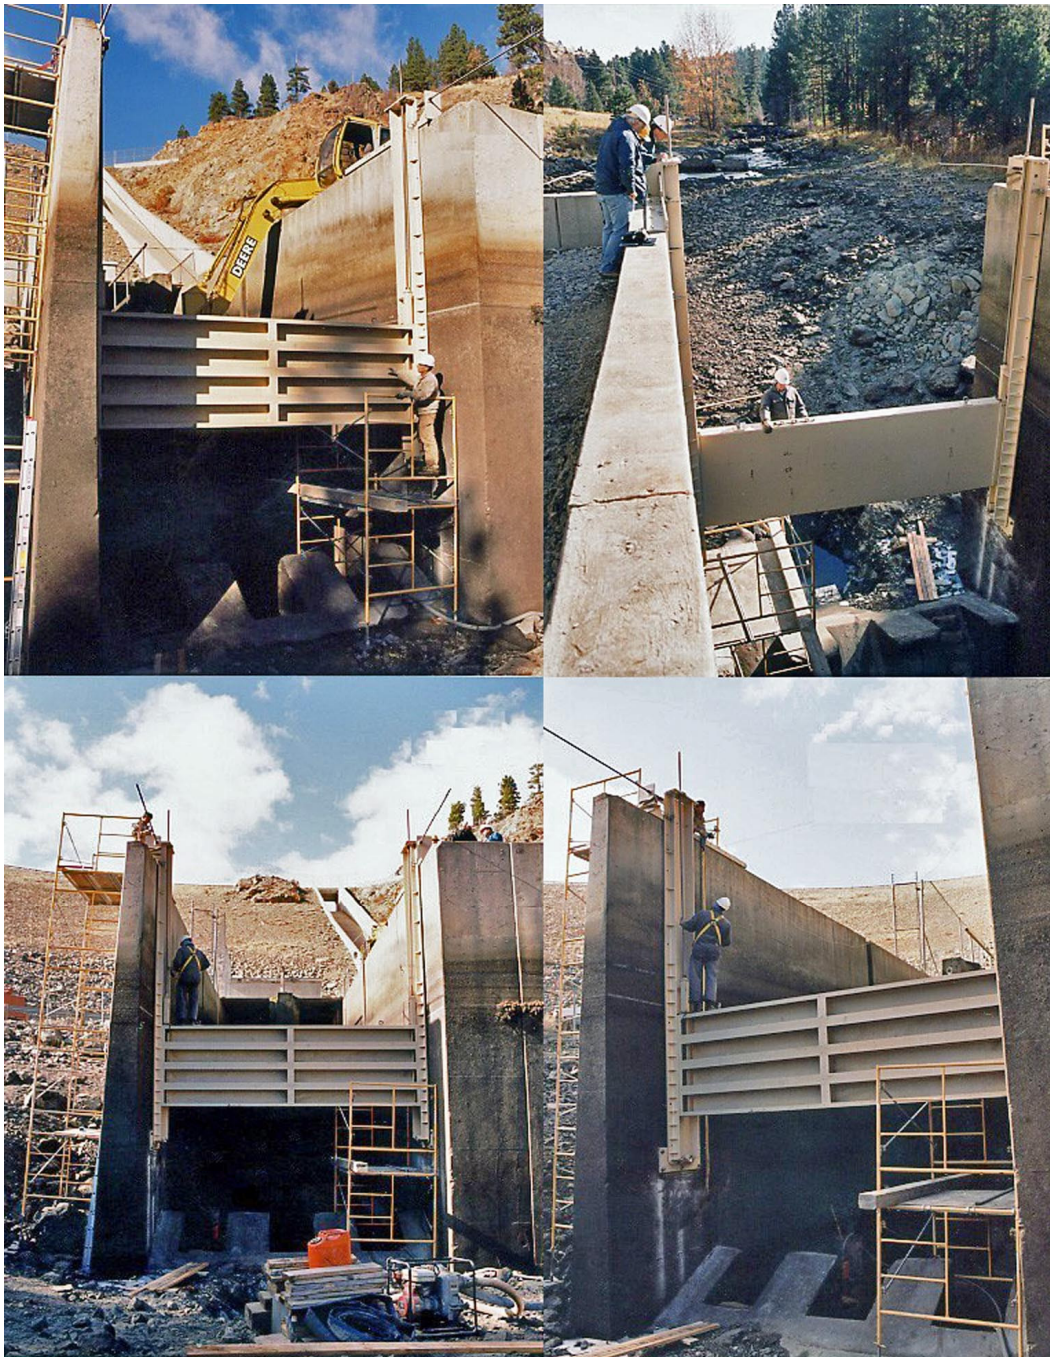
Figure A-51.—Prototype flow deflector installation at Mason Dam in October 2002.

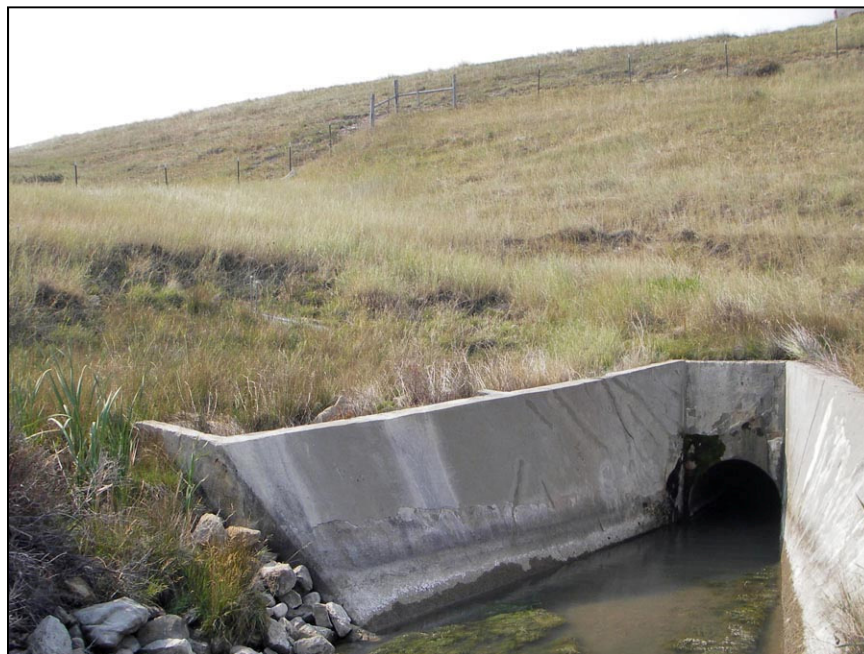
**Figure A-56.**—Original trapezoidal energy dissipator.

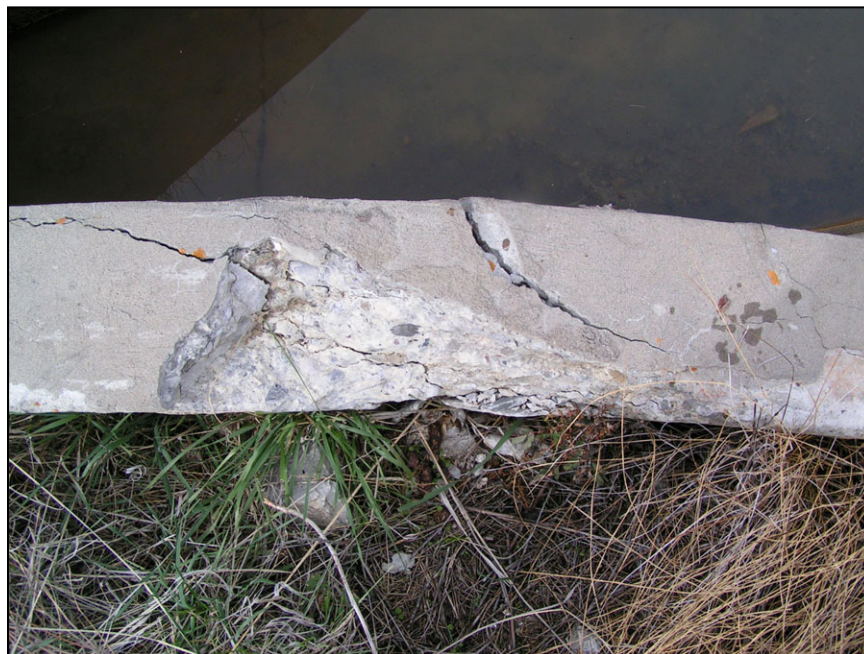
**Figure A-57.**—Deflection in left wall of dissipator.

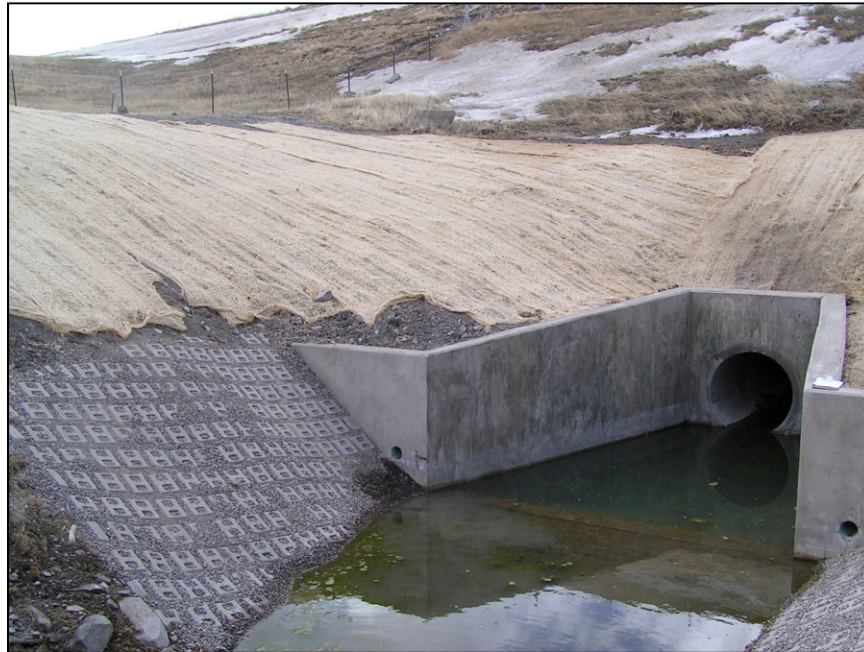
Figure A-58.—Replacement structure.

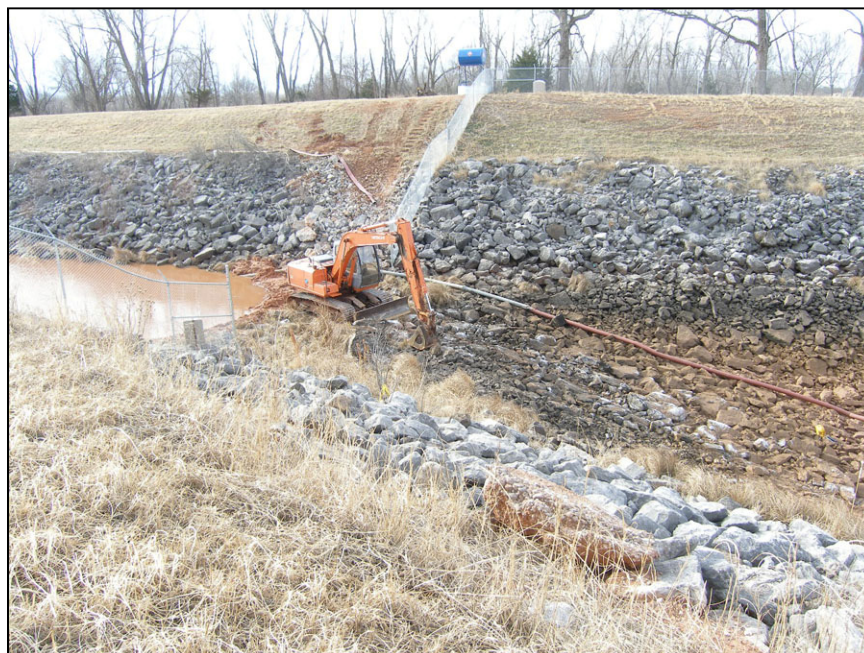
**Figure A-60.**—The contractor created a small earthen dike in the downstream river channel to facilitate unwatering of the stilling basin.

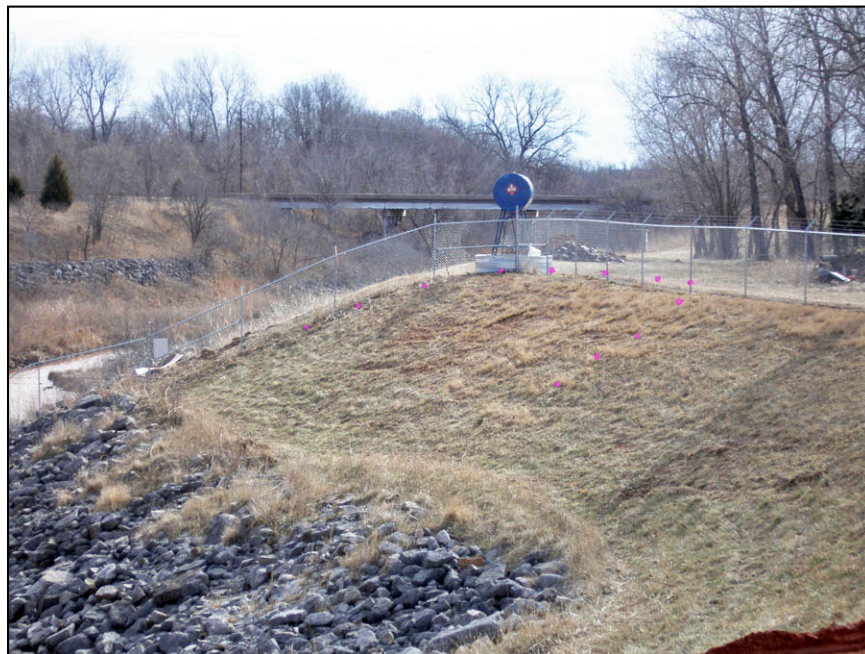
**Figure A-63.**—Shortly after unwatering, an excavated slope downstream and to the right of the stilling basin was observed to be experiencing cracking and developing a slump. There are pink flags marking the edge of the slump area.

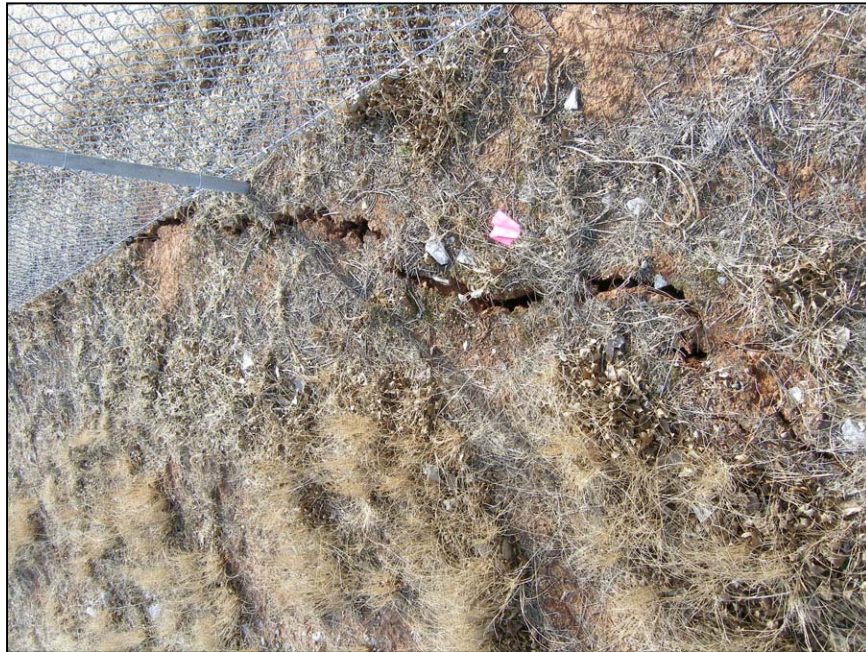
**Figure A-64.**—Cracking developing on slope near fence line.

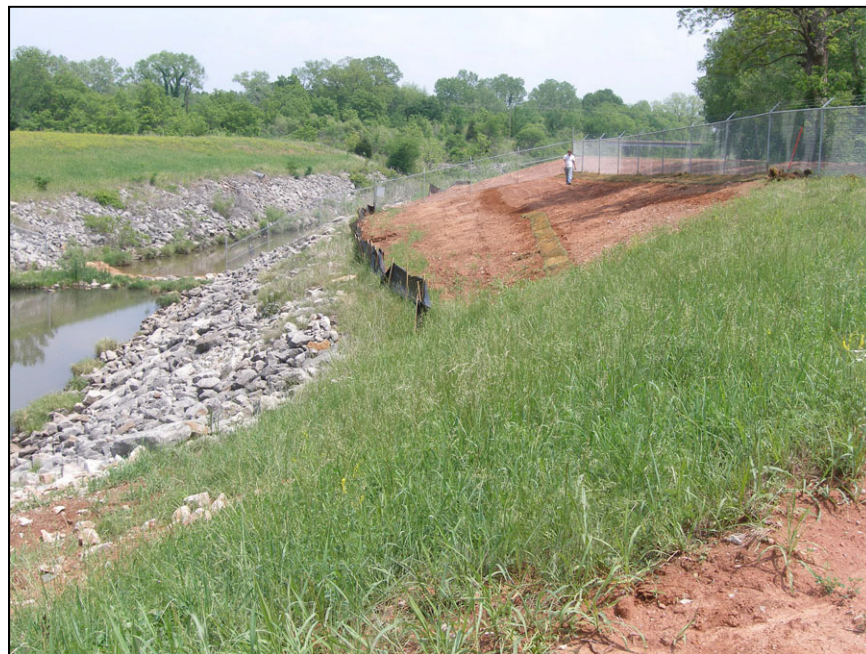
**Figure A-65.**—Slump area after cutting back slope. Sod is being placed to prevent erosion.

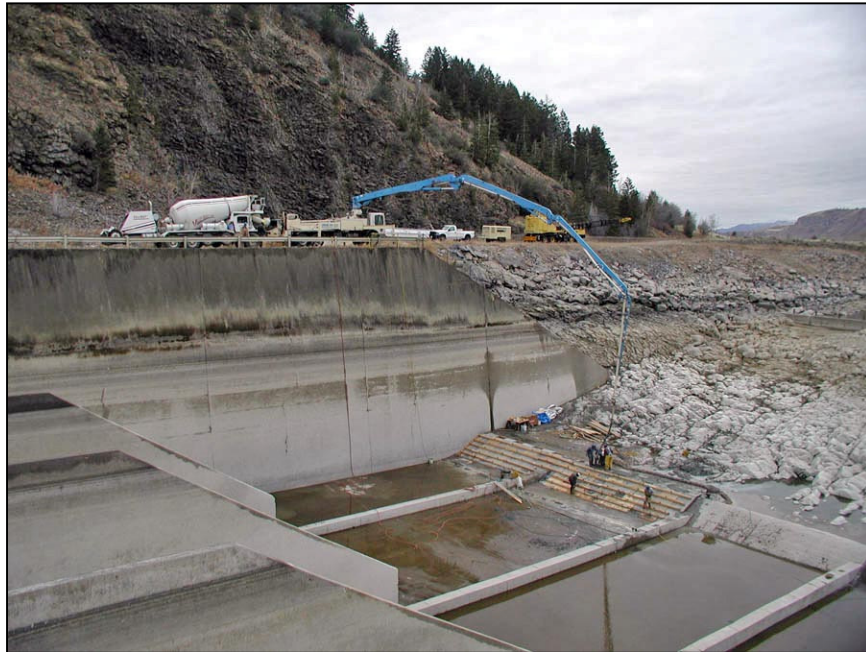
Figure A-71.—Concrete being pumped to forms for repairs to dentate sill.

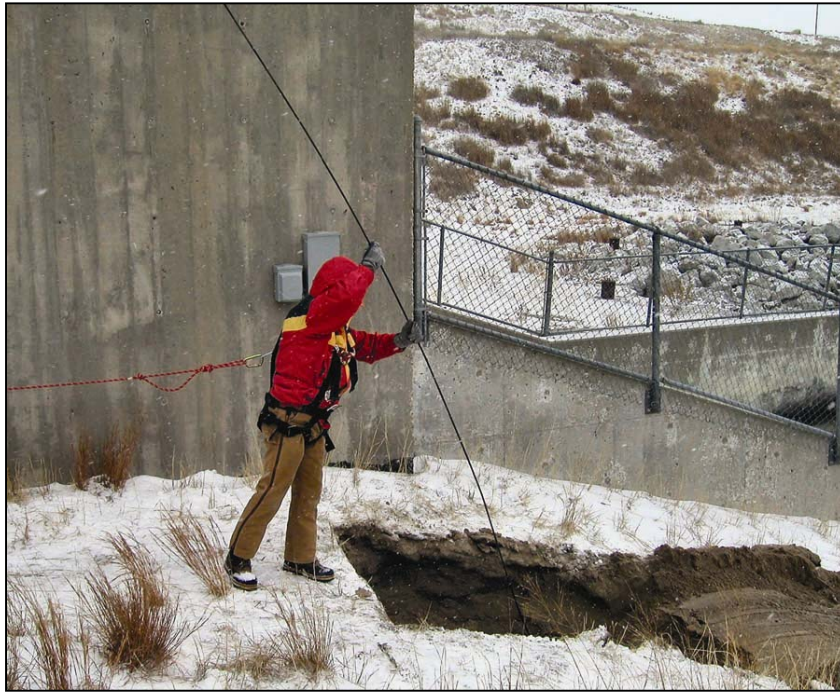
**Figure A-125.**—The depression is being probed to determine its depth.

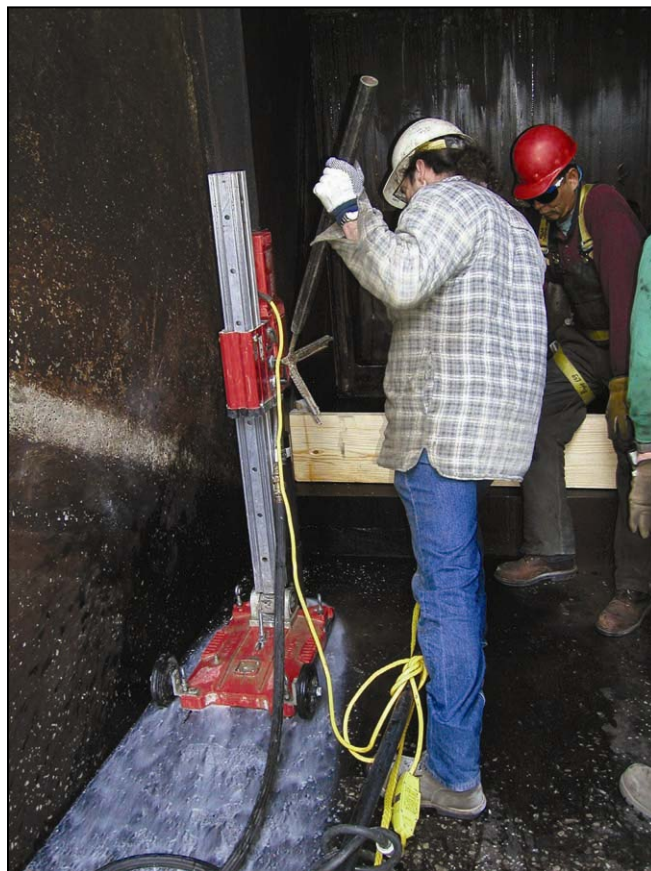
**Figure A-126.**—Drill crew drilling a hole in right bay of stilling basin.

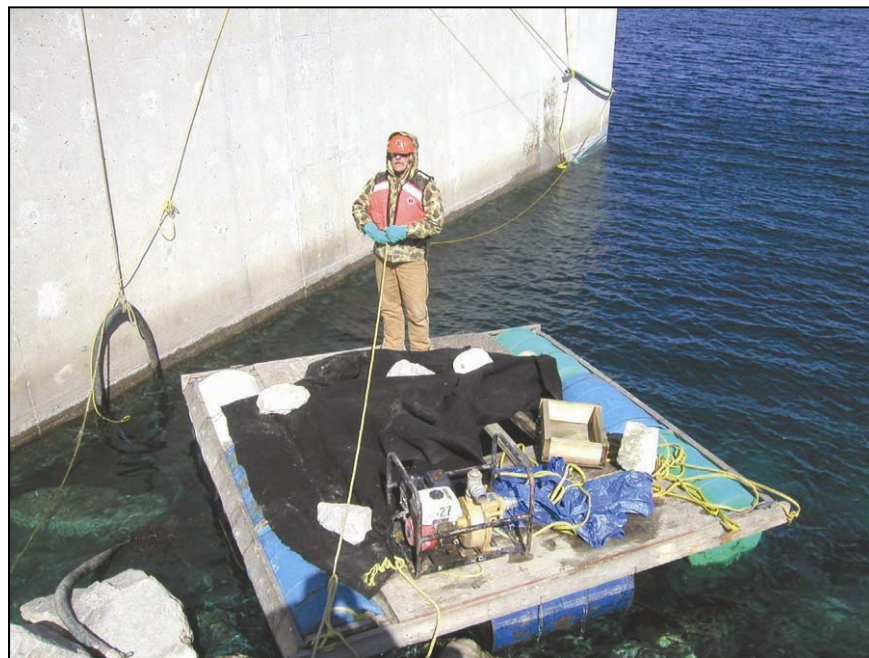
Figure A-129.—Barge used to monitor for grout blowout through foundation.
