# Silver Lake Embankment Seepage Investigation

## Sargent County, North Dakota

Investigation Report - SWC Project #391

February 2016

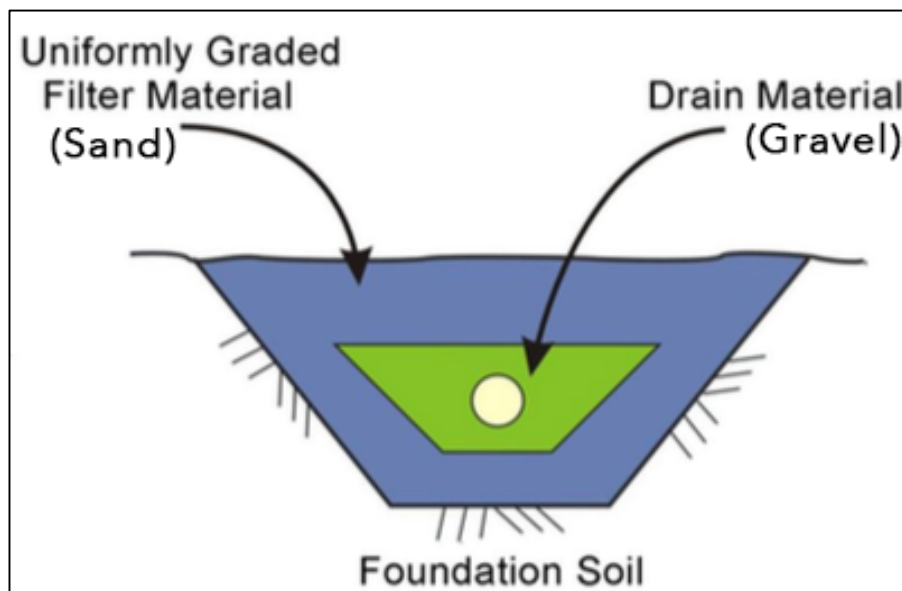
**Figure 7.** Cross section view of a standard toe drain.

Toe drains are composed of sand and gravel layers allowing the passage of water to a perforated drain while blocking particles eroding due to the seep. The drain then conveys the seepage downstream of the embankment. **Figure 7** is the general cross section view of a toe drain edited from “Figure 2-12” from FEMA’s “Filters for Embankment Dams Best Practices for Design and Construction October 2011”. The designed toe drain would run parallel to the embankment along the downstream toe.
