Technical Manual: Conduits through Embankment Dams

Best Practices for Design, Construction, Problem
Identification and Evaluation, Inspection,
Maintenance, Renovation, and Repair

Federal Emergency Management Agency

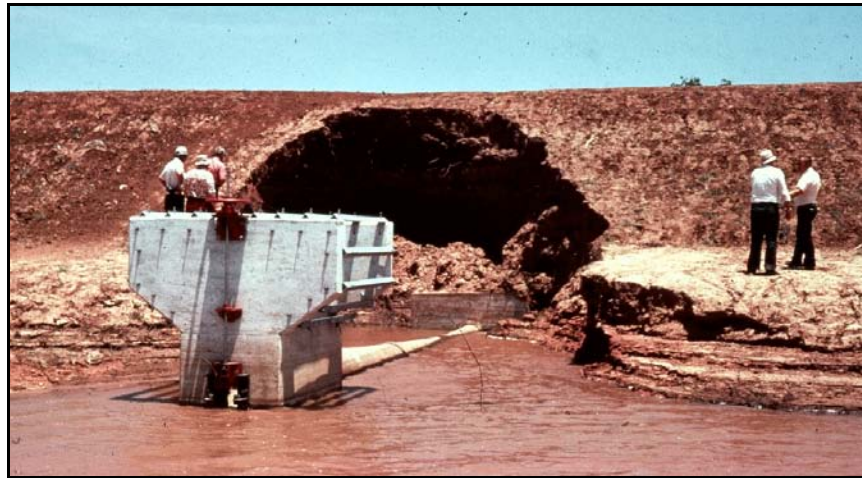
Figure 5.—Embankment dam failure caused by internal erosion of earthfill near the conduit. Flow was not directly along the contact between earthfill and conduit, but in the earthfill away from conduit. Hydraulic fracture in highly dispersive clay embankment soils caused the failure. The embankment design included antiseep collars, but not a filter diaphragm.

Historically, a single term, “piping,” has been commonly used in literature to describe all erosional processes involved in embankment dam failures. The reason for this is that frequently after a failure, a tunnel-shaped feature resembling a pipe is observed. See figure 5 for an example. In this document, two terms will be used to describe failures of embankment dams associated with uncontrolled flow of water, rather than using a single generic term. The two terms that will be used in this document are:

Often, the end result of internal erosion along the hydraulic fracture is a tunnel-shaped void (see figure 5). Loss of the reservoir contents can occur by water flowing through the tunnel-shaped void. Where the tunnel-shaped void enlarges sufficiently (see figure 5), the roof of the tunnel collapses, leaving a v-shaped notch in the embankment dam like that shown in figure 6. If the reservoir had contained a little more storage and the flow had continued a little longer through the tunnel-shaped void, the embankment dam shown in figure 5 would have collapsed and looked similar to the embankment dam in figure 6.

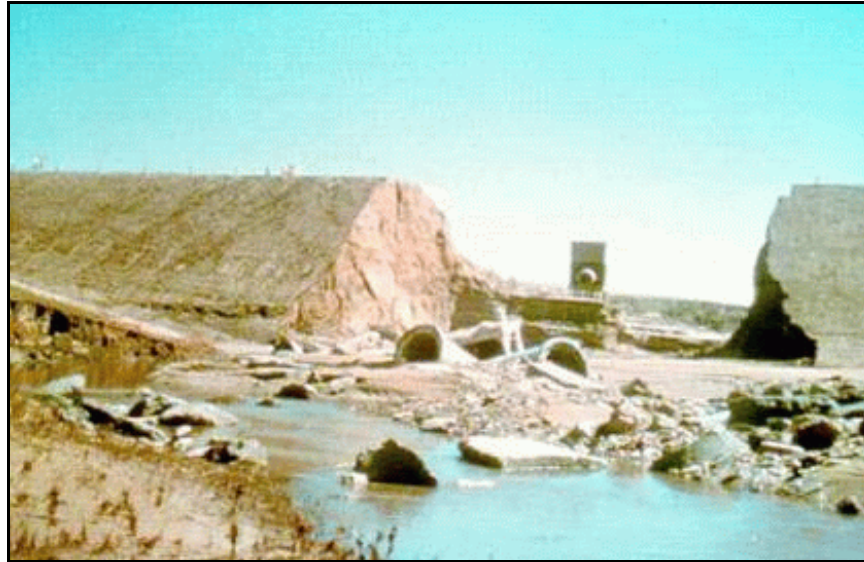
Figure 6.—Embankment dam failure caused by internal erosion of earthfill near the conduit. The initial failure was tunnel shaped, but the collapse of the roof of the tunnel resulted in the observed shape of breach. Hydraulic fracture in highly dispersive clay embankment soils caused the failure. The embankment dam design included antiseep collars, but no filter diaphragm.

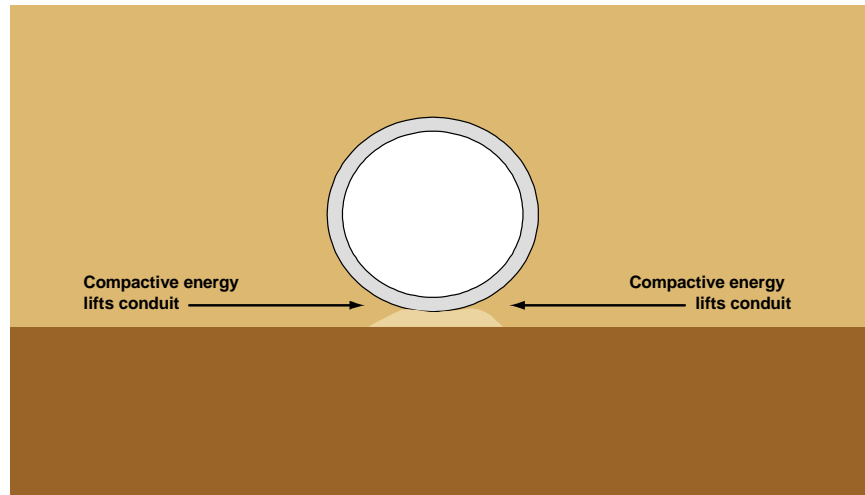
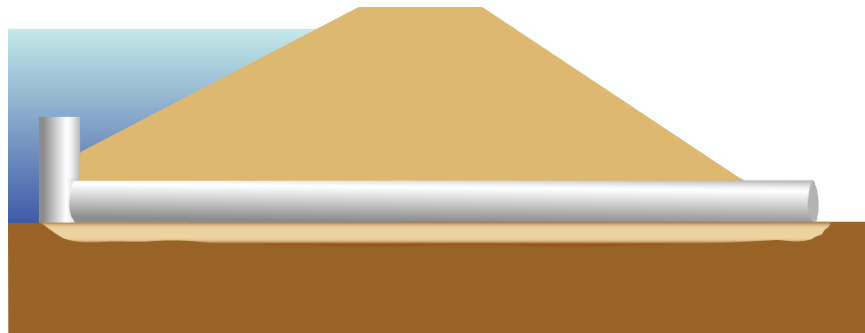
If too much compactive energy is applied while attempting to compact the embankment materials under the haunches of the conduit, a void can occur beneath the conduit.

The void can extend beneath the entire length of the conduit.

Water from the reservoir can penetrate the void, initiating internal erosion of the side walls.

Figure 9.—The internal erosion process associated with the creation of a void caused by excessive compactive energy used to compact embankment materials against the conduit.

Flowing water from the reservoir continues the internal erosion process within the void. Intergranular seepage is not necessarily involved in this process, and the soils surrounding the void may be unsaturated.

The resulting failure often leaves a tunnel-shaped void along the conduit.

- Figure 7 illustrates the internal erosion process as a result of a hydraulic fracture through the embankment dam.
- Figure 8 illustrates the internal erosion process as a result of low density embankment materials under the haunches of a pipe due to poor compaction.
- Figure 9 illustrates the internal erosion process associated with the creation of a void caused by excessive compactive energy used to compact embankment materials against the conduit.
- Figure 10 shows the backward erosion piping process associated with intergranular seepage and the subsequent backward erosion of soil particles.

As previously discussed, Failure Mode No. 3 may involve either a backward erosion piping or internal erosion mechanism of particle erosion. The *Introduction* of this document includes extensive discussions of factors that should be evaluated to determine which of these mechanisms is likely for a specific situation. Figures 8 and 9 illustrate failure mechanisms resulting from internal erosion along a conduit.

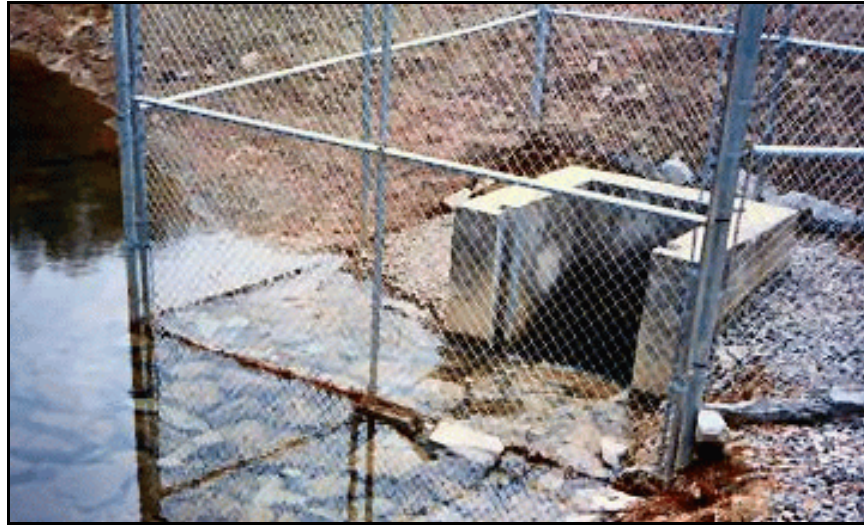
Figure 13.—An example of a decant intake structure.

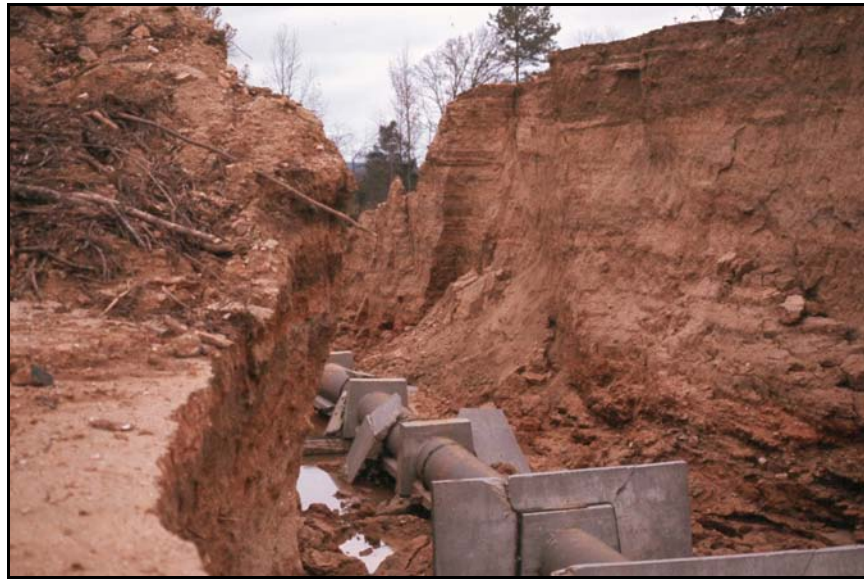
Figure 17.—Failure of an embankment dam following first filling. The failure was attributed to internal erosion because the time required for seepage to develop through the compacted embankment and cause failure was very short. Also, the soils are not the type ordinarily considered susceptible to backward erosion piping. Antiseep collars were not effective in preventing the failure.

Figures 14 through 16 show examples of the construction difficulties involved with compaction around antiseep collars. Appendix A gives a detailed history of the design rationale used for antiseep collars and reasons for their being discontinued. Figures 17 and 18 show examples of the ineffectiveness of antiseep collars in preventing embankment dam failure resulting from internal erosion near conduits.

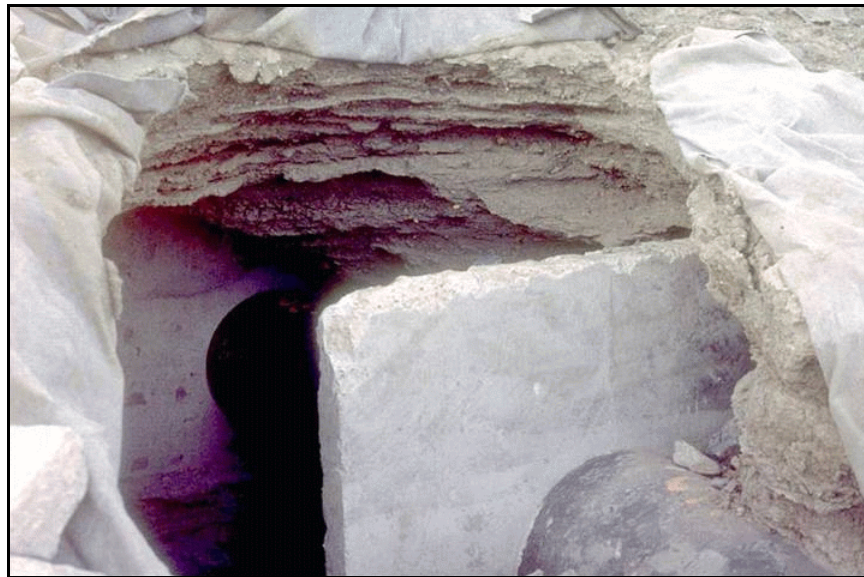
Figure 18.—Antiseep collars were not adequate to prevent the internal erosion failure of this embankment dam. The internal erosion that occurred on first filling of the reservoir occurred in dispersive clay soils that are not susceptible to backward erosion piping.

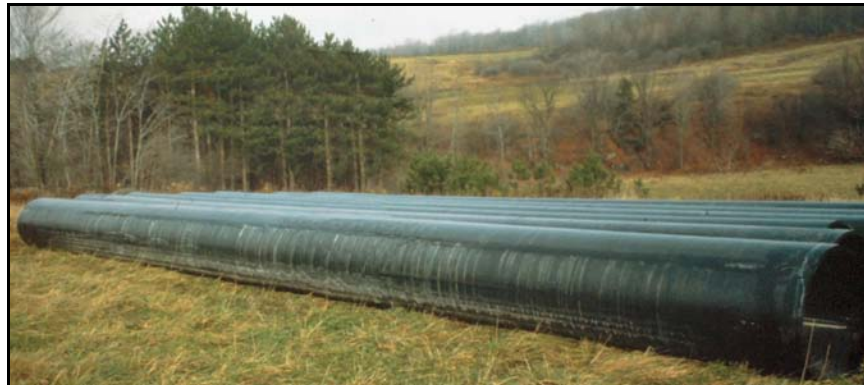
Figure 24.—HDPE pipe to be used for sliplining of an existing conduit.

Solid wall, high density polyethylene (HDPE) is the most commonly used thermoplastic material for sliplining of existing conduits. Figure 24 shows an example of HDPE pipe. HDPE pipe is an inert material and as such is not subject to corrosion or deterioration, has a long service life, and requires little maintenance. This is especially important in small conduits that are not easily renovated and cannot be easily inspected. HDPE has been used in sliplining of existing conduits, since the early 1980s. HDPE is typically available in sizes up to 63 inches in diameter. The manufacturer can fabricate HDPE pipe fittings, such as bends, flanges, reducers, and transitions. Specialized fittings can also be custom fabricated. HDPE pipe is typically black. However, HDPE pipe is also available with gray and white pigmentation to reduce glare and improve conduit inspection using closed circuit television (CCTV) equipment. For guidance on the use of HDPE pipe in conduit sliplining applications, see section 12.1.1.

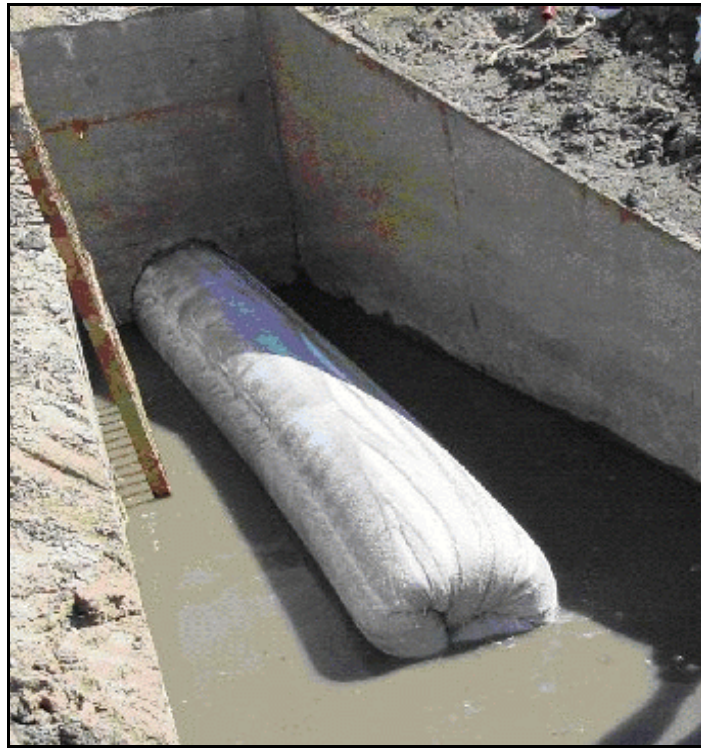
Figure 26.—CIPP liner exiting from an existing conduit via the hydrostatic inversion method.

Thermoset plastics are rigid after manufacturing or curing and cannot be reformed. The most commonly used thermoset plastic for lining nonpressurized conduits is cured-in-place pipe (CIPP). CIPP is also referred to as an “elastic sock.” CIPP consists of a polyester needle-felt or glass fiber/felt reinforcement preimpregnated with polyester resin (USACE, 2001d, p. 11). The preimpregnation process is usually done at the factory for quality control purposes. On the inner surface of the CIPP liner is generally a coating or membrane of polyester, polyethylene, surlyn, or polyurethane, depending on the type of application. The membrane provides a low friction and hydraulically efficient inner surface to the CIPP liner. Figure 26 shows CIPP being used to line an existing conduit. CIPP has been successfully used in renovating deteriorated pipelines, drain pipes, and conduits through levees for over 25 years. CIPP has been used for conduit renovation through embankment dams since about the mid-1990s.

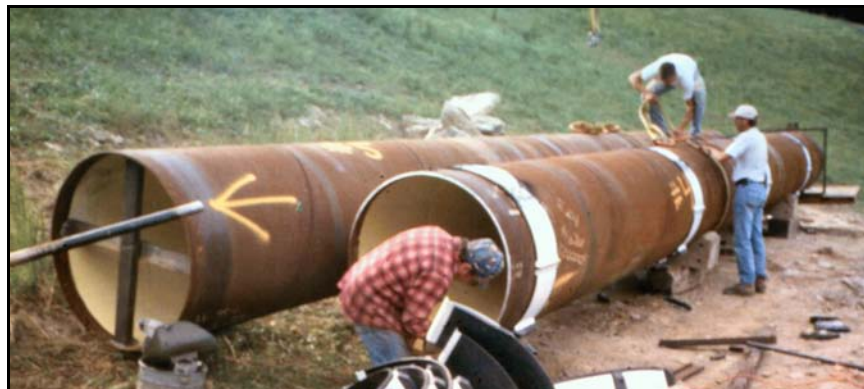
Figure 27.—Steel pipe slipliner being prepared for insertion into an existing conduit.

Steel pipe has been used in some sliplining applications (figure 27), but has more often been used as a liner in reinforced cast-in-place conduits. Steel pipe has been used in sliplining of existing conduits since the 1980s. Steel pipe used as conduit liner has been used since about the early 1920s. The advantages of using steel pipe for conduits include:

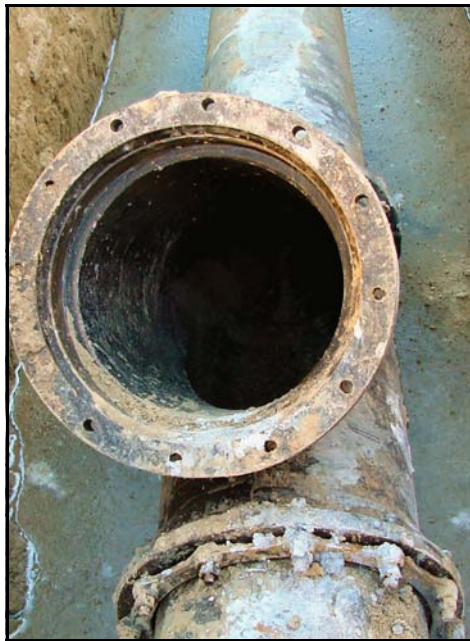
Figure 29.—Flanged joints of ductile iron pipe improve the watertightness of the joint.

- Manufactured to tight tolerance in a controlled environment.
- Long service life, if proper linings and coatings are used.
- High tensile and compressive strength.
- Flanged joints (figure 29) provide improved watertightness over bell and spigot connections.

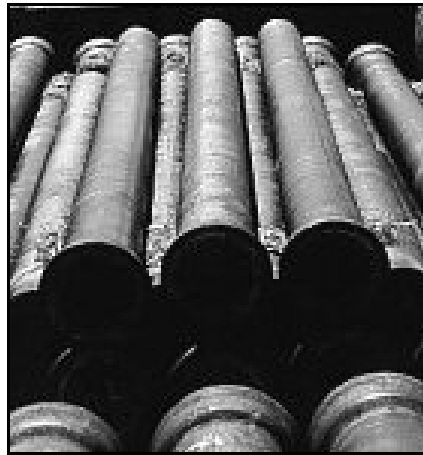
Figure 30.—Cast iron pipe is not considered acceptable for use in conduit applications.

Cast-iron is metallic iron containing more than 2 percent dissolved carbon within its matrix and less than 4.5 percent (as opposed to steel, which contains less than 2 percent). Cast-iron (figure 30) pipe cannot be wrought, so it must be manufactured by casting in a foundry. The molten iron is poured into a vertical annular mold. The mold is removed after the iron cools and solidifies. Commercial availability of cast-iron pipe typically is up to 15 inches diameter. Cast-iron pipe has been around for centuries, and used for storm water and sewer systems. The available length for single pieces is up to 40 feet. Many cast-iron pipes have been in service over 100 years.

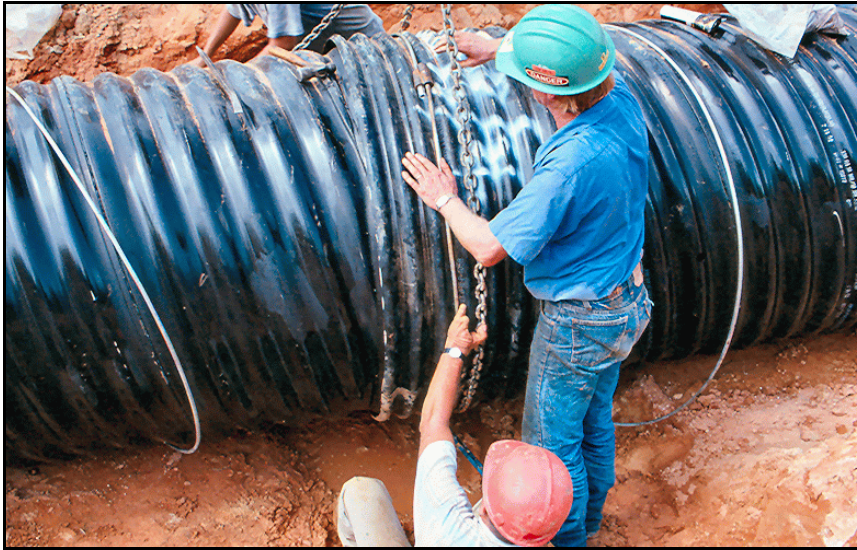
Figure 31.—A CMP conduit being installed.

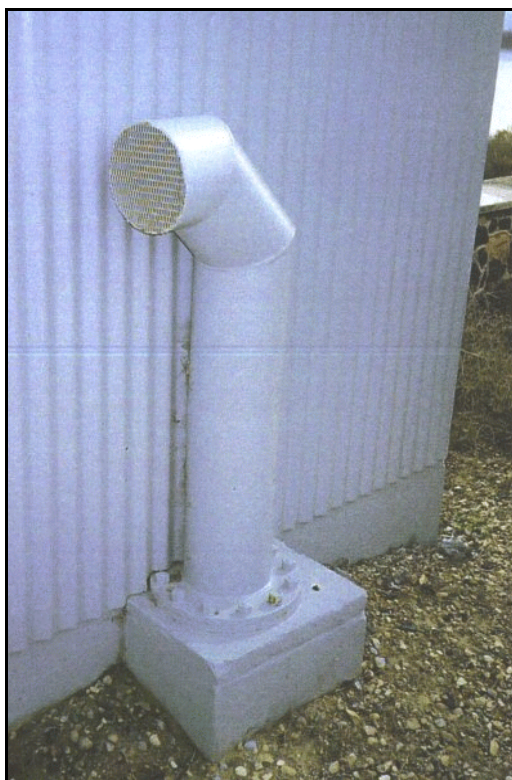
Figure 32.—An air vent is required in closed conduits downstream from the controlling gate or valve to prevent collapse or the formation of low air pressures.

An important consideration in any closed conduit design for an outlet works is the proper use of air venting. Air vents can permit air to enter the conduit to prevent collapse or to prevent the formation of low pressures within flowing water, which could lead to cavitation and its possible attendant damage. Air vents can also be used to bleed air from a conduit prior to operation. Figure 32 shows an example of an air vent leading from the conduit that daylights onto the surface of the embankment dam. For guidance on the location, airflow rates, and structural considerations of air vents, see Reclamation's *Air-Water Flow in Hydraulic Structures* (1980).

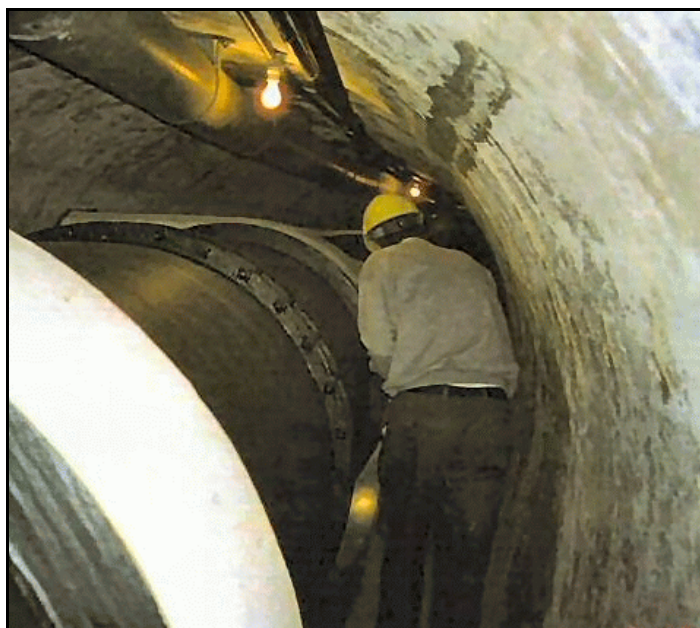
Figure 37.—A steel pipe is located within a larger downstream access conduit.

- *Access.*—The outlet works can be operated through an interior conduit (typically a steel pipe), which is located within the larger downstream access conduit while the downstream portion of the conduit is inspected. Figure 37 shows an example of this type of arrangement. Access for inspection and maintenance of the larger downstream access conduit can be more frequent with this arrangement. Access for inspection and maintenance of the conduit upstream of the intermediate point can be limited (i.e., bulkheads must be installed).

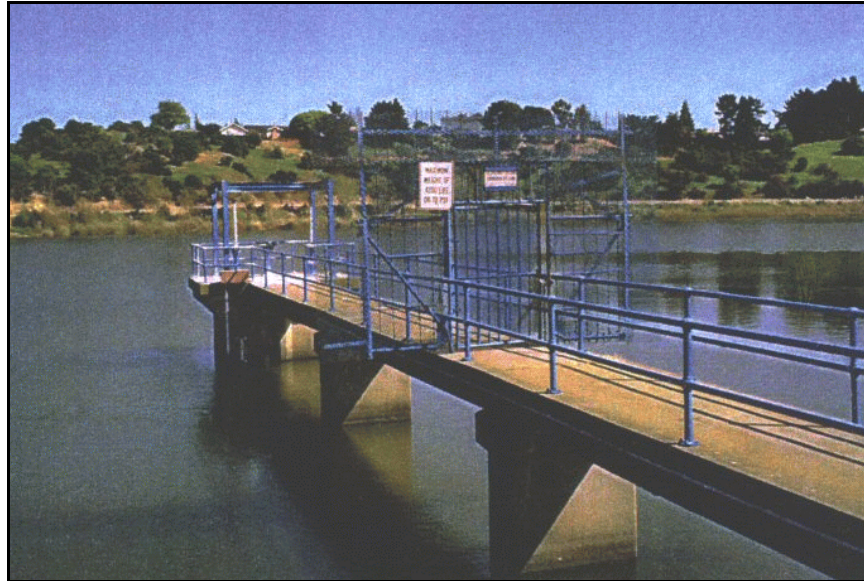
Figure 38.—A footbridge or access bridge is often required to operate gates or valves located at the intake tower.

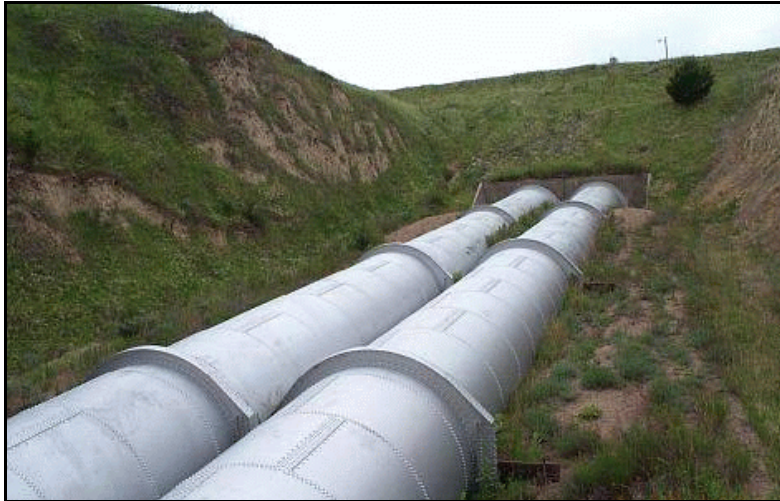
Figure 41.—Penstocks extending through an embankment dam.

Power conduits (also known as “penstocks”) are used to transport water from an intake structure located in the reservoir to a downstream facility for the generation of power. Figure 41 shows an example of penstocks extending through an embankment dam. The power conduit typically operates in a pressurized condition. The power conduit is usually constructed of steel pipe encased by reinforced

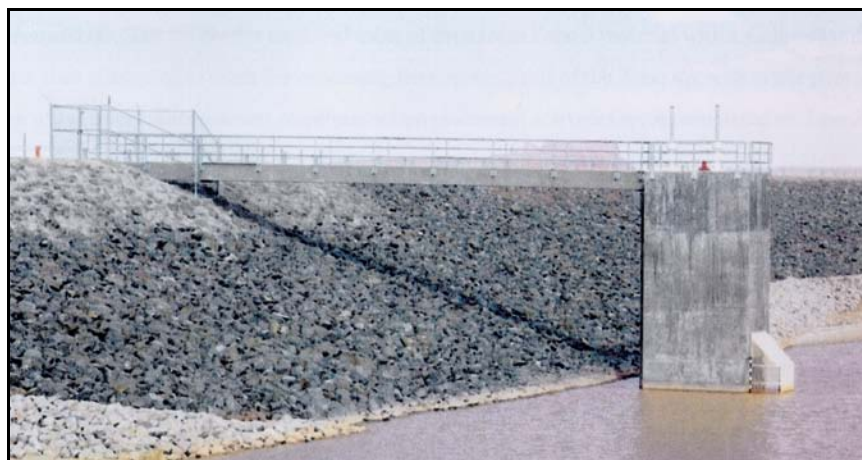
Figure 42.—Typical outlet works intake structure.

Intake structures.—In addition to forming the entrance to the conduit, an intake structure may accommodate control devices, support necessary auxiliary appurtenances (such as trashracks, fishscreens, and bypass devices), and include temporary diversion openings and provisions for installation of bulkhead or stoplog closure devices.

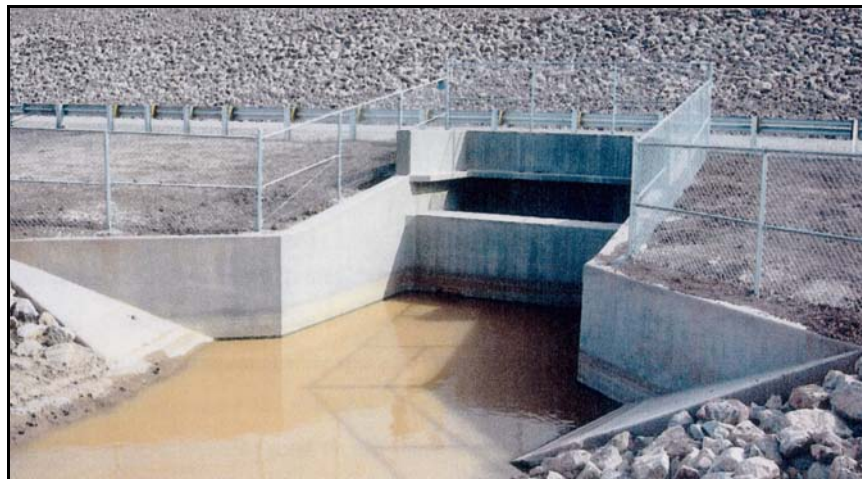
Figure 43.—Typical outlet works terminal structure.

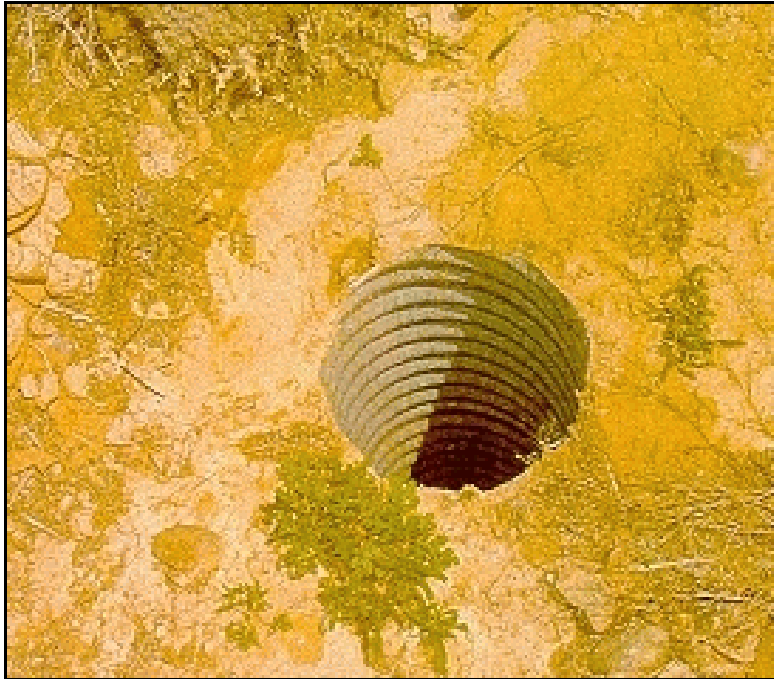
Figure 44.—No intake structure exists for this outlet works. This conduit is prone to plugging with trash and debris.

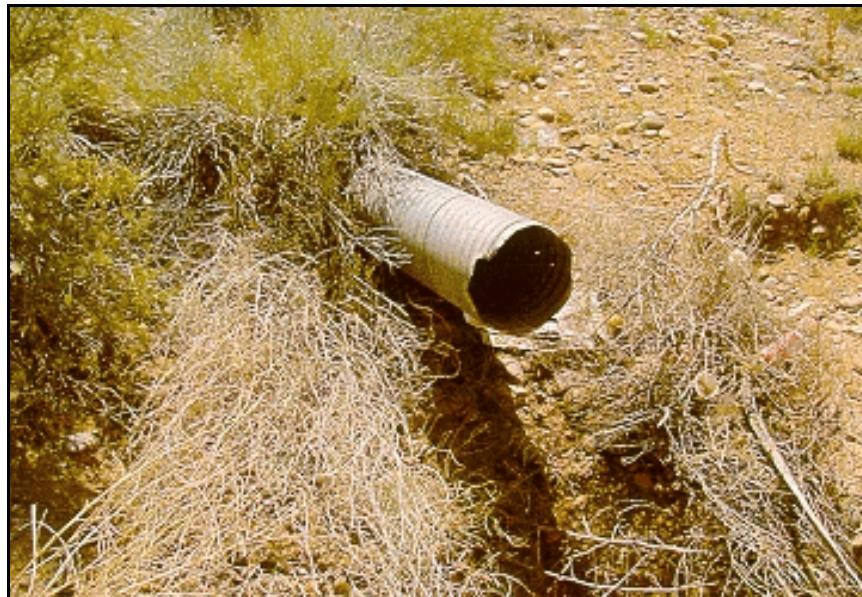
Figure 45.—No terminal structure or erosion protection exists for this outlet works. The embankment around the exit portal has experienced significant erosion.

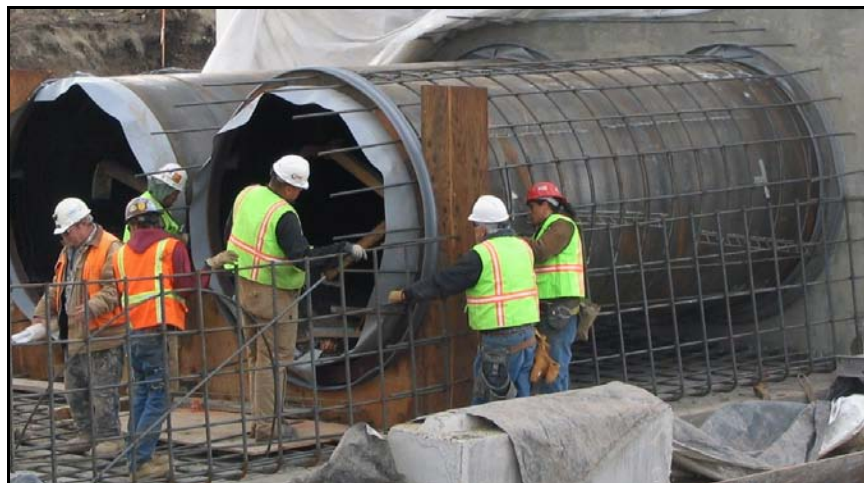
Figure 53.—A multibarrel outlet works conduit under construction.

In some special situations, double or triple barrel conduits may be required. Operational and/or flow capacity requirements usually determine the number of barrels required. Structural design of multibarrel conduits should adhere to the guidance in this section. Figure 53 shows an example of a double barrel conduit under construction.

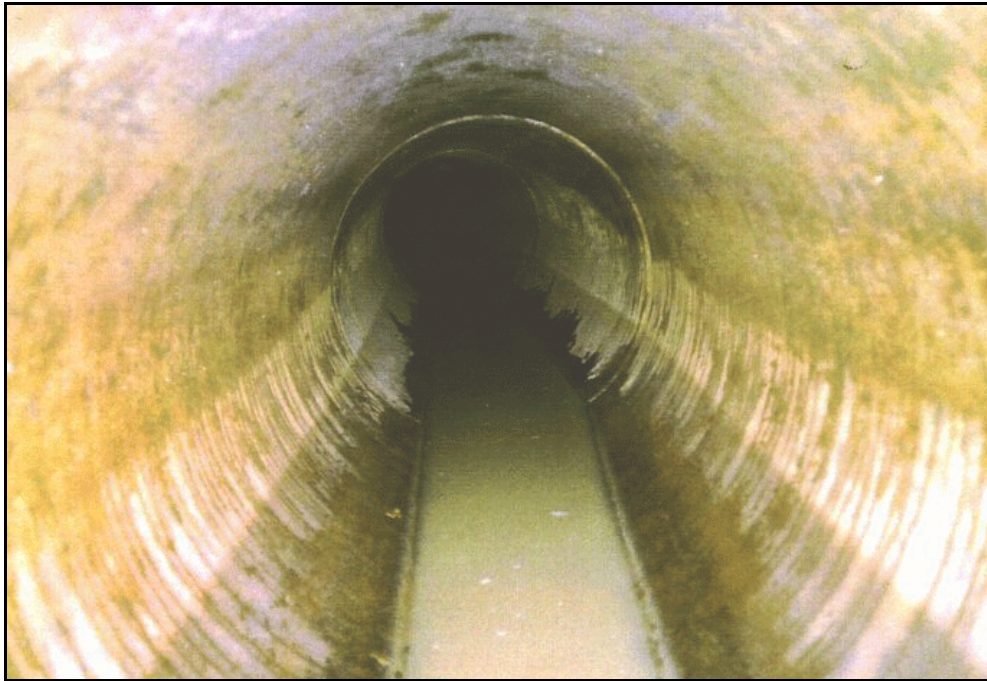
Figure 54.—An example of the interior of conduit shape A.

Figures 54, 55, and 56 show the interiors of conduit shapes A, B, and C, respectively. Conduit shape A is typically used for pressure flow. Conduit shapes B and C are typically used for nonpressurized flow conditions. Conduit shapes B and C are also used as the larger downstream access conduit in arrangement 1, as discussed in

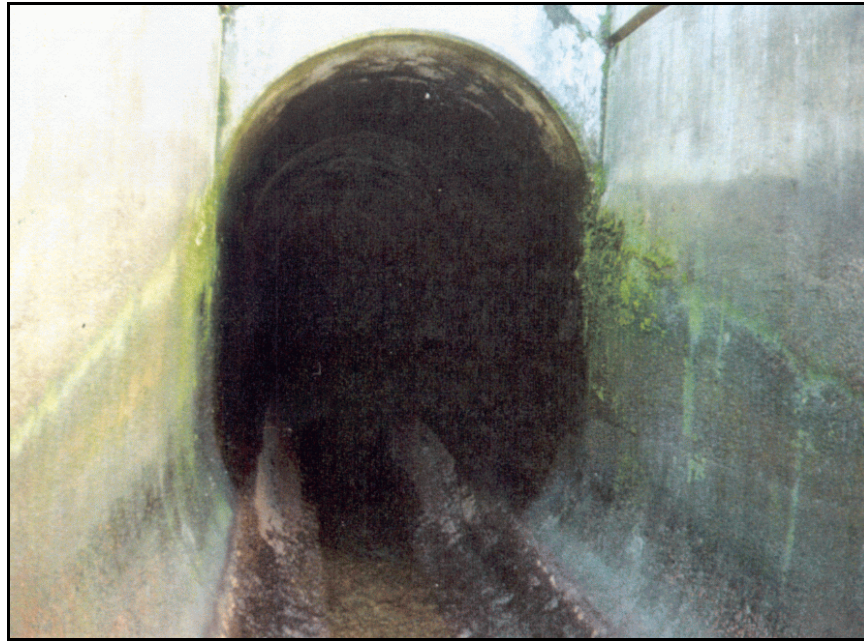
Figure 58.—An example of the interior of conduit shape E.

Conduit shape E (figure 50) is formed by separating two semicircular sections by short side sections. Figure 58 shows an example of the interior of conduit shape E. Conduit shape E generally achieves maximum economy of materials by mobilizing more of the relieving fill pressure. The sides of the conduit should be sloped to 1H:10V or more through the impervious zone to allow equipment to compact the earthfill directly against the conduit. Contractors may use straight cords to avoid using curved forming techniques for the exterior of this shape. If straight cords are used, the designer must ensure that stress concentrations do not change and adequate concrete thickness is provided.

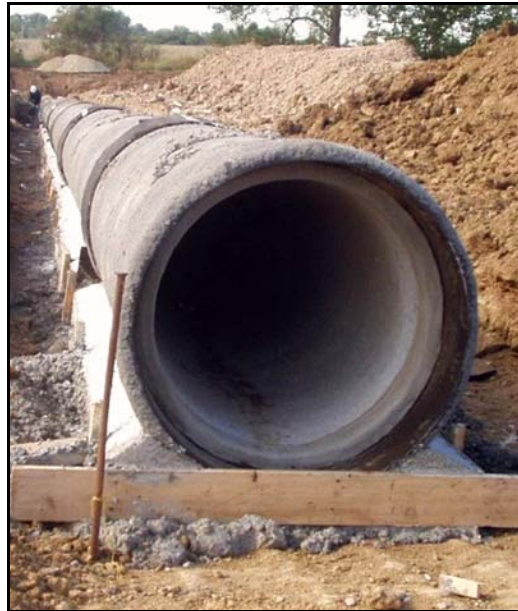
Figure 60.—Precast concrete using bedding as support.

Designers of conduits through low hazard embankment dams often use concrete bedding beneath fully circular conduits. Bedding generally comes up to about 25 percent of the conduit height to provide support and facilitate compaction under the haunches. Bedding often has joints located at the circular pipe joints so as to not interfere with pipe movement. Figure 60 shows a precast circular conduit using bedding for support. For guidance on the use of bedding in conjunction with fully circular conduits, see NRCS's *The Structural Design of Underground Conduits* (1958) and USACE's *Culverts, Conduits, and Pipes* (1998a). The selection of whether to use cradles or bedding is typically a function of the height of the embankment dam. Cradles are often used for higher dams, where more lateral support is required. Regardless of whether a cradle or bedding is used, the use of a filter diaphragm or collar is a valuable defensive design measure that should be employed, even for low hazard classification sites with favorable conditions.

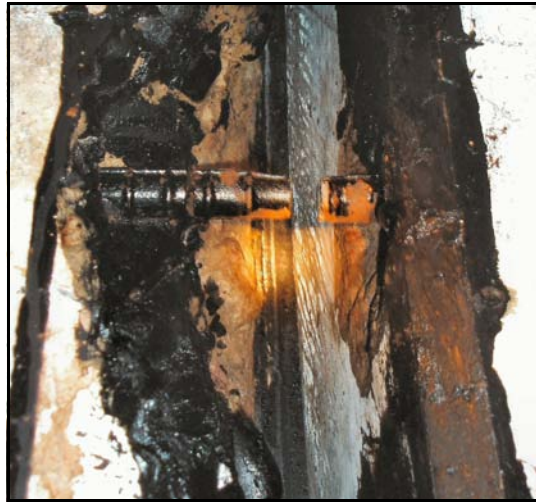
Figure 63.—Longitudinal reinforcement across a conduit joint experienced tensile failure caused by lateral spreading of the embankment dam.

the conduit and for bending stresses due to nonuniform foundation conditions along the length of the conduit section. Figure 63 shows an example of longitudinal reinforcement that experienced tensile failure caused by lateral spreading of the embankment dam.

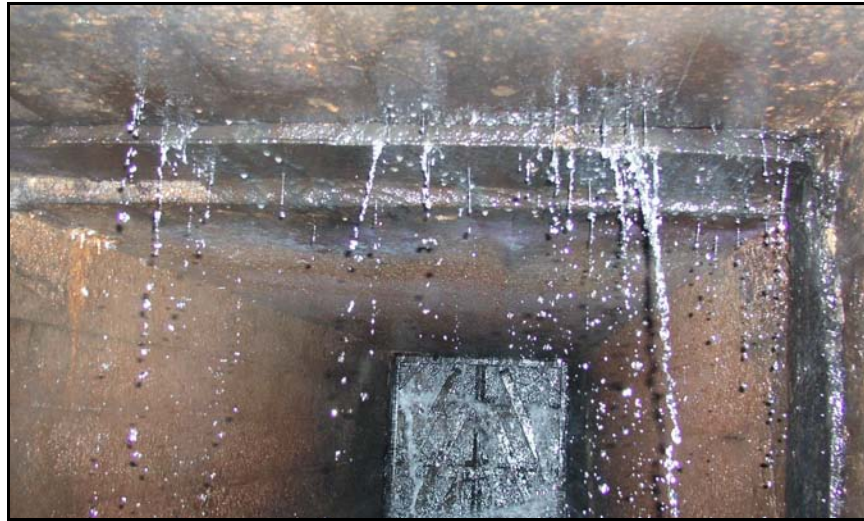
Figure 70.—Water seeping through a joint in an outlet works conduit. The joint has experienced differential settlement. This joint had no longitudinal reinforcement extending across the joint. The mortar joint filling has cracked and deteriorated.

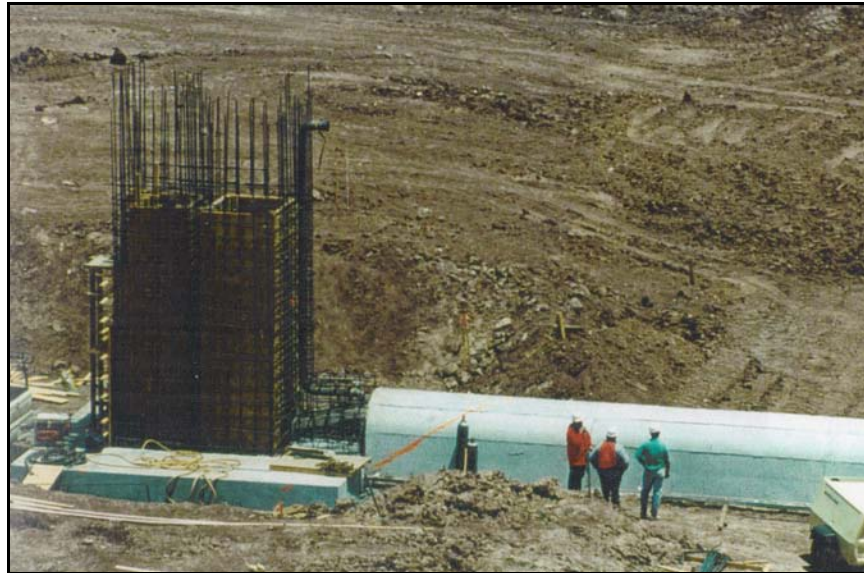
Figure 72.—Special design considerations are required in locations where differential settlement between two structures can occur.

Special precautions should be taken for joints where the conduit connects to a structure, such as an intake structure (figure 72). This location may be in an area susceptible to differential settlement due to the differing weights of the two structures and the foundation beneath them. An engineered fill to limit settlement may be needed under the intake structure, when the structure and conduit cannot be located on bedrock or a firm foundation. If the intake structure is constructed on a pile foundation, special precautions are also required for the first few joints of the conduit because high stresses can develop as a result of bending stresses caused by differential settlement. Extending the conduit and locating the intake structure beyond the limits affected by the embankment dam can reduce these stresses.

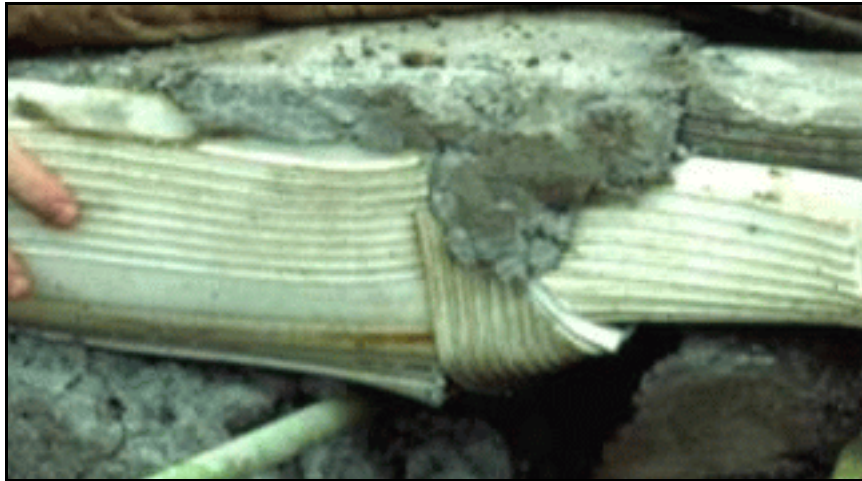
Figure 77.—A poorly secured waterstop moved during concrete placement.

- *Poorly secured waterstop.*—Poorly secured waterstop can result in uneven embedment or an undulating alignment. A poorly secured waterstop can move during concrete placement and may become ineffective in preventing the movement of water through the conduit joint. Figure 77 shows an example of a poorly secured waterstop that experienced movement during concrete

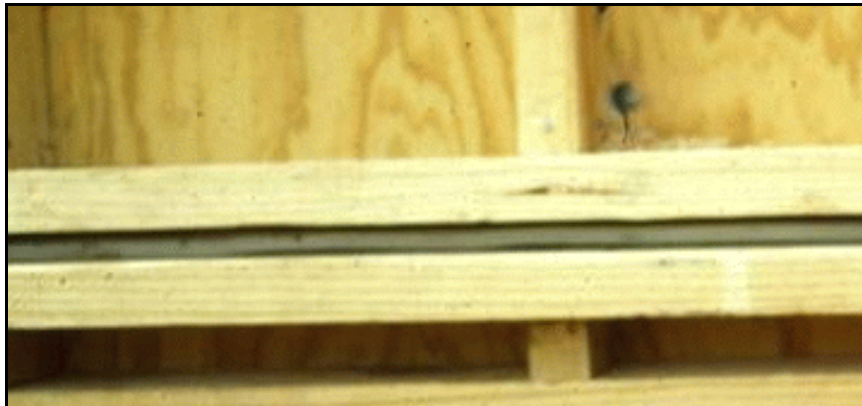
Figure 78.—Waterstop held firmly in place by use of a specially cut slot in the form.

placement. The most secure way to support waterstop during concrete placement is with the use of properly built forms (commonly referred to as split forms). Figure 78 shows an example of a waterstop inserted through a specially cut slot in the form. Additional support is provided to the waterstop on the nonplacement side, to ensure no movement occurs. Proper waterstop installation requires that one-half of the waterstop be embedded on each side of the joint. Nailing, stapling, or insertion of wire through the waterstop should not be allowed, since this may affect the integrity of the material and shorten the seepage path around the waterstop. Often contractors use hog ring fasteners crimped along the edge of the waterstop and wired to reinforcing steel to secure the waterstop. If hog rings are used, extreme care should be exercised not to pierce the waterstop when crimping, since this could result in shortening of the seepage path around the waterstop. Also, reinforcing bars should not be allowed to penetrate the waterstop.

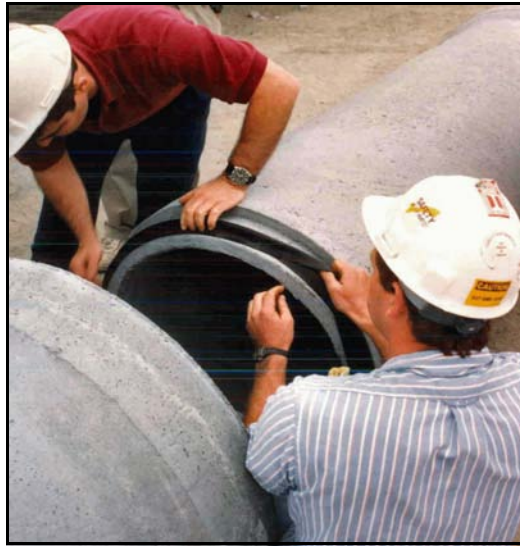
Figure 79.—A rubber gasket is installed at the spigot end of the precast concrete pipe.

of the joint is fabricated to contain a rectangular recess that holds a continuous solid rubber ring of circular cross section. The rubber gasket is compressed when the spigot is pushed into the bell end of the joint. Figure 79 shows an example of a rubber gasket being installed on a precast pipe. The gasket and steel rings, if used, are manufactured to high tolerances to ensure a reliable high pressure seal. Lubricating the gasket and inside face of the bell with vegetable soap can ease assembly. In embankment dams, a mastic sealing compound (figures 66-69) and metal or geotextile bands are typically placed around the outside length of the joint to prevent any movement of soil backfill into the joint space that might interfere with future joint movement.

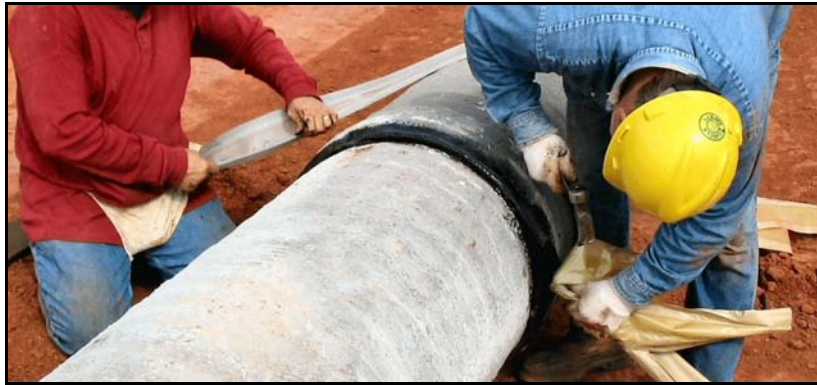
Figure 80.—Mastic being applied to exterior annular joint space of precast concrete pipe.

- A sealing compound (mastic) shall be applied to completely fill the exterior annular space between the placed pipe sections. Figure 80 shows mastic being applied to the annular space of a precast pipe.

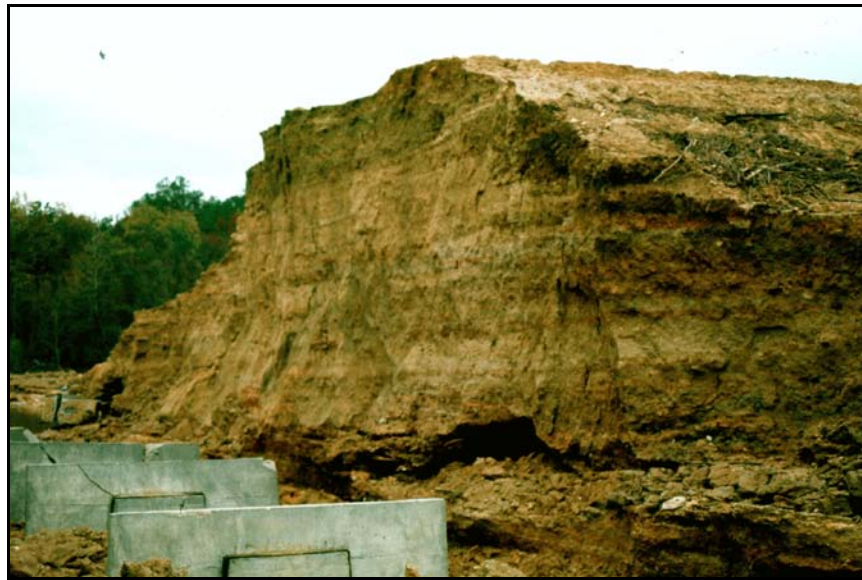
Figure 82.—The failure of this embankment dam located in South Carolina was attributed to hydraulic fracture. The eroded seam located to the right of the conduit may have been the hydraulic fracture that formed and allowed internal erosion and failure of the embankment dam. The embankment was composed of dispersive clays.

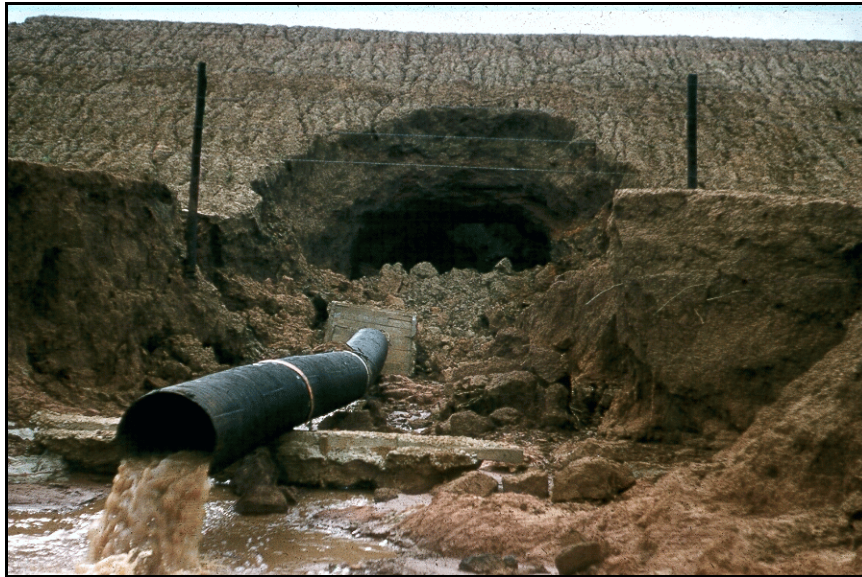
Figure 84.—An embankment dam in Mississippi constructed of dispersive clay soil, failed on first filling with low reservoir level. Failure was likely caused by cracks from differential settlement, hydraulic fracture, or poor compaction about the outlet works conduit. This embankment dam had no filter.

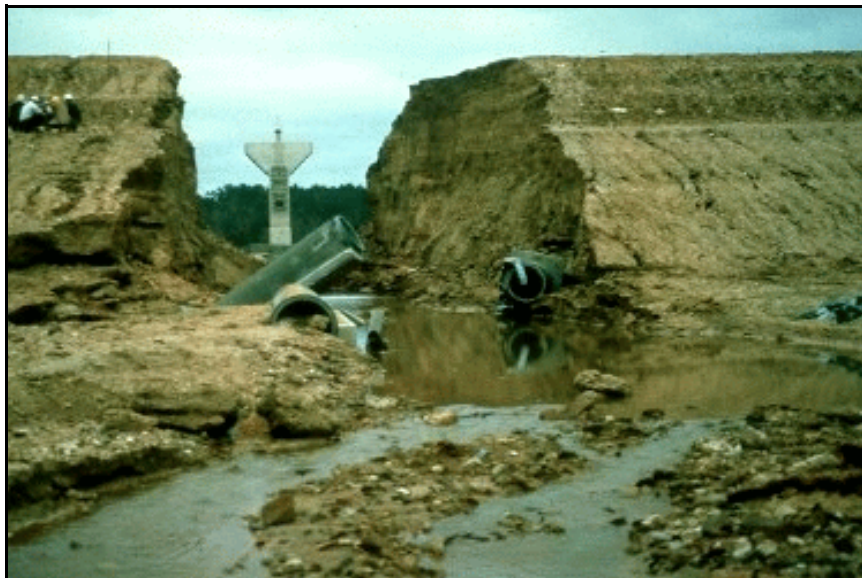
Figure 85.—This embankment dam constructed with dispersive clays failed on first filling of the dam.

Embankment dams usually contain a zone of lower permeability soil to reduce the seepage through the embankment. In small embankment dams, the entire dam may be constructed of the same soil, termed a homogeneous construction. If this zone of low permeability, clayey soil develops cracks, particularly transverse cracks, from hydraulic fracture, desiccation, or other causes, the integrity of the embankment dam may be compromised. Water flowing through a crack in any soil will erode and enlarge the crack, unless the crack is able to swell closed before erosion occurs. If the crack continues to erode, this can lead to a breaching of the embankment dam. Figures 84 and 85 show failures known to be associated with highly dispersive clay embankments. Figure 84 shows a small embankment dam that failed when water flowed along a transverse crack in the dam. The transverse crack was caused by hydraulic fracture of the earthfill associated with differential settlement near the conduit. Failures of embankment dams constructed of dispersive clays without appropriate defensive design measures have been common (figure 85).

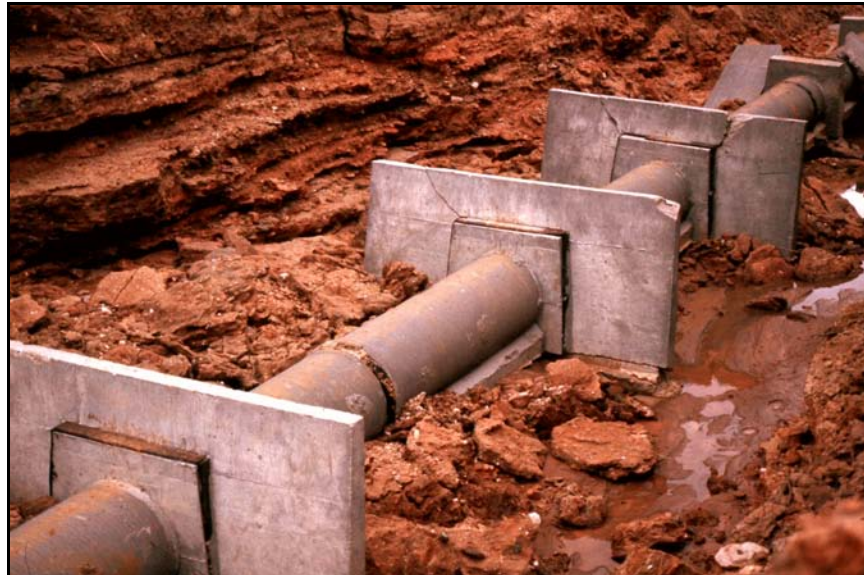
Figure 102.—Conduit with intact antiseepage collars. The collars would have interrupted flow along conduit. Internal erosion or backward piping erosion likely occurred through hydraulic fractures in surrounding earthfill, resulting in failure of this embankment dam.

Figure 102 shows a conduit with its antiseep collars intact after an internal erosion failure of the embankment dam. In this case, it appears unlikely that the flow path for the failure was a continuous uninterrupted flow along the conduit, but at least part of the flow path was in the earthfill surrounding the conduit. In most cases, it has not been possible to determine the exact flow path that water followed in internal erosion failures, because the evidence was destroyed by the failure. If hydraulic fracture and other causes of cracks in compacted backfill were ignored as the potential cause for failures, one might incorrectly assume that all failures that occur in the vicinity of conduits are attributable to flow along the conduit. In Failure Mode No. 4 (discussed in the following section), hydraulic fractures occur in the soil mass beyond the immediate vicinity of the conduit, usually associated with differential settlement in the fill caused either by the conduit or excavations made to install the conduit, or uneven bedrock profiles near the conduit.

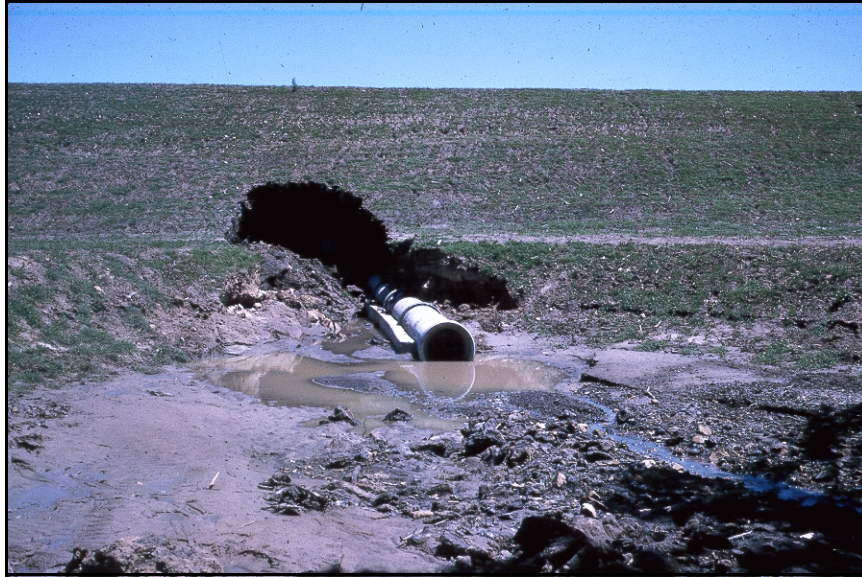
Figure 104.—Failure of an embankment dam due to internal erosion of hydraulic fracture cracks upon first filling of the reservoir.

Figure 104 shows a small embankment dam that failed by internal erosion. The conduit created differential settlement in soils above the conduit that resulted in hydraulic fracture. The embankment soils were highly dispersive clays.
