Technical Manual: Conduits through Embankment Dams

Best Practices for Design, Construction, Problem
Identification and Evaluation, Inspection,
Maintenance, Renovation, and Repair

Federal Emergency Management Agency

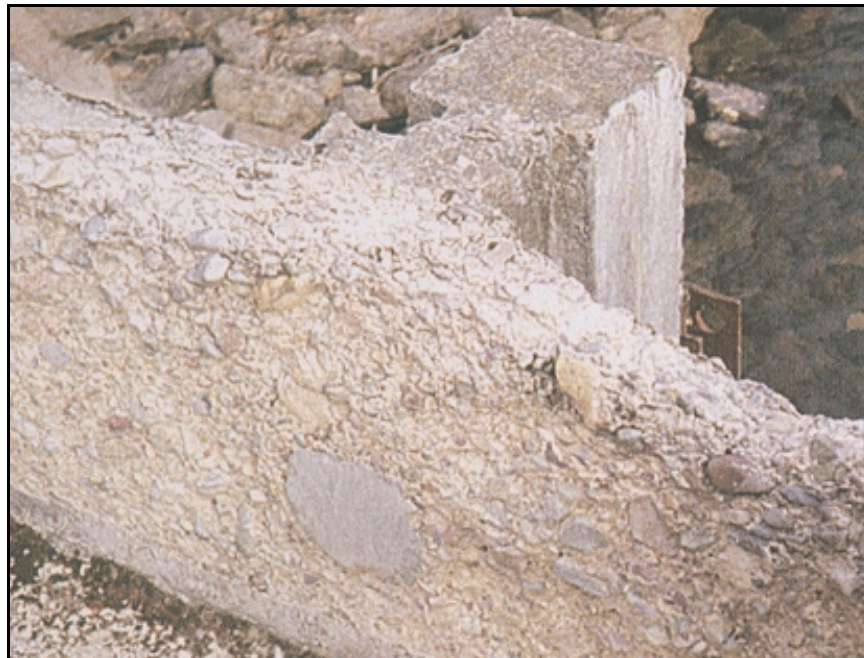
Figure 106.—Concrete deterioration from freezing and thawing.

- *Freezing and thawing.*—Repeated cycles of freezing and thawing can affect the durability of concrete. Concrete readily absorbs water and is vulnerable to damage, if the water within its system of pores can freeze and generate disruptive pressures. If the pores existing in the concrete are inadequate in size and number to accommodate the greater volume occupied by the ice, the concrete will fracture. The rate of progression of the freezing and thawing deterioration will depend upon the number of cycles, the degree of saturation during freezing, the porosity of the concrete, and the exposure conditions. Concrete experiencing damage by freezing and thawing is characterized by a disintegrated appearance. Deterioration due to freezing and thawing is especially severe in the northern and mountain zones of the United States. Deterioration from freezing and thawing progresses from the exterior surface to the concrete inward. As the concrete on the surface fails and is removed by spalling, the depth of freezing progresses inward (Reclamation, 2003, p. 7). Freezing and thawing typically is not a significant concern for conduits, since most of the conduit is submerged or has limited exposure. However, freezing and thawing can become a problem for entrance and terminal structures. Figure 106 shows a concrete intake structure that has been exposed to repeated cycles of freezing and thawing. In new construction, the entrainment of small bubbles of air into fresh concrete has been found to provide relief for pressures developed by free water as it freezes and expands. Repairs to existing structures require replacement concrete or epoxy-bonded concrete (Reclamation, 1997, p. 26).

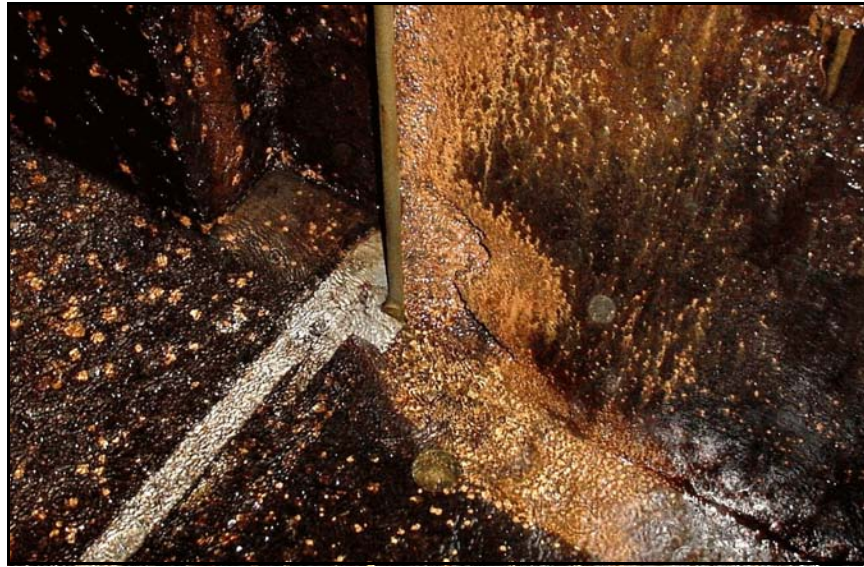
Figure 108.—Cavitation damage to the cast-iron lining of a conduit immediately downstream of a slide gate, caused by high velocity flow.

risk of cavitation can be evaluated by computing the cavitation index for flow, which is a function of velocity and pressure. Normally, for flow velocities less than 40 ft/s, cavitation will be minimal. Discontinuities or irregularities on flow surfaces and/or misalignments in conduits carrying high velocity flow can induce cavitation. These discontinuities, irregularities, or misalignments cause the flowing water to separate from the conduit surface, resulting in negative pressure zones and bubbles of water vapor. When these bubbles travel downstream and collapse next to the conduit surface, the high pressure impact removes small particles of the conduit surface (pitting). As the pitting continues, a progressively deepening cavity develops, which causes additional irregularities that leads to even larger cavities farther downstream (also known as a Christmas tree pattern). Cavitation is common just downstream of mechanical control equipment, such as gates or valves (figure 108) where pressure flow changes to free flow. Damage from cavitation and abrasion can appear to be similar. Cavitation damage appears as a plucking out of the surface material with no fine scale evidence of flow direction. Abrasion damage is normally flow directional.

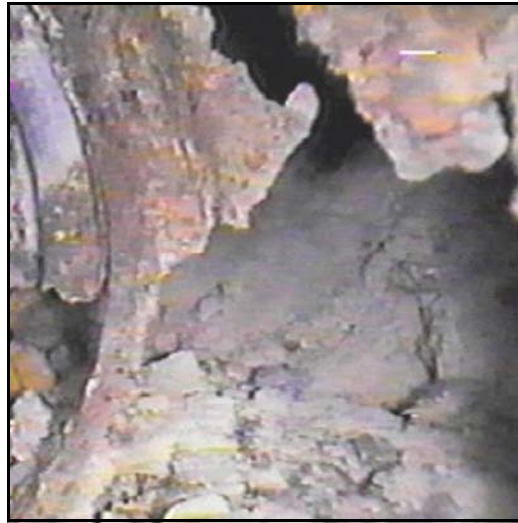
Figure 109.—Corrosion has completely destroyed this CMP spillway conduit. Backfill materials that surrounded the conduit have been eroded by flow within the conduit.

In the past, CMP has been a commonly used material for conduits through embankment dams. Thousands of embankment dams in the United States and all over the world have CMP conduits installed in them. Corrosion is a common problem with CMP conduits (figure 109). Many State highway departments have made extensive studies on the use and durability of CMP for culverts under highway embankments. However, available information on the use of CMP for conduits through embankment dams is limited. A study of 50 existing CMP conduits in watershed dams located in the Midwestern United States was done in 1989 (Koelliker and Lin, 1990). The study determined that the estimated average life of the sampled CMP conduits was 43 years, but the lifespan ranged from 24 to 72 years. This study also found that leakage and associated corrosion at pipe joints was most often the primary limiting aspect of life expectancy. Many spillway conduit systems constructed with CMP experience corrosion at the joint connection between the conduit section and the riser (the vertical pipe or inlet that connects to the outlet pipe). Spillway risers are subject to deformation and movement (tilting) caused by ice loadings or erosion, which can open the joint connection with the outlet pipe. The riser itself is also susceptible to corrosion.

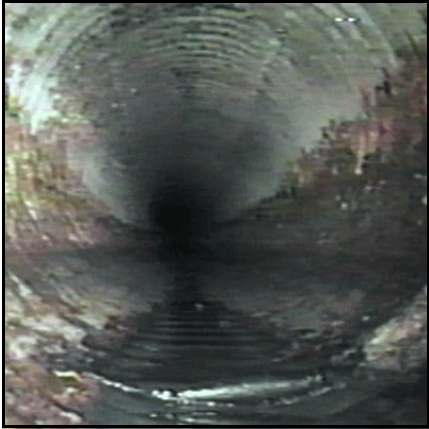
Figure 110.—CMP corrosion within an outlet works conduit.

For guidance on estimating the service life of CMP conduits, see the National Corrugated Steel Pipe Association's *CSP Durability Guide* (2000) and FHWA's, *Durability of Special Coatings for Corrugated Steel Pipe* (1991). Caution should be exercised in attempting to determine the service life of CMP used in conduits through embankment dams. Many of these CMPs may have used no corrosion protection, and many of the coatings and linings available today were not available when the embankment dams were originally constructed. Prior to 1950, galvanized steel was the only metallic coating available for CMP. If a CMP has experienced denting during installation, this could result in corrosion in areas where the protective coating has been damaged. Figures 110 through 113 show the results of corrosion affecting CMP outlet works conduits.

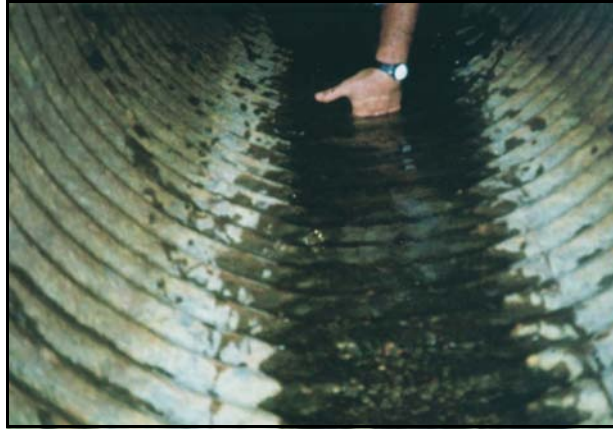
Figure 111.—CMP corrosion on the invert of an outlet works conduit.

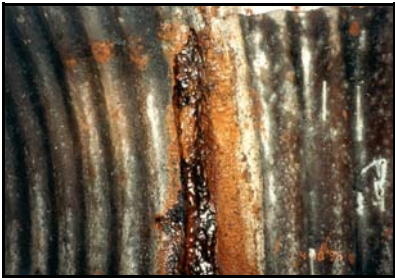
Figure 112.—CMP corrosion within an outlet works conduit caused by a leaking pipe joint.

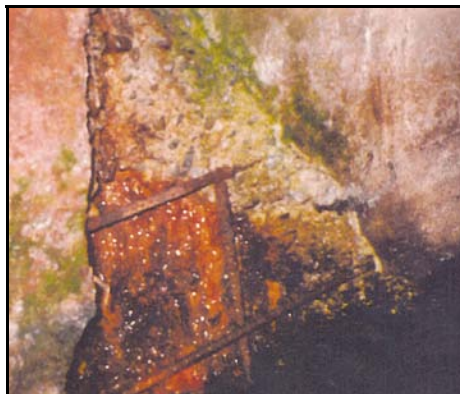
Figure 114.—Spalled concrete and exposed reinforcement in an outlet works conduit.

Corrosion of reinforcement in concrete conduits can also occur when it becomes exposed. Reinforcement can become exposed by cracking or spalling of the concrete (figure 114), inadequate cover, or porous concrete. When reinforcement is exposed to corrosive elements, the iron oxides formed expand (requiring more space within the concrete than the original reinforcement), resulting in tensile stresses within the surrounding concrete. These tensile stresses cause cracking and delamination of the concrete. Rust stains on the conduit surface may be an indicator of reinforcement corrosion.

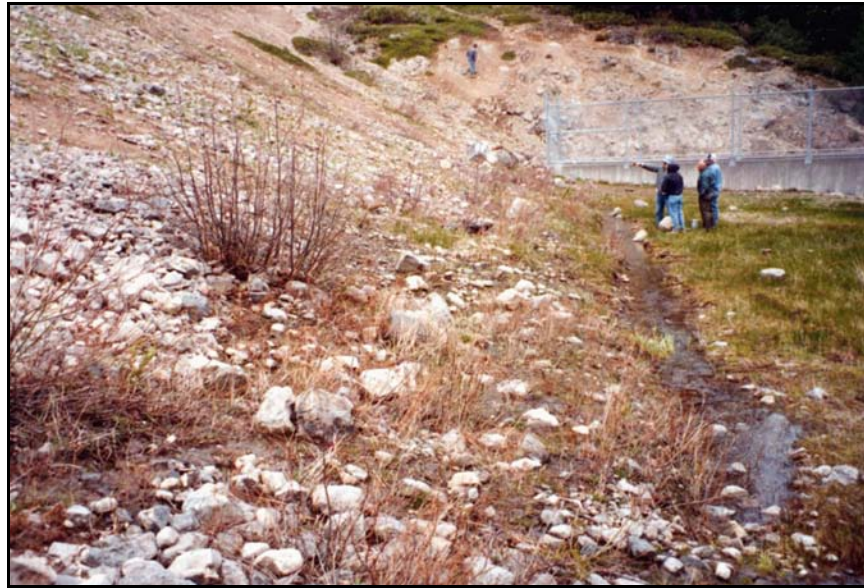
Figure 118.—Visual inspection for seepage on the downstream face of an embankment dam.

Dam safety organizations and embankment dam owners may employ a variety of inspections during the life of a conduit (figure 118). These inspections may include the following types (Reclamation, 1988, p. I-2):

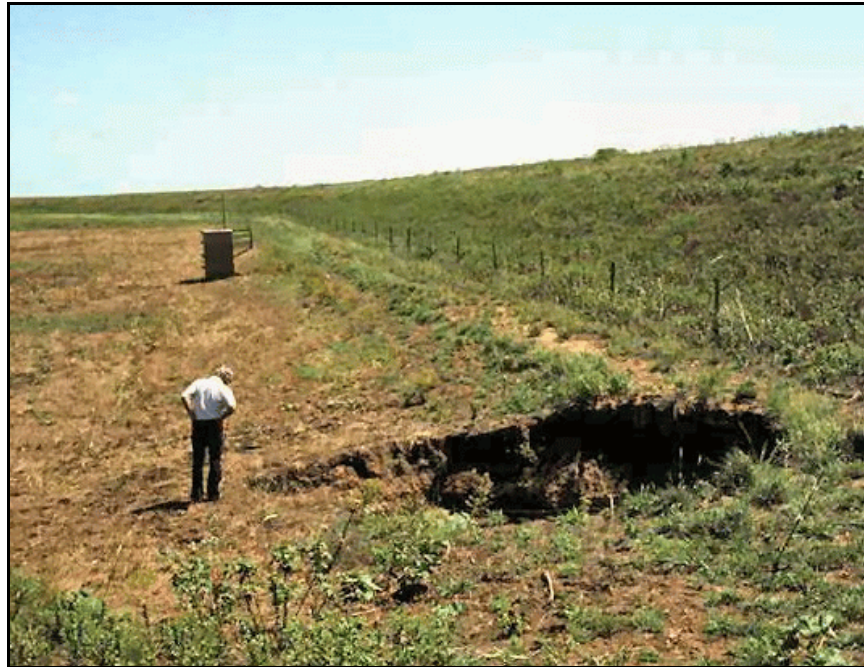
Figure 119.—Sinkhole in the crest of an embankment dam.

- Look for signs of infiltration of soil into the conduit. Depressions, sinkholes (figures 119 and 120), or cavities that exit onto the surface of the embankment dam along the centerline conduit alignment are usually an indication that internal erosion or backward erosion piping is occurring. These features often appear as holes that line up with one another. Such features should be marked with reference points and monitored to determine whether they are expanding with time. Sinkholes should be probed to determine the extent of the void, which may be dome shaped and enlarge with depth. The seepage and flow conditions on the downstream slope and through the conduit, should be examined for evidence of association with the sinkhole. Sinkholes are a cause for immediate concern and further investigation. Beware that some animals may take over these areas, and they may not be recognizable as sinkholes or cavities.

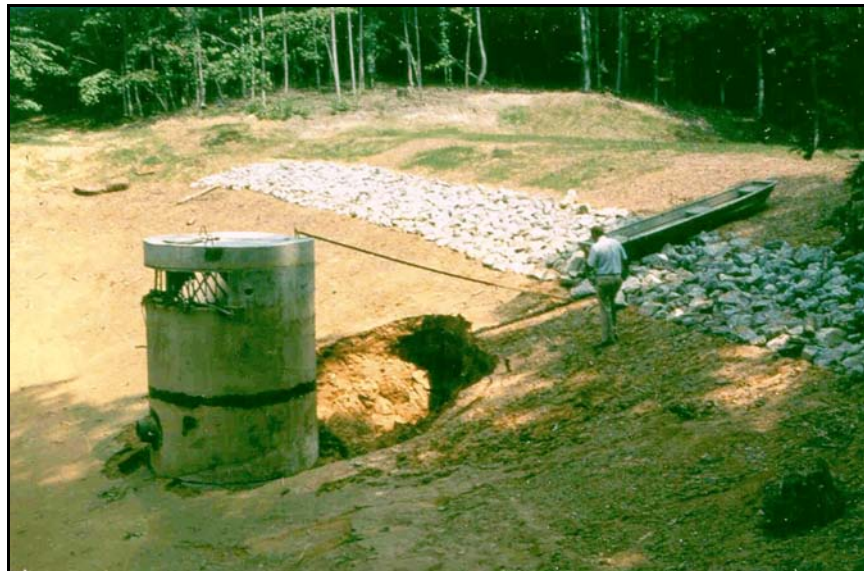
Figure 120.—Sinkhole around a spillway riser. Photo courtesy of Schnabel Engineering.

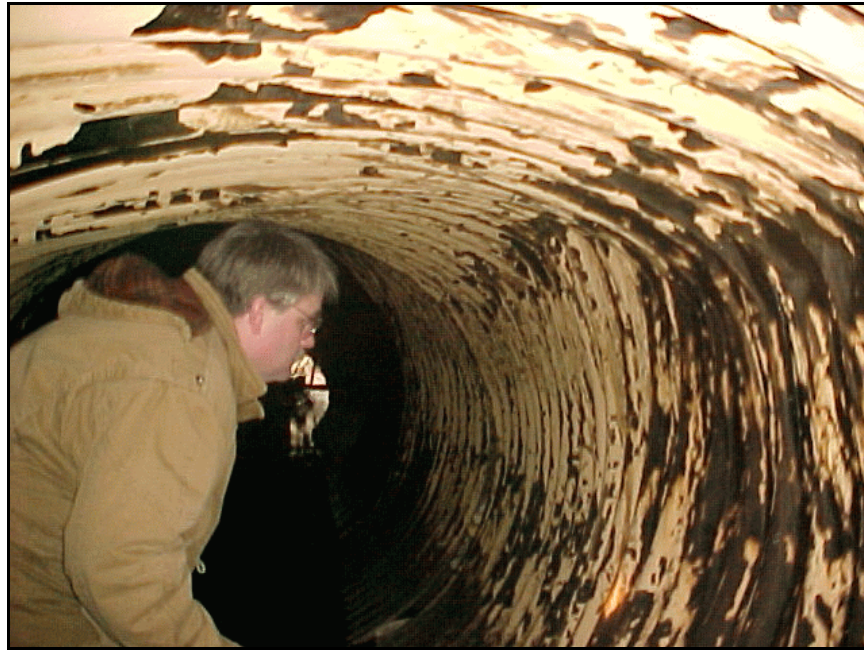
Figure 121.—Inspection of a CMP conduit looking for signs of deterioration.

Typical problems within the interior of conduits include deterioration, obstructions, joint offsets and separations, defective joints, cracking, and mechanical equipment misoperation (figures 121 and 122).

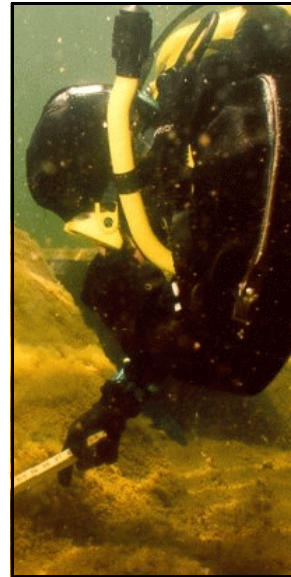
Figure 123.—Diver performing an underwater inspection.

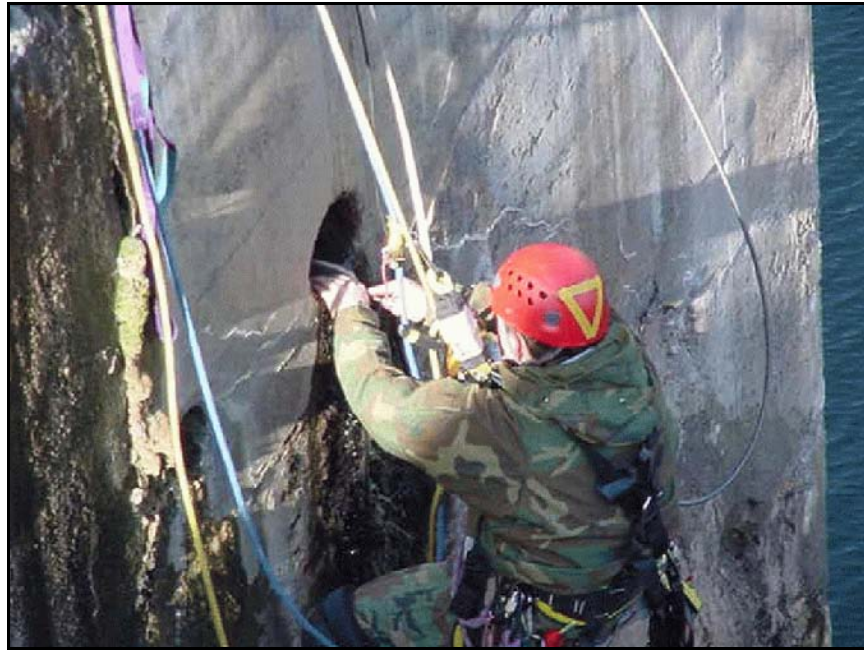
Figure 124.—Climber performing an inspection on a terminal structure wall.

Although not often required for conduits, a climbing team may be utilized to perform inspection of the inaccessible portions of intake towers and the walls of terminal structures (figure 124).

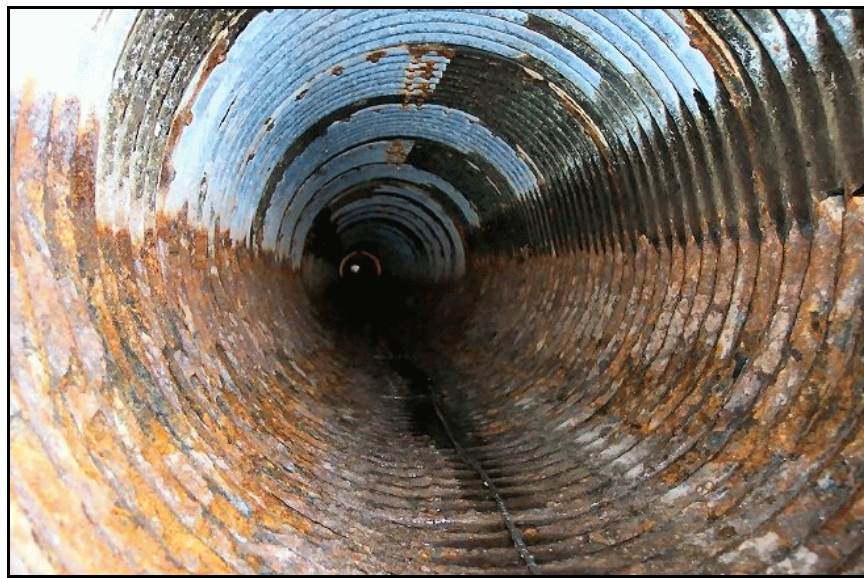
Figure 127.—Corrosion within a 24-inch-diameter CMP outlet works conduit.

CCTV is a very useful method for examining small or inaccessible conduits (figures 126, 127, and 128). CCTV inspection provides significant improvements over other methods of inspection, such as man-entry inspection where an inspector crawls through the conduit (36 inches or larger) and documents the conditions, manual inspection where a sled with a camera is pushed through the conduit using long push rods, and mechanical inspection where a camera tethered to a wire rope is pulled through the conduit. CCTV inspection has the advantages of being able to examine conduits regardless of size limitations, has complete mobility, and provides real time video images.

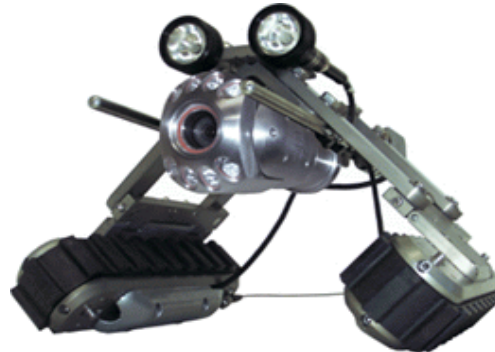
Figure 129.—Camera-crawler used for CCTV inspection of conduits. Photo courtesy of Inuktun Services, Ltd.

Generally, a CCTV inspection consists of a video camera attached to a self-propelled transport vehicle (crawler). Some crawlers utilize tracks, and others use wheels. The transport vehicle and camera are commonly referred to as a camera-crawler (figure 129). An operator remotely controls both the transport vehicle and camera. The camera can provide both longitudinal and circumferential views of the interior

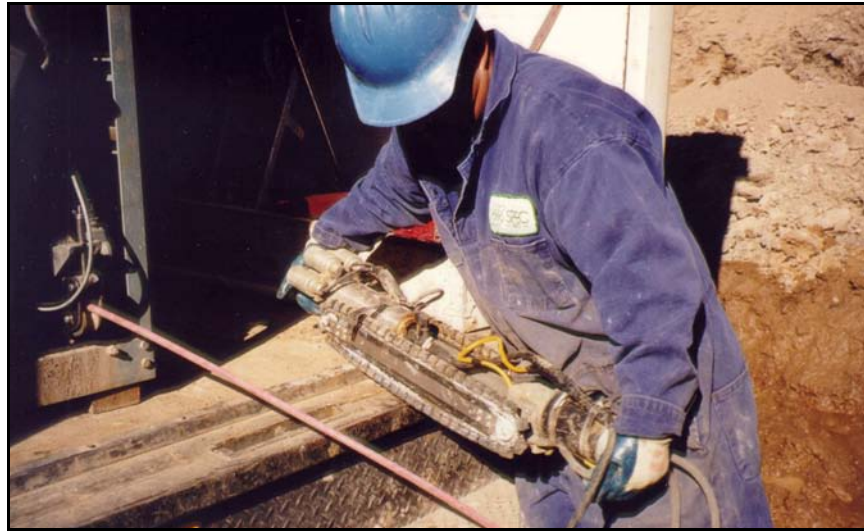
Figure 130.—Most CCTV inspection equipment is portable and can be carried to conduit access locations.

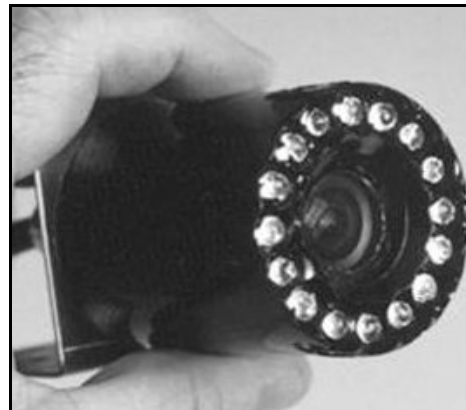
Figure 131.—A small color video camera used for CCTV inspection.

Sometimes the conduit is too small and a transport vehicle cannot be used, or obstructions/invert conditions exist that prevent the transport vehicle from traversing the conduit. For these types of situations, a small color video camera (1.5 to 3 inches in diameter) with maximum pressure depth ratings up to 1,000 feet of water can be used. Figure 131 shows an example of this type of video camera. This video camera can be attached to metal or PVC poles (commonly referred to as push poles) and manually pushed up the conduit. Push poles are normally used for straight sections of conduit. The use of push poles for advancement is generally limited to about 400 feet of conduit length. If bends exist in the conduit, a flexible snake device (spring steel wire, coiled wire, or flexible polypropylene-jacketed fiberglass push rod) can be used instead of the push poles. A coaxial cable connects the video camera to a video cassette recorder and television monitor. Snake devices are generally limited to about 75 to 200 feet of conduit length.

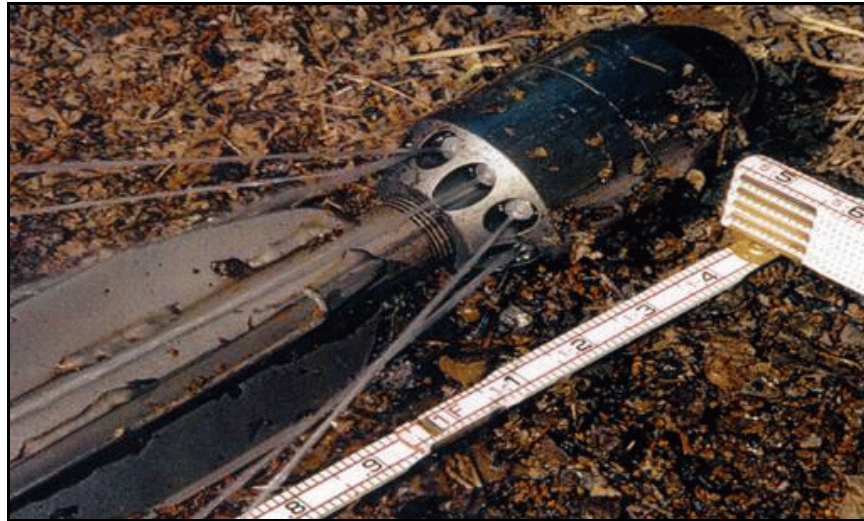
Figure 133.—Pressure washing cleaning head.

- *Pressure washing*.—Pressure washing (figure 133) involves the use of a flexible hose attached to a metal nozzle that directs jets of water out in front of it to loosen debris and sediments in the conduit. The jet is created by a shaped restriction in the flow channel that forces water to accelerate and converts potential energy (pressure) into kinetic energy (velocity). The nozzle is propelled forward by reverse angle jets. The reverse angle jets also push debris and sediments backwards toward the end of the conduit, where the flexible hose exits. Pressure washing is best suited where biomasses or mineral encrustation are to be removed. The pressure selected for cleaning should fully consider the condition of the types of conduit material, age, and type of joints. The lowest possible pressure that effectively cleans the conduits should be used. The jets on the nozzle should be angled no more than about 30 degrees, so the jets are not aimed directly at the conduit wall. The nozzle should be kept rotating and moving and should not be allowed to remain in one spot during jetting.

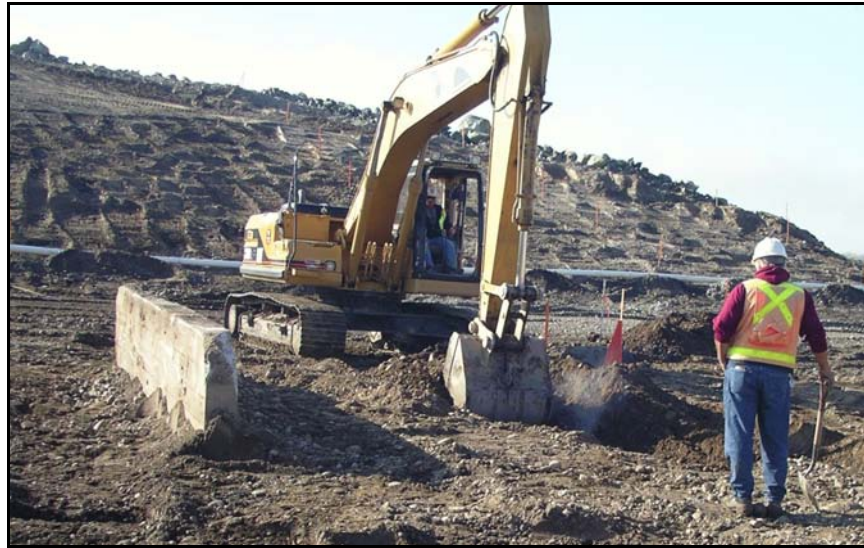
Figure 135.—An outlet works conduit is being excavated during a forensic investigation. The top of an antiseep collar is exposed on the left side of the figure.

consist of experienced geotechnical and civil engineers, geologists, surveyors, and construction personnel. All anticipated items of interest (e.g., voids) should be clearly communicated to all parties involved prior to the commencement of embankment excavation. Test pits are usually excavated along the conduit, extending a specified depth below the bottom of the conduit. The contractor must take care to prevent damage to in-situ conditions before the investigation team can document them. Figure 135 shows an outlet works conduit excavation during a forensic investigation. Figure 136 shows how polyurethane grout flowed through the backfill surrounding an outlet works conduit during joint sealing operations. Close coordination between the forensic team and contractor were required in order to preserve this information for study.

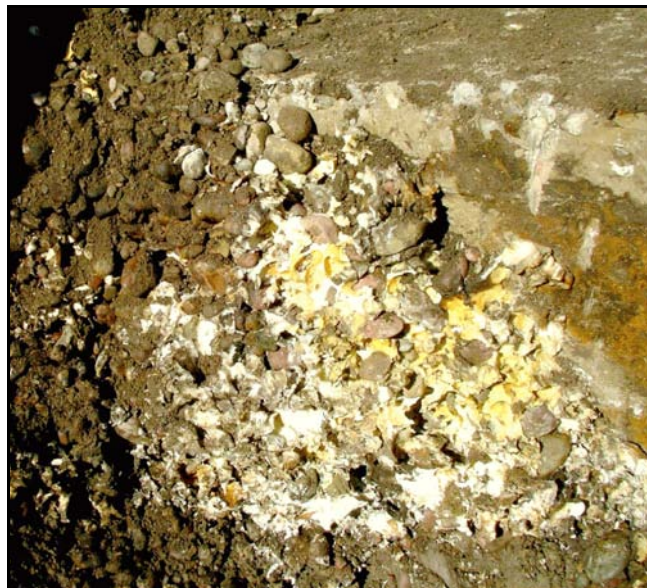
Figure 136.—Close coordination between the forensic team and contractor allowed for careful study of how polyurethane grout injected into the deteriorated joints of a conduit flows through surrounding backfill. In this case, the forensic investigation showed the injection of grout was relatively successful in sealing the joints of the conduit.

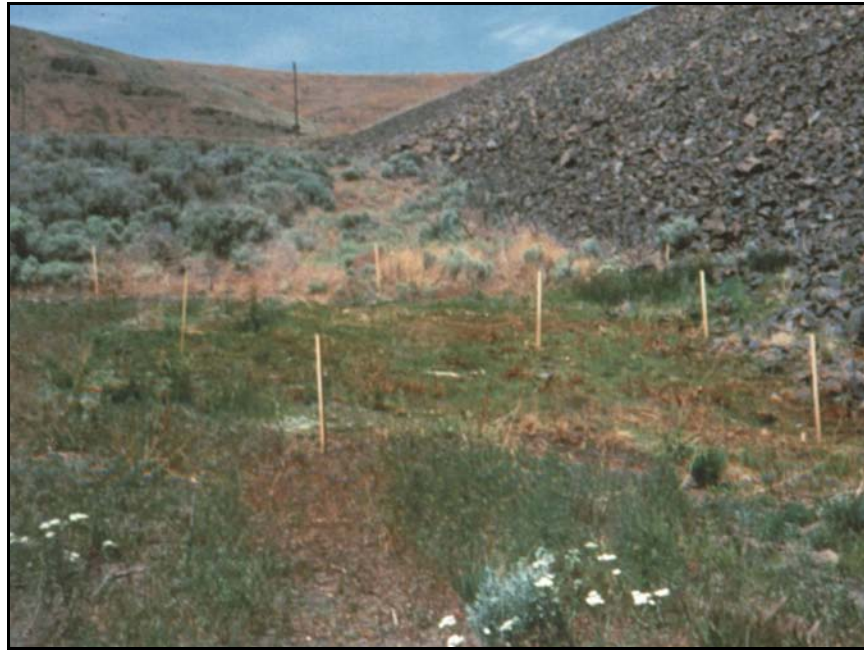
Figure 137.—The perimeter of a wet area at the downstream toe of an embankment dam located with wooden stakes.

For saturated areas on the downstream slope of an embankment dam, the perimeter of the hole or wet area should be surveyed to determine the extent of the area. As a minimum, the perimeter of the hole or wet area can be staked out with metal fence posts or wooden stakes (figure 137) and the length, width and location of the wet area recorded and photographed for future reference. For saturated areas on the embankment dam face, the degree of wetness should also be estimated and recorded, such as “boggy,” or “surface moist but firm underfoot.” Any flow of water from the wet area or into a sinkhole should be measured, if possible, and/or estimated and recorded. See section 11.3 for guidance on actions involving sinkholes.

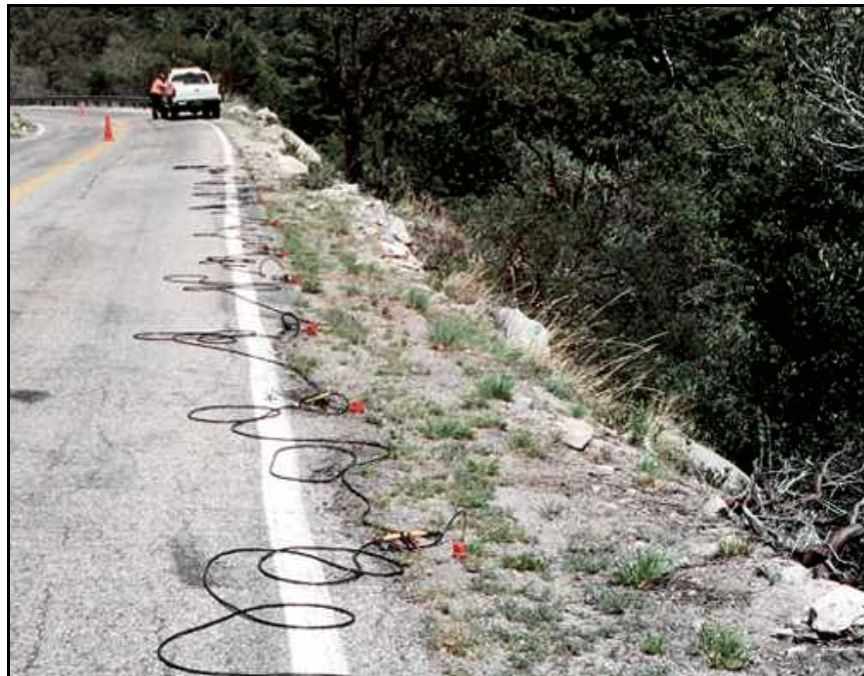
Figure 138.—Seismic tomography being used on an embankment dam. Photo courtesy of URS Corporation.

The seismic tomography method (figure 138) is a noninvasive geophysical method similar to methods applied in medicine, such as ultrasound, computerized axial tomography (CAT) scans, and magnetic resonance imaging (MRI). Seismic tomography uses elastic waves produced by seismic sources implanted around or within boreholes in the embankment dam. Receivers (geophones or accelerometers) installed at other locations on the structure record the generated waves.

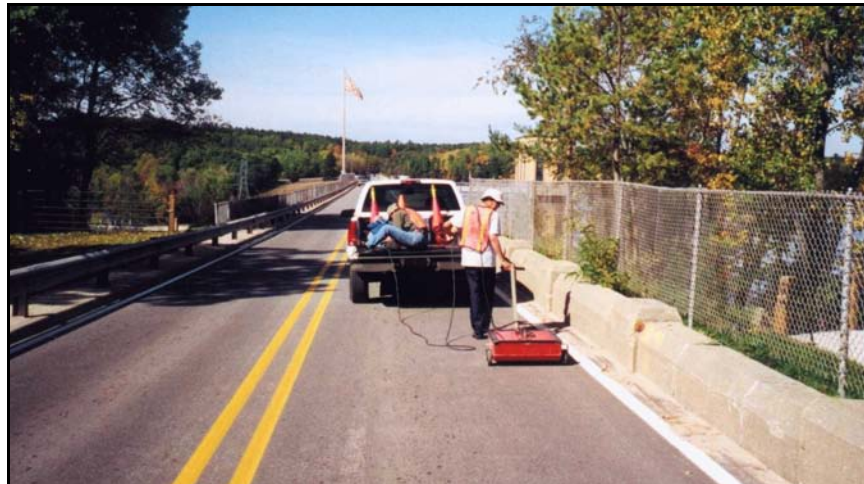
Figure 142.—Conducting a ground-penetrating radar survey across dam crest to locate voids beneath roadway and spillway. Photo courtesy Schnabel Engineering.

Ground-penetrating radar (GPR) uses high frequency electromagnetic energy to penetrate below the ground surface (figure 142). An antenna is used to transmit a short duration pulse, which travels through the air and the subsurface until it is reflected back by a change in the dielectrical properties of the material being imaged. The resulting reflections are displayed in sounding or section format, with sections being the far more common display mode. If the GPR profiles are conducted on a close spacing, the resulting data can be treated in a data volume manner, allowing arbitrary slices through a three-dimensional data mass. This three-dimensional technique can be labor intensive to acquire and process.

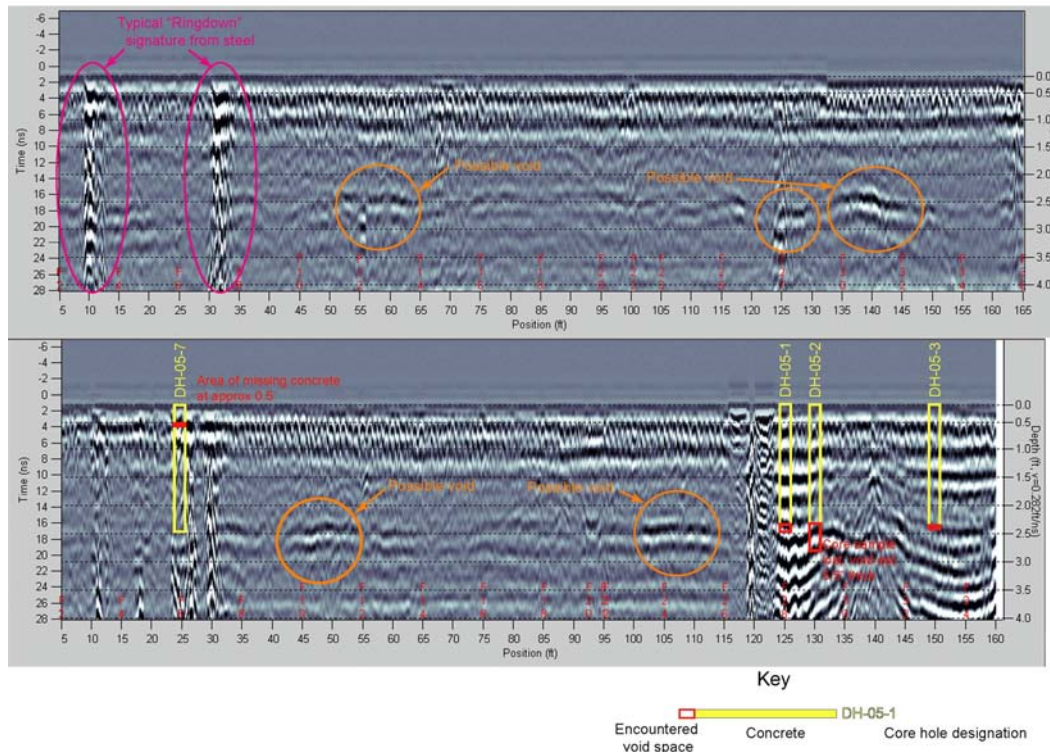
Figure 144.—GPR profiles along a conduit invert. The large amplitude white-black reflection patterns are associated with concrete underlain by voids in drill holes (DH) DH-05-01 through -03.

Known void areas are extremely useful in “calibrating” a GPR survey at a particular site. Lacking known void areas, core drilling or other direct inspection methods are highly desirable to aid in the GPR data interpretation. GPR data profiles can be difficult to interpret properly, if no site “ground truth” is available. Figure 143 shows a core hole being drilled to reveal voids behind the concrete, and figure 144 shows an example of GPR profiles along a conduit invert.

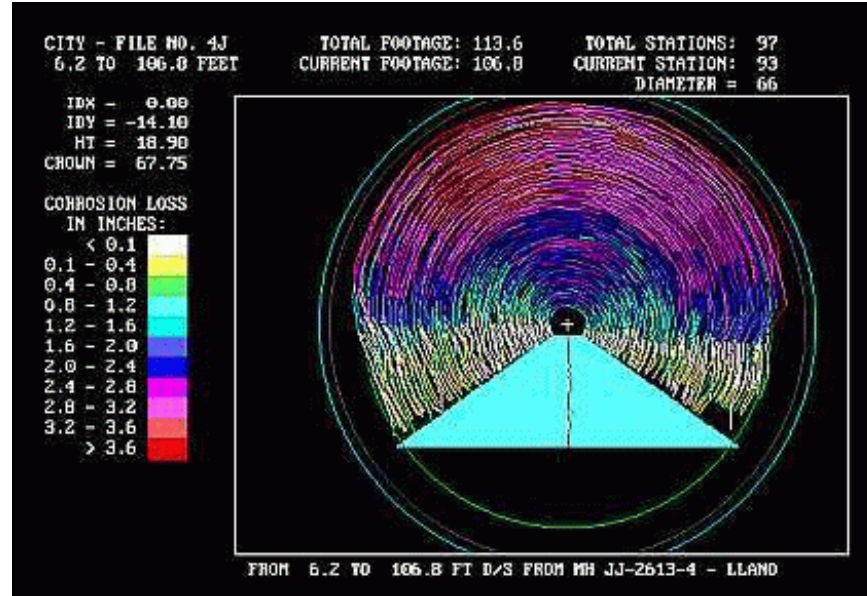
Figure 145.—A rotating sonar transducer mounted on a sled can be pulled through a conduit to measure and record changes in dimensions along the conduit. This can be very useful when determining the size for a proposed slipliner. Here, the measured corrosion loss of the crown of a steel pipe is shown at many locations on one image. The bottom of the conduit was submerged. The sonar device can work in water or air, but requires different settings for each. Thus, both above water and underwater sonar measurements cannot be made at the same time, although a mechanical device on the sonar sled can simultaneously provide information for the bottom of the pipe. Figure courtesy Sonex Corporation.

for generated sonar pulses to return to the transducer (through air or water) are a function of the distance that the pulse travels, it is possible to precisely measure the distance to the conduit surface. When processed by a computer, thousands of these measurements can be used to generate a map (figure 145) of the condition (deflection, joint size, depth of deterioration, etc.) of the conduit. The precision of the system is such that measurements of fractions of an inch can be made. The sonic velocity can vary with temperature and humidity, and calibration is required prior to commencing with the inspection. The accuracy of the measurements depends upon the calibration. The sonar can also be used in navigating the transporting unit within the conduit.

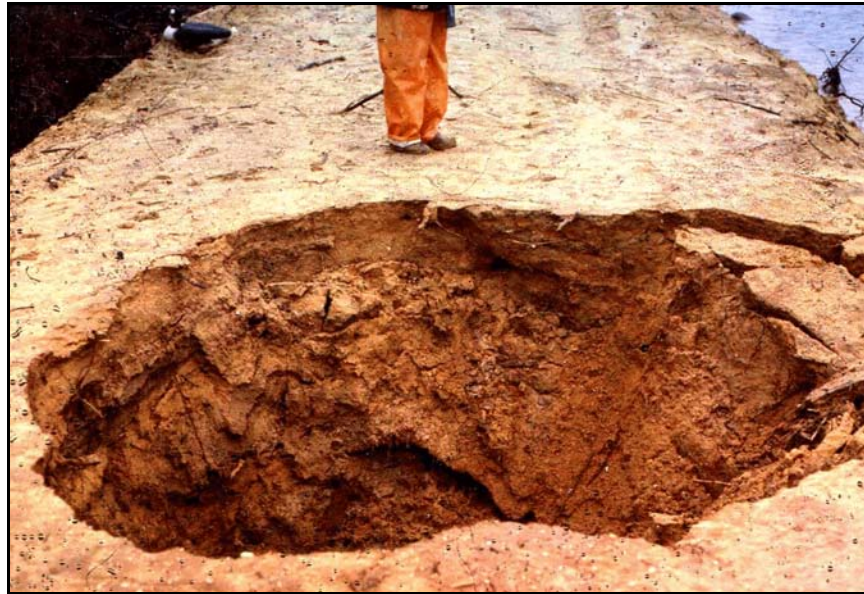
Figure 147.—Sinkhole over a spillway conduit.

Sinkholes or subsidence of the embankment surface in the immediate area of the conduit are usually the result of erosion of the embankment material. They usually indicate a very serious problem that needs immediate attention. Figure 147 shows an example of a sinkhole that occurred over an spillway conduit.

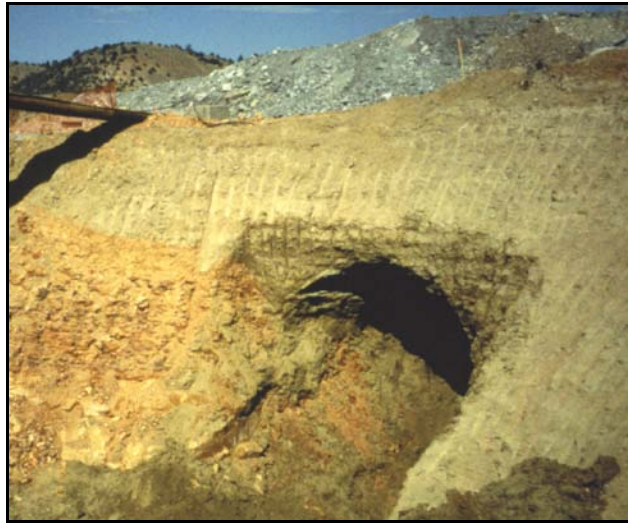
Figure 149.—Incipient sinkhole in an embankment dam. Eventually, the continued removal of the soil at the bottom of the cavern would have caused the roof to migrate to the surface of the embankment dam.

Most often, a sinkhole that was caused by erosion of embankment material into a conduit will be located immediately above the alignment of the conduit, and the following discussions apply to this situation. Figure 148 illustrates a typical sequence of the formation of a sinkhole located above a conduit. Figure 149 shows an example of a sinkhole where the continued removal of soil would have caused the roof of the cavern to migrate to the surface of the embankment dam. Sinkholes that are not associated with a conduit may have different considerations and are not further discussed here.

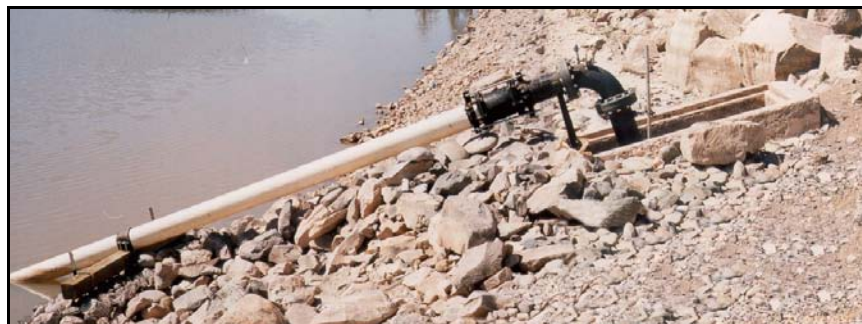
Figure 150.—Siphon used to lower the reservoir water surface through the upper entrance of an outlet works intake structure.

A siphon is a closed conduit system formed in the shape of an inverted U. A siphon (figure 150) can be used to partially drain a small reservoir. A single or a series of siphons can be constructed. Typically, siphons are placed up and over the embankment dam and extended to the toe of the dam. The downstream portion of the siphon can be charged with water and then released to create the siphonic action to start the siphoning of water. The downstream end of the siphon should be equipped with a gate or valve to facilitate creating the siphonic action. Multiple methods should be considered for priming siphons, such as a vacuum pump, water pump, or hand pump. Provisions for breaking the siphon (siphon breaker vent) should be provided at the crest of the embankment dam, should the need arise. At the discharge end of the siphon, the area should be properly protected to ensure that the discharging water does not cause erosional damage. A siphon over an embankment dam is illustrated in figure 151. The siphon in figure 151 is shown extending over the dam crest to avoid excavation into the embankment dam. If the siphon must be excavated through the embankment dam crest, the guidance provided in chapter 5 should be utilized.

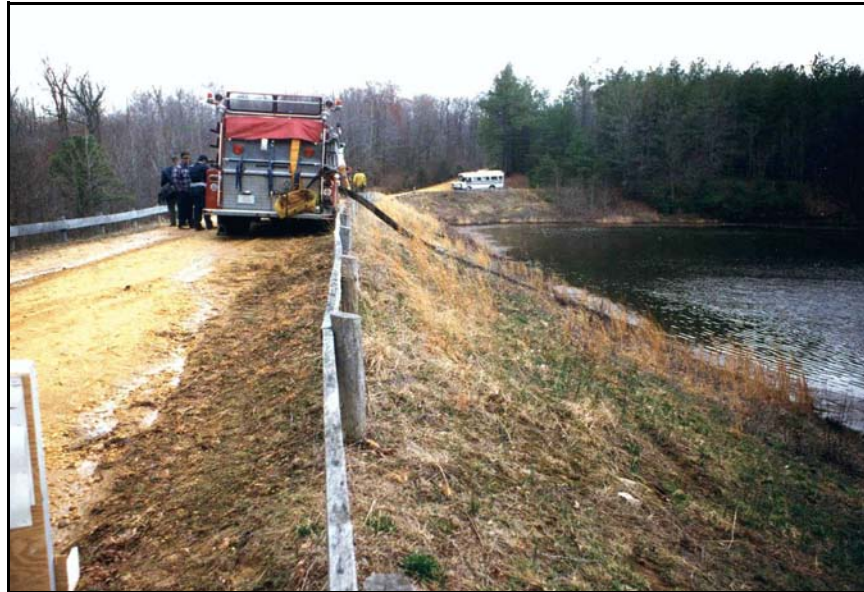
Figure 152.—All available resources may need to be utilized to drain the reservoir in an emergency. Here, the local fire department assists in draining a lake during a thunderstorm after the 45-year old CMP spillway collapsed.

Pumping of the reservoir water can be used to drain relatively small reservoirs. A single or a series of high capacity (e.g., 3,000-gal/min) portable pumps can be delivered to the damsite to assist in draining of the reservoir. The pumps can be positioned in the spillway entrance or on the embankment dam crest (figure 152) and allowed to discharge into the spillway or outlet works, or the pump can be placed over and down the downstream face of the embankment dam to the downstream toe. At the discharge end of the pumps, the area should be properly protected to ensure that the discharging does not cause erosional damage.

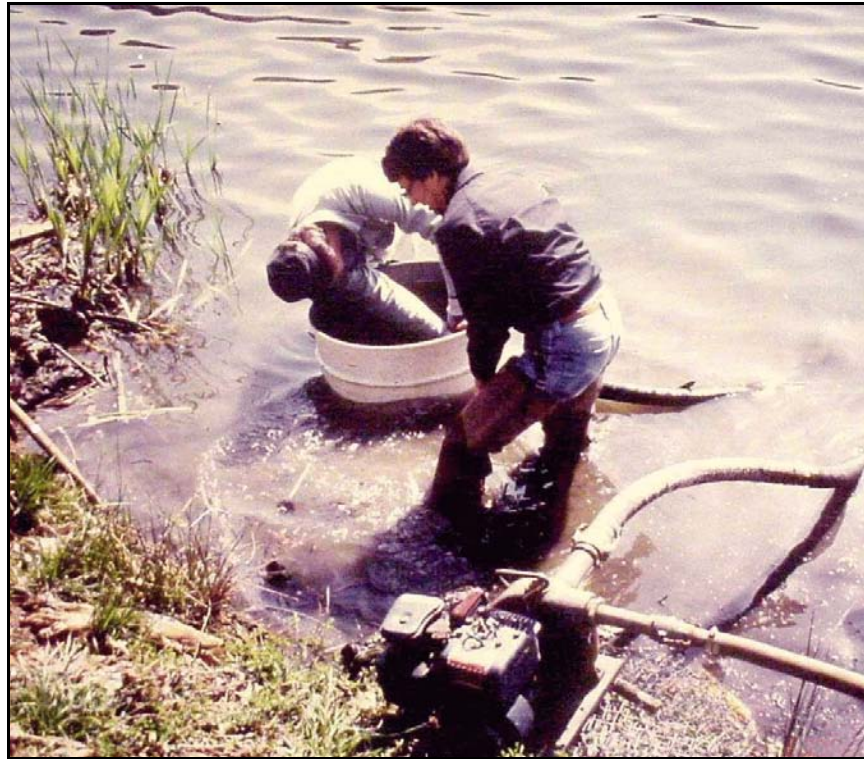
Figure 153.—The upper portion of a small metal pipe riser structure was removed with an acetylene torch. The riser was isolated from the pool by surrounding it with a large drum pressed into the soil. A pump was used to remove the water between the drum and the riser so that the work was completed in the dry.

If the riser can be temporarily isolated from the reservoir with a portable cofferdam, a torch can be used to remove the upper portion of the riser. This procedure was used to lower the pool of an embankment dam in Maryland by about 1.5 feet (figure 153). Care must be taken when removing the inlet structure to ensure that the materials being removed do not fall into and plug the spillway conduit, and debris does not enter the conduit (figure 154).

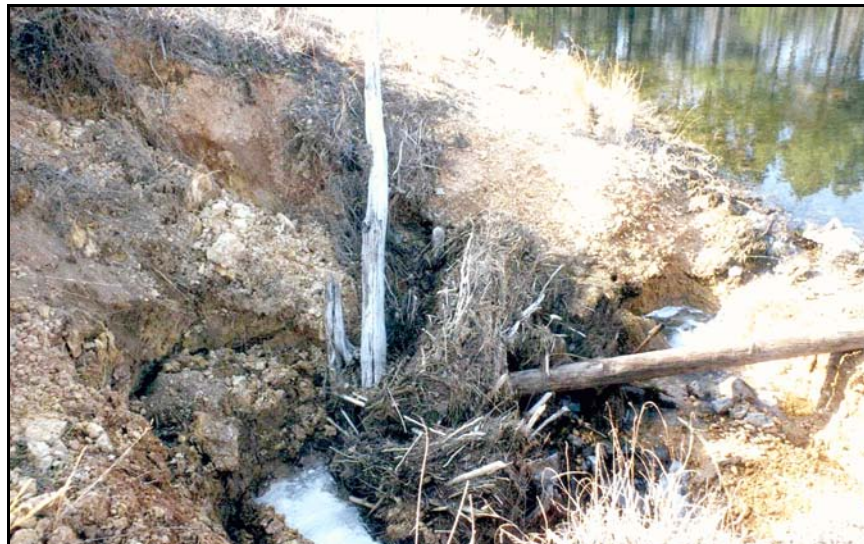
Figure 154.—Care must be taken to ensure that debris does not clog spillway after removal of the riser.

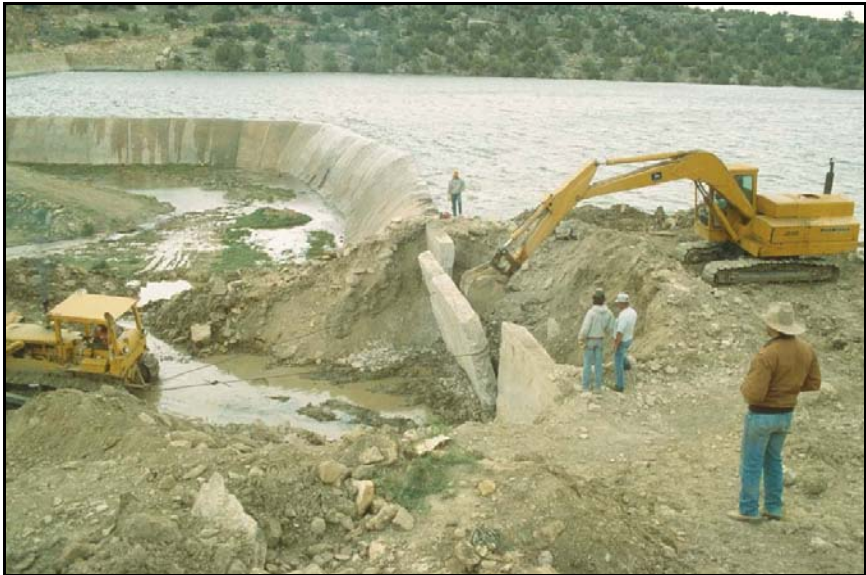
Figure 155.—Spillway being partially breached to lower the reservoir.

The concrete control structure/weir of an existing spillway can be partially or fully removed to facilitate the lowering of the reservoir in the event of an emergency. The concrete control structure is typically used in earth cut spillways as a grade fill. If blasting is employed to remove the concrete, caution should be taken to ensure that the blasting does not cause additional damage to the embankment dam or foundation. Controlled blasting techniques with minimum particle velocities can be used effectively to remove the concrete structure. Figure 155 shows a concrete control structure being partially breached to allow for lowering of the reservoir.

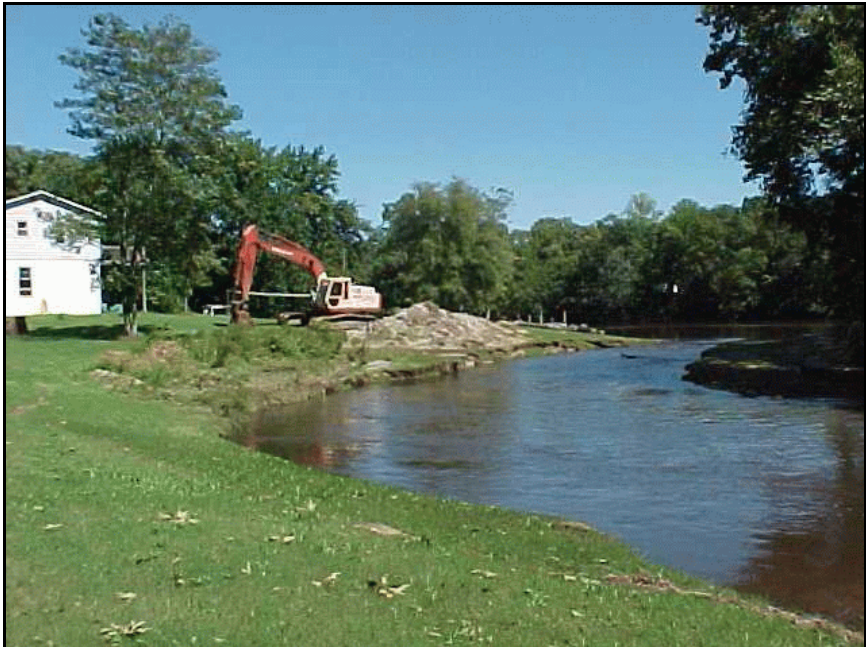
Figure 156.—The owner of this embankment dam excavated a channel around the dam to prevent its overtopping during a hurricane.

Similarly to excavating a channel through an existing earthcut spillway, a trench can be excavated through the abutment of the embankment dam (figure 156) to provide emergency release of the reservoir, if required. The trench should be properly located to ensure that uncontrolled releases of the reservoir through the channel do not encroach upon the embankment dam and cause an unanticipated breaching of the embankment dam. Care should also be employed to ensure that the excavated channel does not cause larger-than-anticipated flooding downstream of the embankment dam. Construction and cautions similar to those mentioned in the previous section for the excavation of a trench through an existing earthcut spillway should be employed.

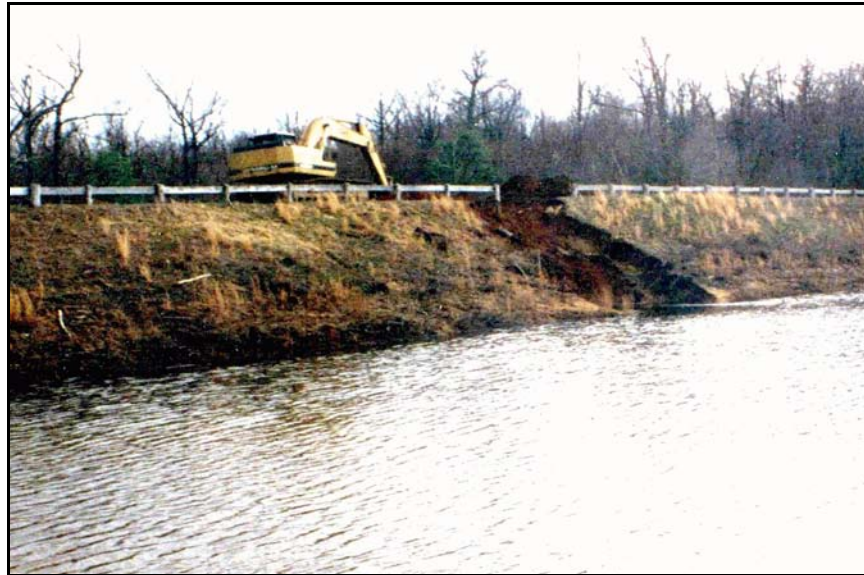
Figure 157.—A controlled breach of an embankment dam begins after the 45-year old CMP spillway conduit collapsed and the lake level began to rise.

The breaching of the embankment dam should be done in stages and in a controlled manner to ensure that a catastrophic failure of the embankment dam does not occur, causing unanticipated and unwanted downstream property damage or loss of life (figure 157). First, a discharge channel should be excavated down the embankment downstream face or abutment area to convey the discharging water safely to the downstream channel. This channel should be excavated down to or into erosive-resistant materials, if possible. If not, the excavated channel should be protected by lining the channel with erosion-resistant materials, such as rock riprap, concrete rubble (if temporary), sandbagging, plastic sheeting, or geotextiles. The embankment dam can then be breached in a slow and staged operation. The embankment dam is first excavated down to a point that will allow a predetermined maximum amount of water to flow through the breach. The initial flow of water through the breach should be as minimal as possible and allowed to stabilize and diminish before removing another small portion of the embankment dam. The excavation of the embankment material should be kept at a minimal amount to limit the quantity of water discharging through the breach section at any time. This process can then be repeated until the desired breach dimensions have been obtained. If possible, a cofferdam should be upstream of the area to be breached, which serves to prevent a catastrophic failure, if the breached section begins to erode in an uncontrolled manner. See the Balman Reservoir Dam and Empire Dam case histories in appendix B for examples of controlled dam breaches to draw down reservoirs.

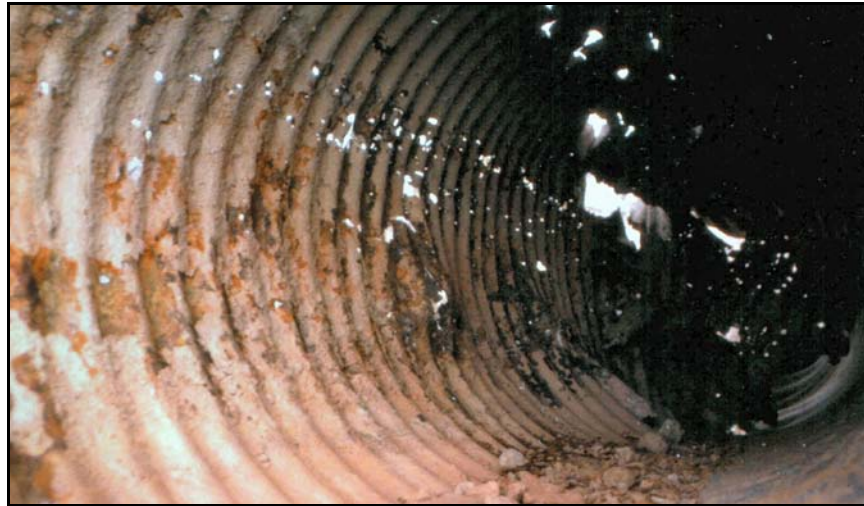
Figure 159.—The holes in this CMP conduit were clearly visible after removal. The conduit was considered to be so severely corroded that sliplining was not an option and it was removed and replaced. Photo courtesy of Maryland Dam Safety Division.

- *Deterioration process.*—If deterioration of the existing conduit is caused by a corrosive process, then the useful life expectancy of the existing conduit should be evaluated based on the knowledge that deterioration will continue. Generally, the slipliner should be designed to accommodate all internal and external loadings without any support provided from the deteriorating conduit. If the existing conduit is expected to provide support for the new slipliner, and the life expectancy of the existing conduit is less than the life of the project, then removal and replacement should be considered (figure 159).
