Technical Manual: Conduits through Embankment Dams

Best Practices for Design, Construction, Problem
Identification and Evaluation, Inspection,
Maintenance, Renovation, and Repair

Federal Emergency Management Agency

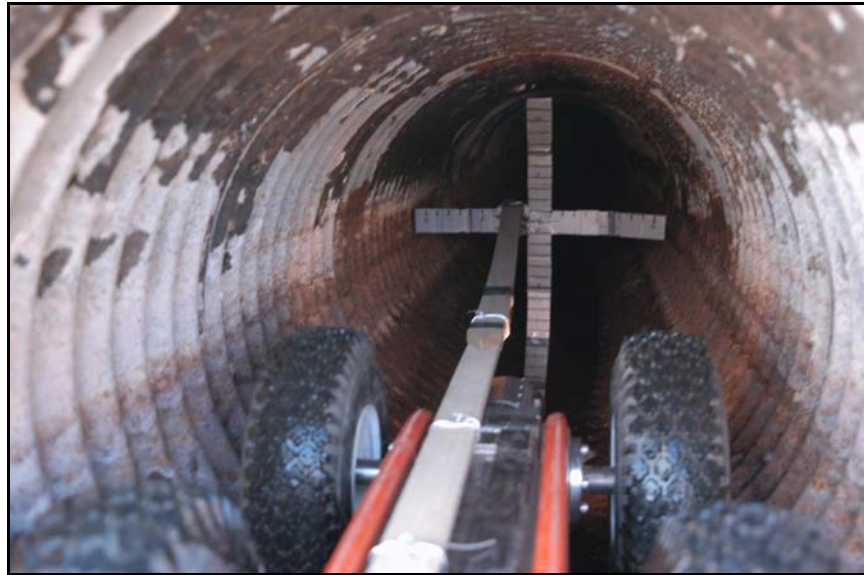
Figure 160.—Crossbar template attached to a CCTV camera-crawler to check for irregularities in the CMP conduit.

protrusions, or irregularities in the existing conduit will control the selection of the slipliner diameter. The pulling or pushing of a template (figures 160 and 161), inflatable pipeline sphere, or soft (typically open cell polyurethane foam) pig (figure 162) through the existing conduit is recommended. This will also ensure that sliplining can be done without difficulty.

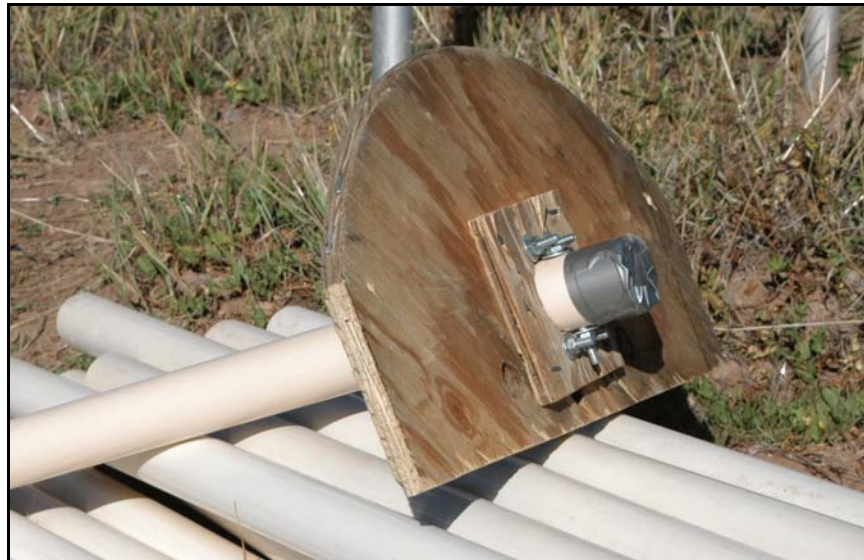
Figure 161.—A horseshoe shaped template used for checking irregularities in a conduit. The template is attached to the CCTV camera-crawler.

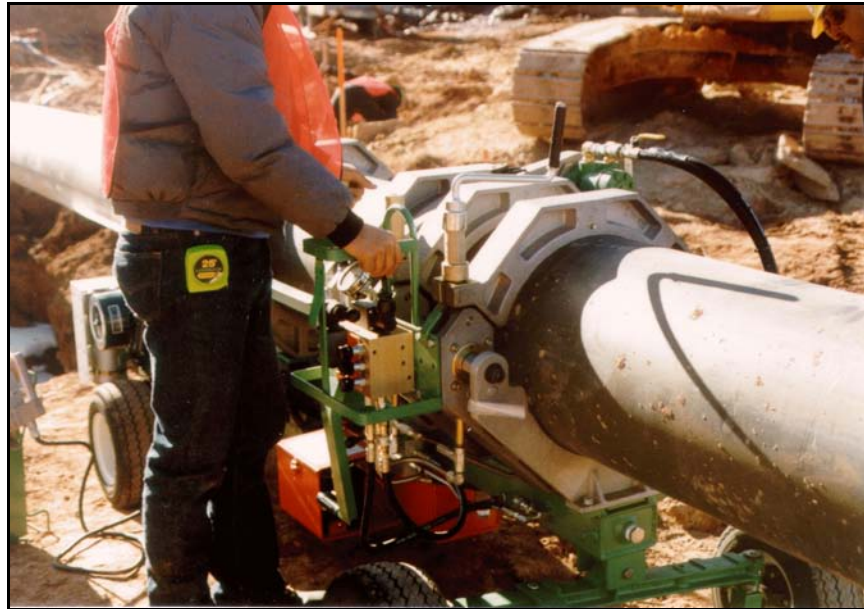
Figure 163.—HDPE pipe joint being fusion welded.

Joints.—The most common method used to join HDPE pipe is heat fusion (ASTM D 2657). This method is also known as butt fusion. The butt fusion technique is a widely used and industry-accepted heat fusion method for joining sections of smooth solid walled HDPE pipe. This method produces a joint that is watertight and is as strong or stronger than the HDPE pipe material itself, if performed correctly. A special machine (figure 163) is used to trim the ends of the pipes (facing or squaring off), align the ends of the pipe, heat both ends of the pipes to about 400 to 450 °F, and force the ends together under pressure. The melt bead size required for the thickness and diameter of the HDPE pipe determines how much pressure and time is needed for fusion of the joint. About 1 hour should be allowed for the joint to adequately cool after completion of the fusion process (figure 164). Trial fusions should be considered at the beginning of the day, so the fusion procedure and equipment settings can be verified for the actual jobsite conditions. Manufacturer's recommended procedures should always be observed for heat fusion.

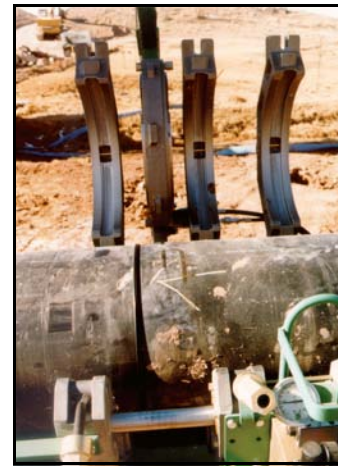
Figure 164.—Finished fusion welded joint.

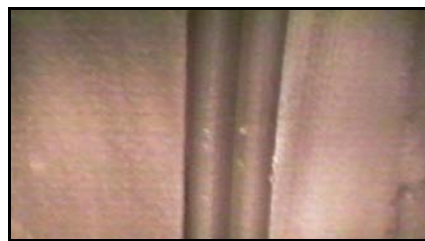
Figure 165.—Interior view of finished joint bead.

A small bead (figure 165) is formed where the melted material is extruded from the joint. Beads appear on both the inside and the outside of the HDPE pipe. The need for bead removal is uncommon, but can be accomplished using special tools after the joint has thoroughly cooled to ambient temperature. If removal is necessary, the personnel using the debeading tool should be properly trained, so the HDPE pipe is not needlessly gouged. The existence of the interior bead has a negligible impact on the hydraulic performance of the slipliner. A bead exists on the exterior surface of the joint. If proper annulus clearance is provided by the designer, this should not affect slipliner insertion or the grouting process. The beads should be thoroughly inspected for uniformity and proper size around the entire joint. Visual inspection is usually adequate; however other methods, such as radiographic or ultrasonic methods, can be used. The use of fusion machine operators who are skilled, knowledgeable, and certified by the manufacturer will produce a good quality joint. Improperly heat fused joints cannot be repaired and must be cut out, and the ends

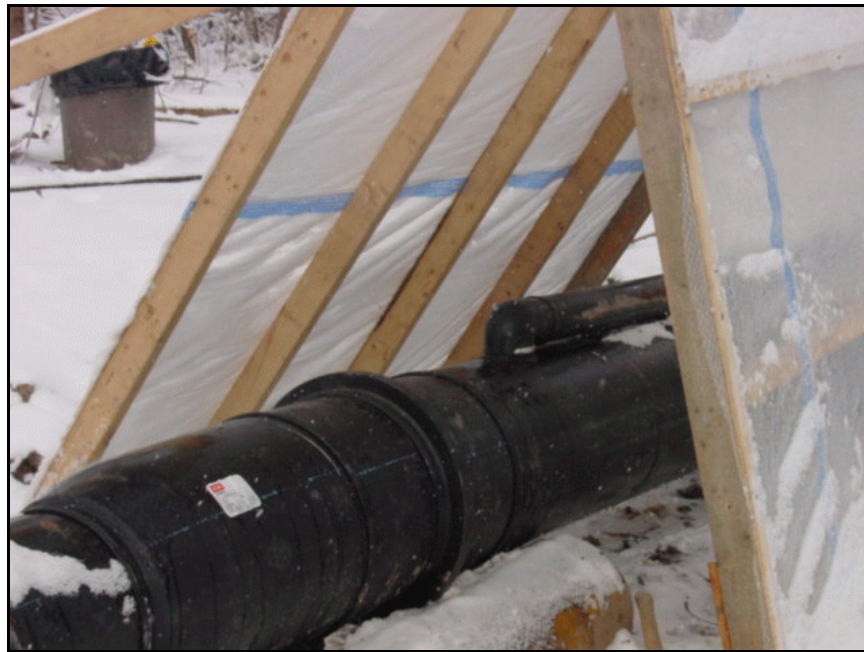
Figure 166.—Cold weather shelter constructed for joining sections of HDPE pipe.

During cold weather, additional time is required to warm up the fusion machine and to heat the ends of the HDPE pipe. A shelter (figure 166) may need to be constructed for joining the sections of HDPE pipe in case of inclement weather. For additional cold weather procedures, see ASTM D 2657.

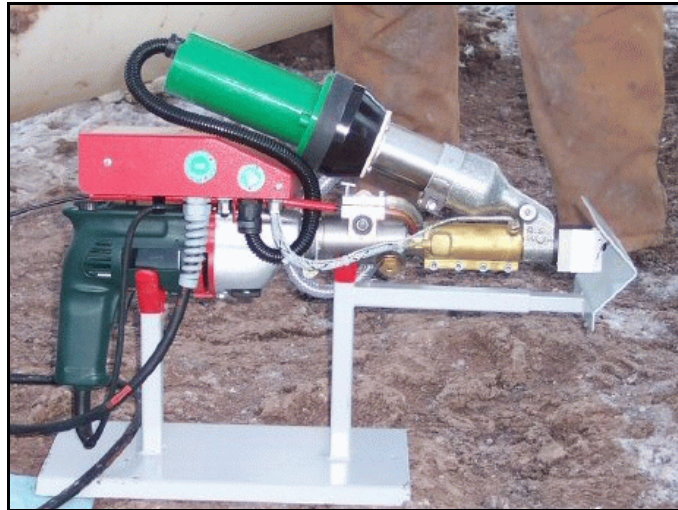
Figure 167.—Hand held extrusion gun.

- *Joints made by extrusion welding.*—Many prefabricated fittings (i.e., elbows, bends, and tees) can be joined to the HDPE slipliner with heat fusion (ASTM D 3261) in the field using an extrusion gun. The extrusion gun (figure 167) is a hand held extruder that preheats the surface of the HDPE pipe and feeds a molten bead of polyethylene into the joint. Extrusion-welded joints are not as strong as butt fusion joints. Proper training is required for using the extrusion gun. Extrusion welding has been successfully used for connecting HDPE grout

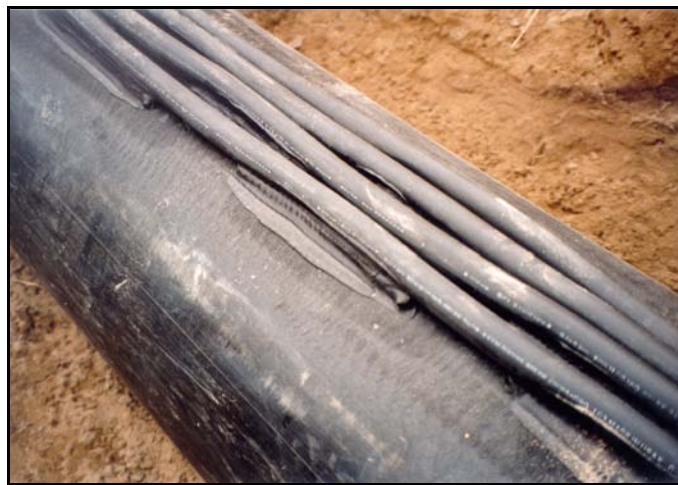
Figure 168.—HDPE grout pipe attached to HDPE slipliner.

and air vent pipes to the slipliner (figure 168). Extrusion welding cannot be used to repair damaged HDPE pipe.

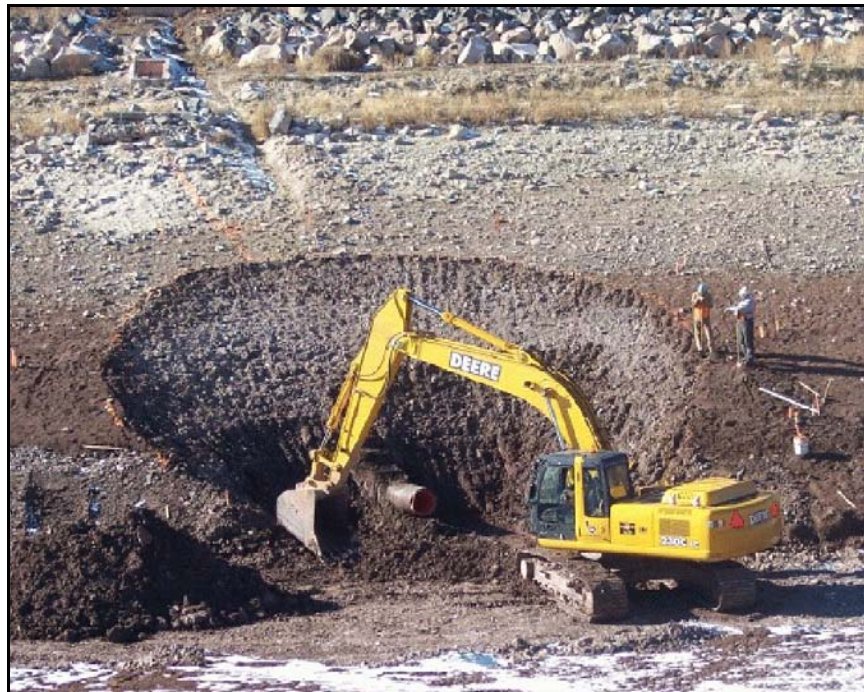
Figure 170.—The intake structure has been removed as part of a conduit renovation.

Entrance and terminal structures.—The sliplining of an existing conduit may require partial or full removal and replacement of certain structures to improve release capabilities or to facilitate construction. Figure 170 shows an intake structure

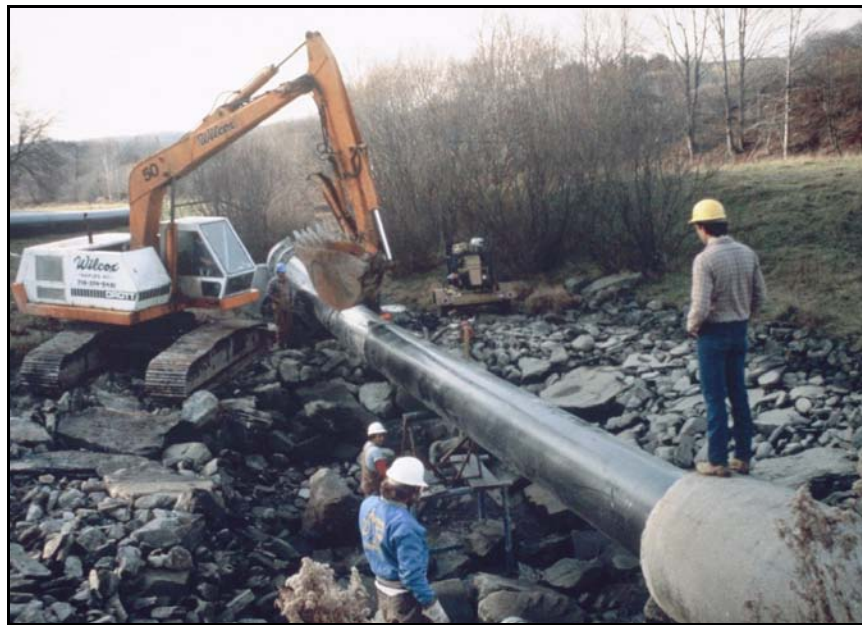
Figure 171.—Insertion of an HDPE slipliner into an existing concrete conduit. A backhoe is being used to assist with slipliner insertion.

- *Access and insertion.*—HDPE pipe is light in weight relative to more traditional pipe materials, and as such is easier to insert into existing conduits. Pulling, pushing, or a combination of both are the typical methods for slipliner insertion. Backhoes, bulldozers, and winches have been used to assist with the slipliner insertion (figure 171).

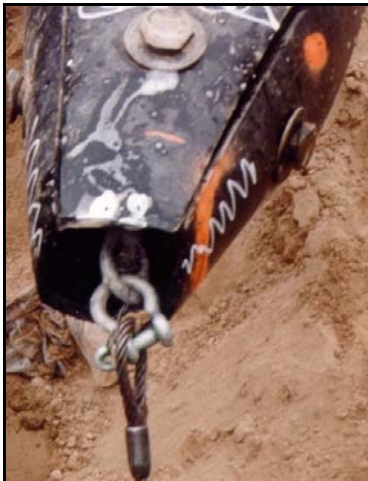
Figure 172.—Nose of HDPE slipliner modified for pulling into an existing conduit.

The nose cone pulling head (also known as the banana nose or soft nose) is a simple and cost effective configuration to use where the pulling stress on the HDPE slipliner is less than 700 lb/in². The nose cone pulling head is made from a few extra feet of HDPE pipe that has been fused onto the slipliner. Evenly spaced wedges are cut into the leading edge of the pulling head. A couple of alternatives exist for the nose cone configuration: (1) the wedges are collapsed towards the center to form a cone and fastened together with bolts. A pulling cable is attached to secondary bolts that extend across the collapsed nose (figure 172) and (2) holes are drilled through the wedges and cables or narrow plates are attached to the wedges. The cables or plates are attached to a pull ring (figure 173).

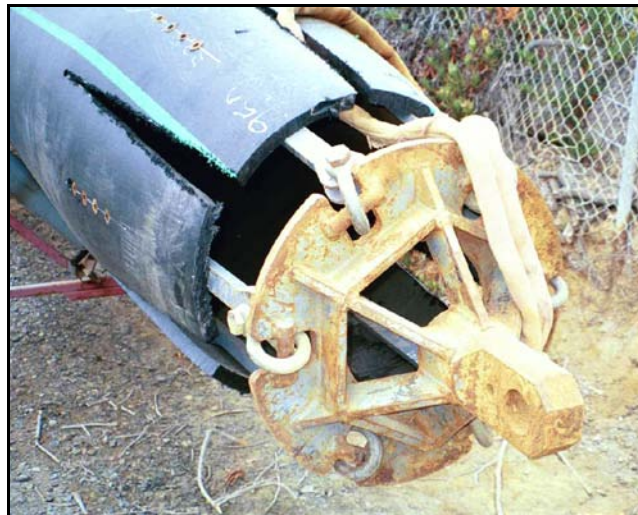
Figure 173.—A nose cone configuration utilizing a pull ring.

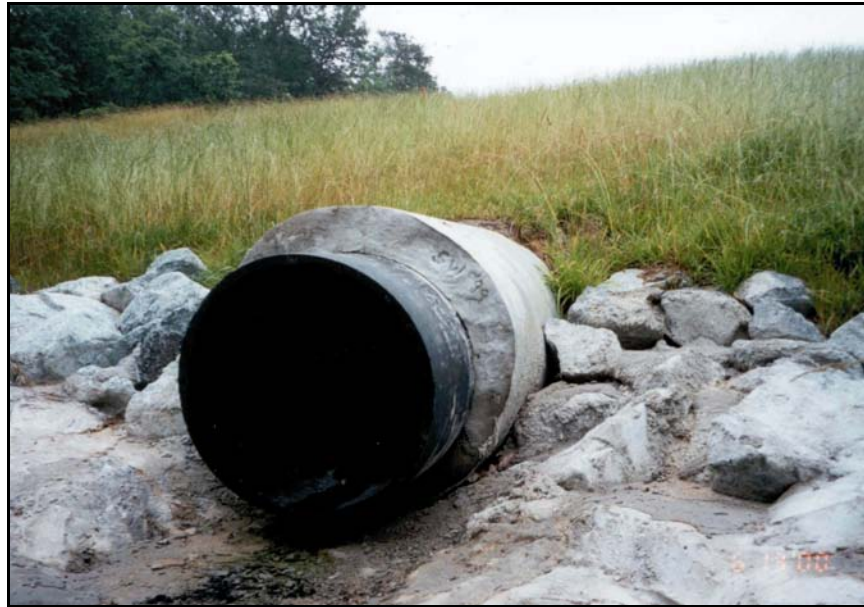
Figure 176.—Completed HDPE slipliner in existing CMP spillway conduit. Photo courtesy of Maryland Dam Safety Division.

Postinspection and acceptance.—The completed HDPE slipliner (figure 176) should be visually inspected by trained personnel to evaluate the conditions within the renovated conduit. If the sliplined conduit is too small for man-entry inspection, CCTV inspection methods should be used. Some designers may want to consider the use of white or gray HDPE pipe to reduce glare using CCTV equipment, figure 177 shows an example of this type of pipe. See section 9.5.2 for guidance on inspection of conduits. No localized dimpling or distortion of the HDPE slipliner wall or infiltration of groundwater or grout should be present.

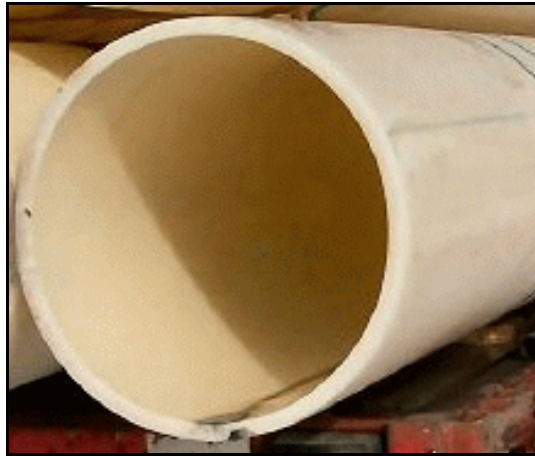
Figure 177.—White HDPE pipe can reduce glare when using CCTV inspection equipment.

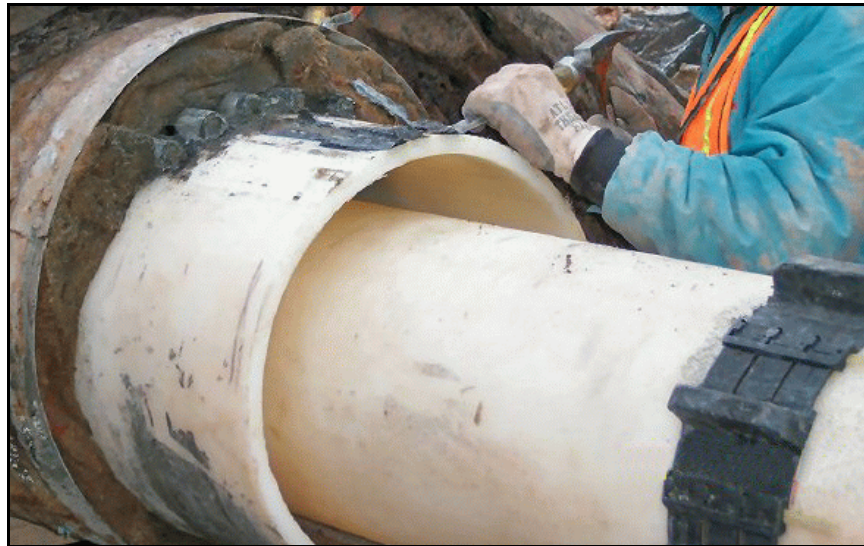
Figure 178.—A 14-inch diameter interior HDPE pipe is being inserted into a 20-inch diameter outside pipe. Intermediate spacers are used to keep the interior HDPE pipe centered and supported. The annulus grouting between the existing CMP and exterior HDPE pipe has been completed.

An additional benefit of the dual containment pipe is that the inside pipe is not subjected to any outside protrusions within the existing conduit that could possibly damage the pipe. The inside pipe is protected by the outside pipe, so if there is any damage the outside pipe will protect the inside pipe. Figure 178 shows an example of dual containment pipe.

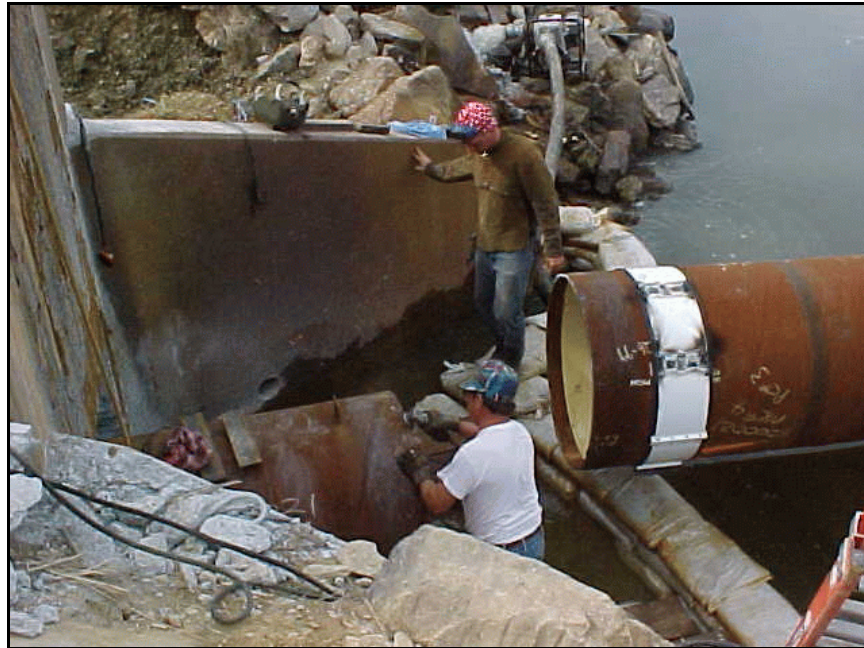
Figure 180.—The Lake Linganore Dam outlet works consists of a 48-in diameter RCP conduit with a sluice gate located at the downstream end, which places the conduit under full reservoir head at all times. Concern about the integrity of the RCP joints led to installation of a steel slipliner when the inoperable sluice gate was replaced.

Steel pipe slipliners (figure 180) are generally applicable, if the existing conduit is straight and does not have bends or significant invert slope changes. Steel pipe slipliners can be installed in conduits with bends or slope changes, if adequate clearance will allow for the insertion of the fabricated pipe sections.

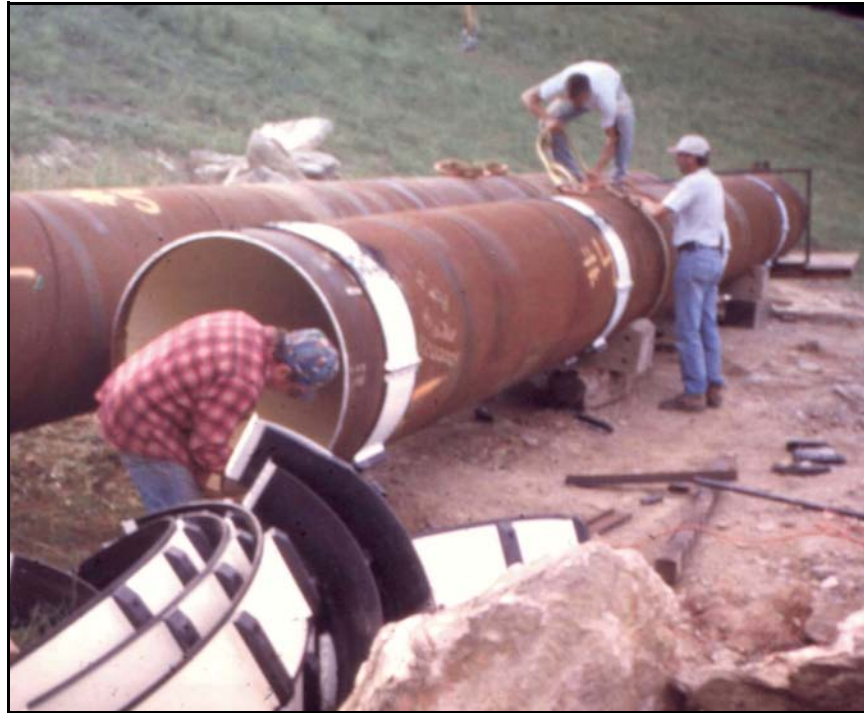
Figure 181.—Spacers being installed on a steel pipe slipliner.

Installation.—The steel pipe slipliner should be supported and braced to prevent distortion during installation and grouting. Spacers are required to maintain separation between the existing conduit and the steel slipliner during grouting. Figure 181 shows spacers being installed on a steel pipe slipliner. Guidance on installation includes the following. Additional guidance on steel pipe installation is available in AWWA M11 (2004c).

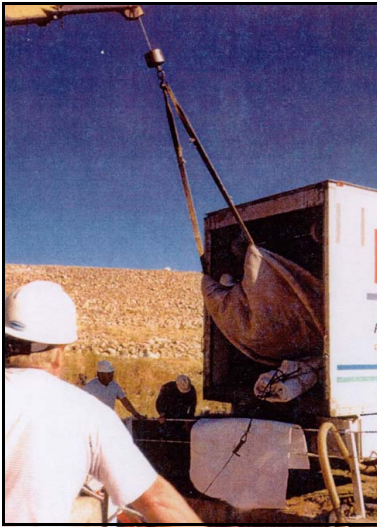
Figure 182.—Unloading the CIPP liner prior to installation.

- *Access and insertion.*—Two methods of installation are available for insertion of the CIPP liner:
 1. *Inversion method.*—The inversion method (figures 182 through 184) consists of utilizing air or water (hydrostatic head) to push the CIPP liner inside-

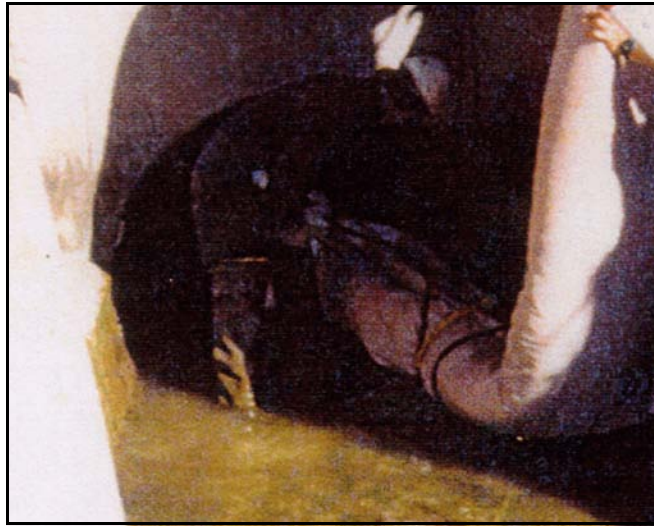
Figure 183.—CIPP liner being positioned for installation.

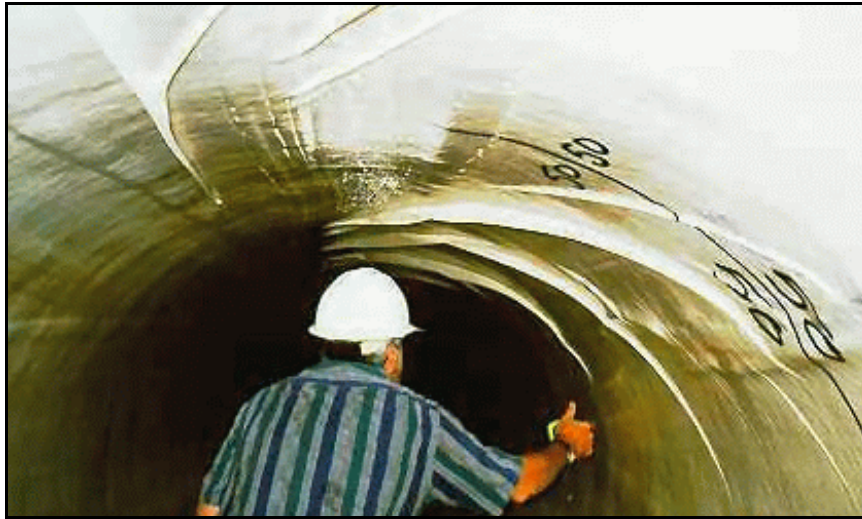
Figure 185.—The calibration hose of this pulled-in-place CIPP developed “fins.” These fins were considered to have an insignificant effect on hydraulic capacity for this particular conduit application and were not removed.

— Trained personnel should visually inspect the completed CIPP installation. No dry spots, lifts, delamination, pinholes, or infiltration of groundwater should be present and the CIPP liner should be in a fully expanded condition. Wrinkles (figure 185) that could reduce the hydraulic capacity of the CIPP liner should not be allowed. If the CIPP-lined conduit is too small for man-entry inspection, CCTV inspection methods should be used. See section 9.5.2 for guidance on inspection of conduits.

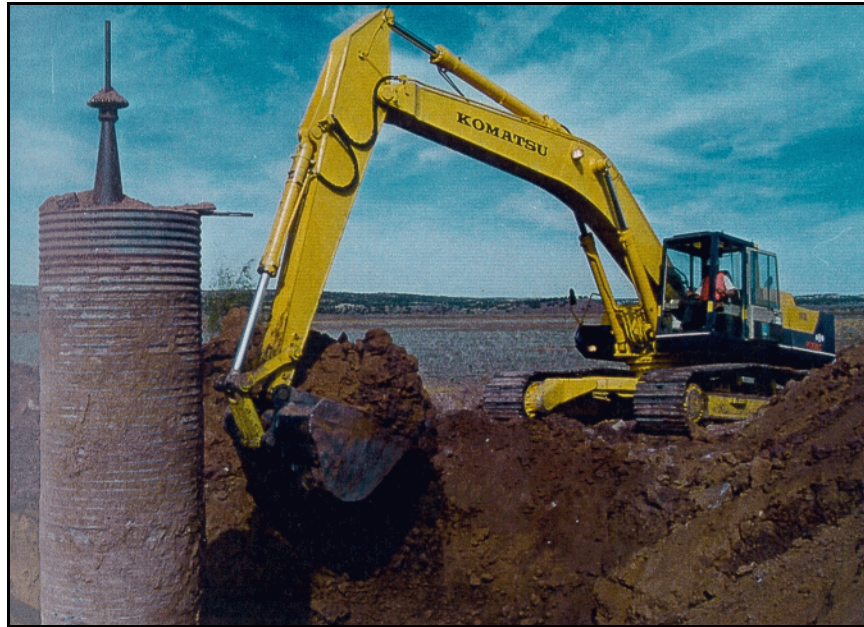
Figure 186.—Excavator removing the intake structure for an existing outlet works.

The first step in removal and replacement of the existing conduit is usually to excavate the embankment dam to the invert of the conduit and remove it. Removal of the entrance structure (figure 186), terminal structure, or other structures may be required due to age or deterioration, or to ease construction of the replacement structures. Occasionally, where removal of the existing conduit is difficult and expensive, the existing conduit may not be removed, but will be abandoned by backfilling the conduit with grout and installing a new conduit at a separate location. See section 14.3 for guidance on abandonment of conduits. Excavations should be wide enough at the bottom to ensure adequate working room for removal of the existing conduit and replacement with the new conduit, and compaction of earthfill materials.

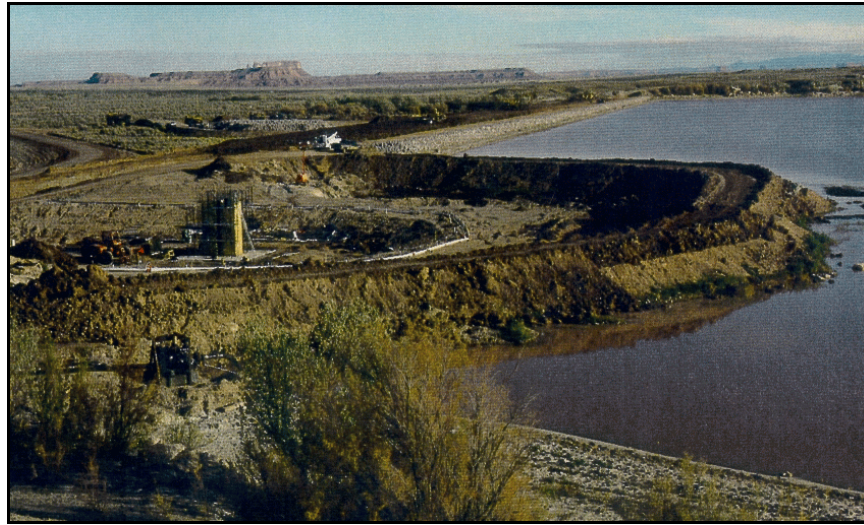
Figure 187.—Cofferdam constructed around the construction area for a new outlet works.

A cofferdam (figure 187) may be needed to act as a temporary barrier to protect the construction area from flooding (Reclamation, 1987a, pp. 499-500). If construction for the removal and replacement of the existing conduit can be performed during the low water season, the use of a cofferdam may be minimal. However, where the reservoir inflow characteristics are such that construction cannot be done during a low water season, the cofferdam must be designed for safety and for optimal height to accommodate the full range of expected inflows during the construction period. Often the flood selected for sizing diversion requirements is based on the projected length of the construction period. For instance, if the projected length of the construction period is 1 year, the cofferdam would need to be able to accommodate a flood with a return interval of 5 years. If the projected length of the construction period is 2 years, a 10-year diversion flood would be used.

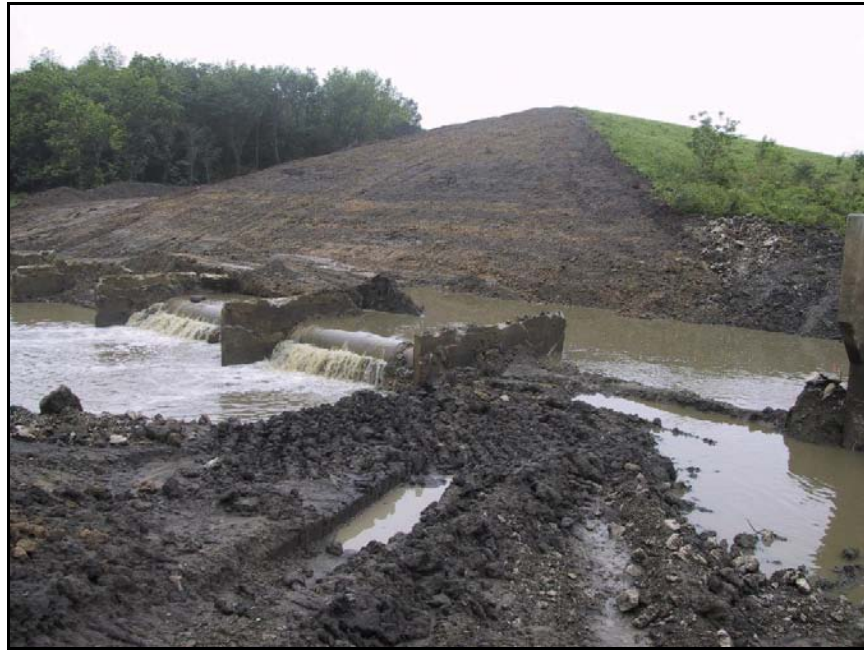
Figure 188.—During the removal of this outlet works conduit a flood occurred. No stream diversion or cofferdam was used at this site.

At some sites, a diversion channel in lieu of a cofferdam may be more practical. Diversions or cofferdams may not be justified for smaller embankment dam projects with limited working room for the removal and replacement of conduits. For these projects, certain hydrologic events during construction may impede progress and cause delays resulting in added costs for clean up of debris caused by flooding. For this situation, construction should be scheduled during periods when the lowest rainfall is probable to avoid these problems. Figure 188 shows an embankment dam site where rainfall during construction has partially flooded the exposed excavation and conduit removal. This flooding resulted in a delay and cleanup before construction could resume.

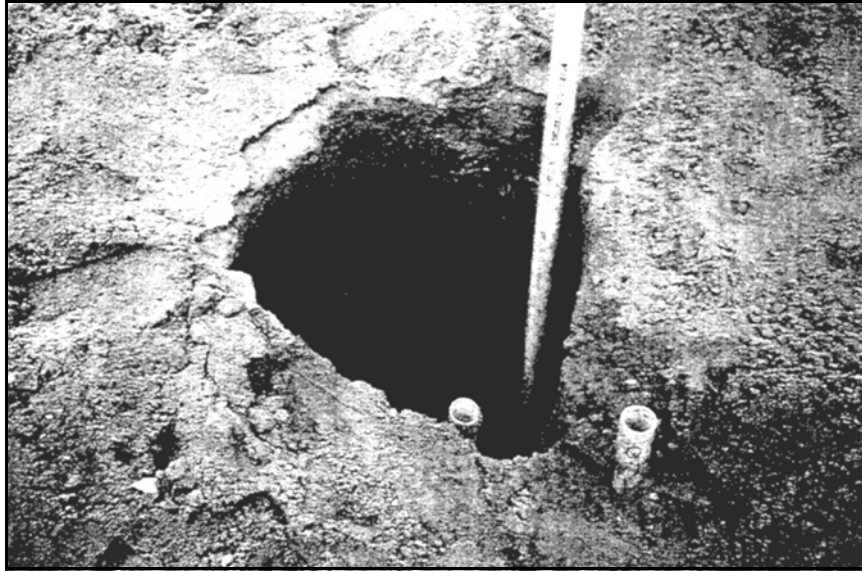
Figure 189.—A very large surface void appeared directly above a test microtunneling installation when the operator stopped advancement of the machine and briefly allowed the slurry pump to continue to circulate the drilling mud. The void appeared in backfill surrounding some test instruments, some of which appeared to support the adjacent soils.

microtunneling, only a very short time is required to erode soil at the face and cause large settlements. The operator must vigilantly control slurry circulation and machine torque to avoid such unacceptable events (USACE, 1995d, p. 4-44). Figure 189 shows a microtunneling installation when an operator stopped advancement.

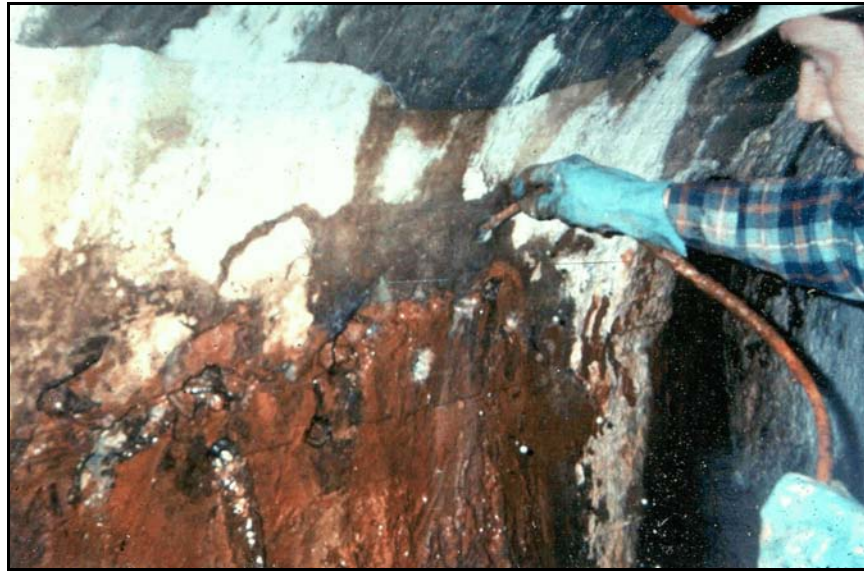
Figure 192.—Injection of urethane grout to stop leakage.

- *Cementitious*.—For guidance on cementitious grout, see section 14.2.2.
- *Chemical*.—For guidance on chemical grout, see section 14.2.2. Figure 192 shows grouting operations within a conduit. Chemical grouts have also been used for grouting voids using drill holes from the surface of the embankment dam. For additional guidance on chemical grouts, see USACE's *Chemical Grouting* (1995a).

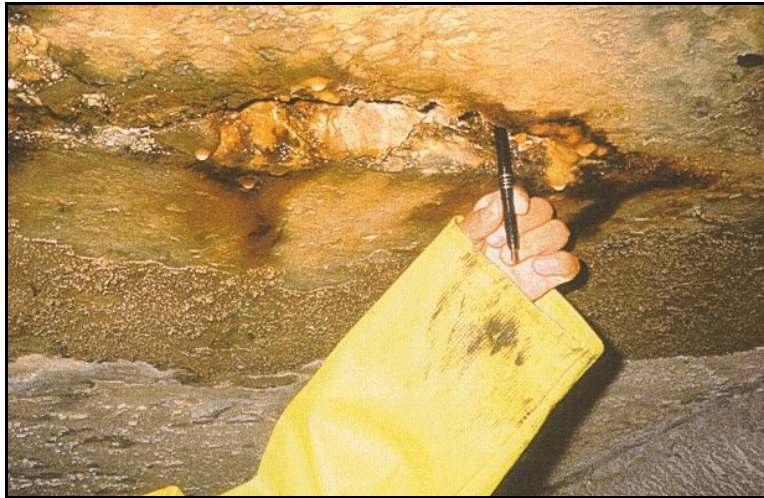
Figure 194.—Evaluate the extent of the damage.

be understood (figure 194). This evaluation will need to determine how quickly the damage is occurring and what the likely progression will be. The simplest and most common evaluation technique is by the use of sounding (hammer blows applied to the concrete surface). Experienced personnel using sounding and visual observation can assess indications of the extent of damage. In smaller conduits, CCTV inspection techniques may be required.

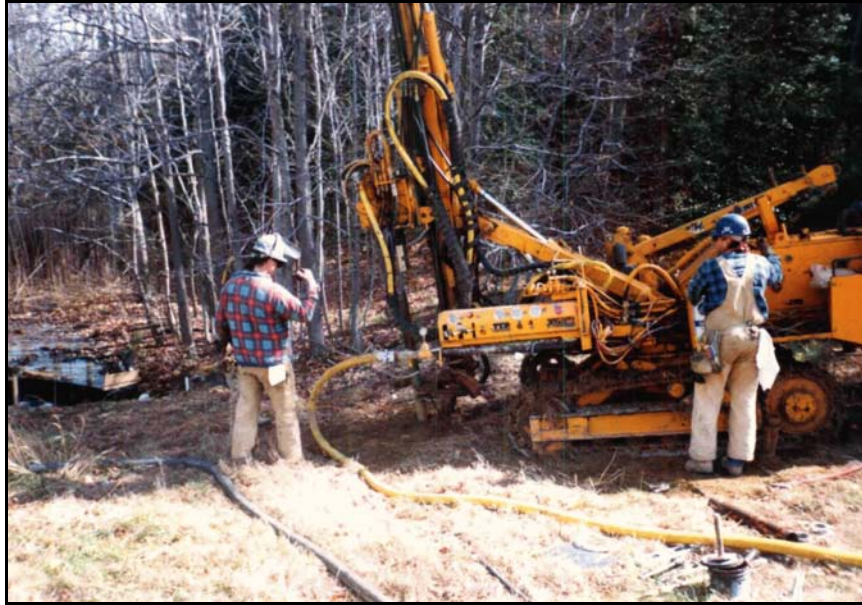
Figure 197.—Abandonment of a conduit by injection of cement grout through holes drilled from the surface of the embankment dam to depths of up to 60 feet.

- *Through holes drilled from the surface of the embankment dam.*— When the upstream and downstream ends of the existing conduit are inaccessible, it may be possible to fill the conduit with grout or concrete through holes drilled from the surface of the embankment dam (figure 197). In order to be successful, the precise location of the existing conduit must be determined, and the driller must be experienced and proceed with caution. For an example of this type of conduit abandonment, see the Clair Peake Dam case history in appendix B.

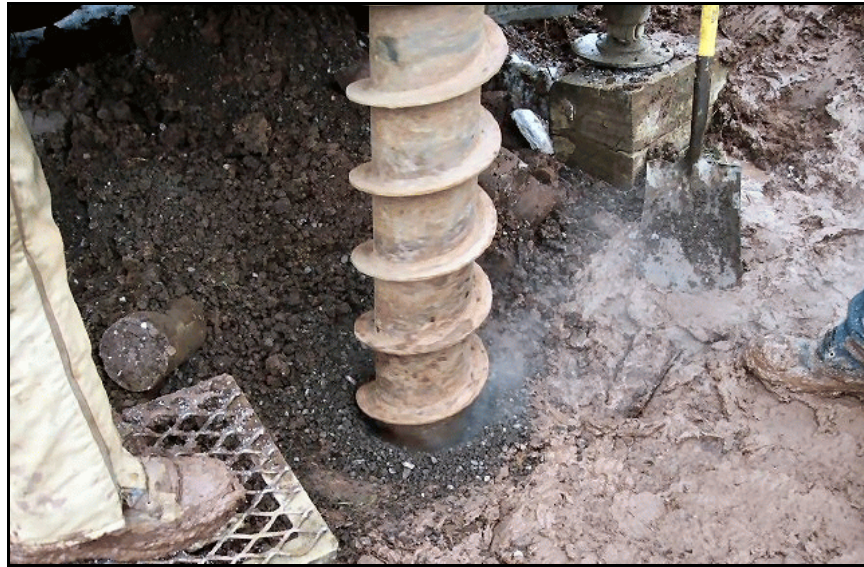
Figure 198.—An auger is being used to drill within an embankment dam.

Auguring is the preferred method for drilling in the core of embankment dams. Auguring uses no drilling fluid and is inherently benign with respect to hydraulic fracturing. A hollow-stem auger permits sampling in the embankment dam and allows sampling/testing of the foundation through the auger's hollow stem, which acts as casing. If fluids must be used, the risks must be understood and specific procedures should be employed to minimize the chance for hydraulic fracturing. Figure 198 shows an example of an auger being used.

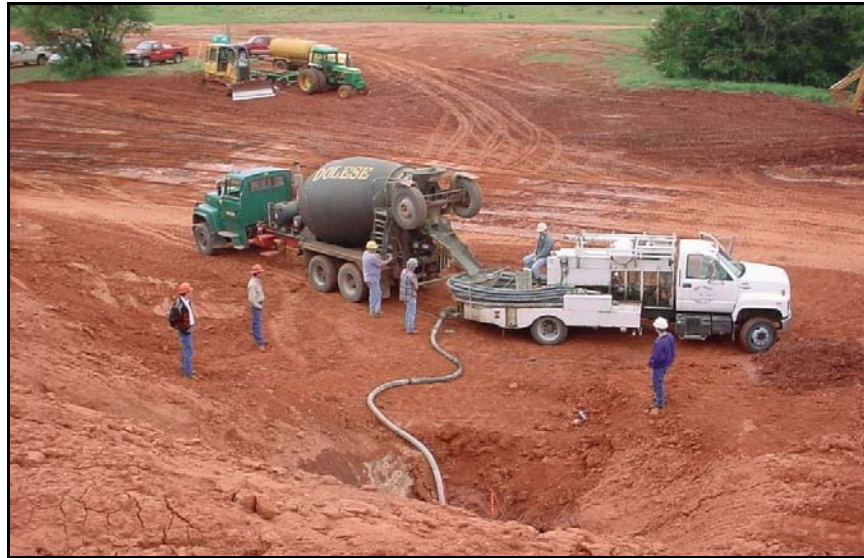
Figure 199.—Grout is delivered to the site and is pumped into the conduit being abandoned.

- *Procedure.*—The pressure at the crown of the conduit as measured at the vent pipe should not exceed 5 lb/in². Grouting is stopped when the air return pipe in the crown flows full with grout. Cap the grout and air return pipes. Remove the bulkhead upon completion of grouting operations. For grouting or backfilling of long existing conduits, the use of sections is recommended. Long grout or backfill placements could result in sufficient expansion and/or contraction to induce cracking of the existing conduit (concrete). The use of sections is also conducive to ensuring an acceptable seal. Figures 199 and 200 show grouting operations involved with the abandonment of an outlet works conduit.

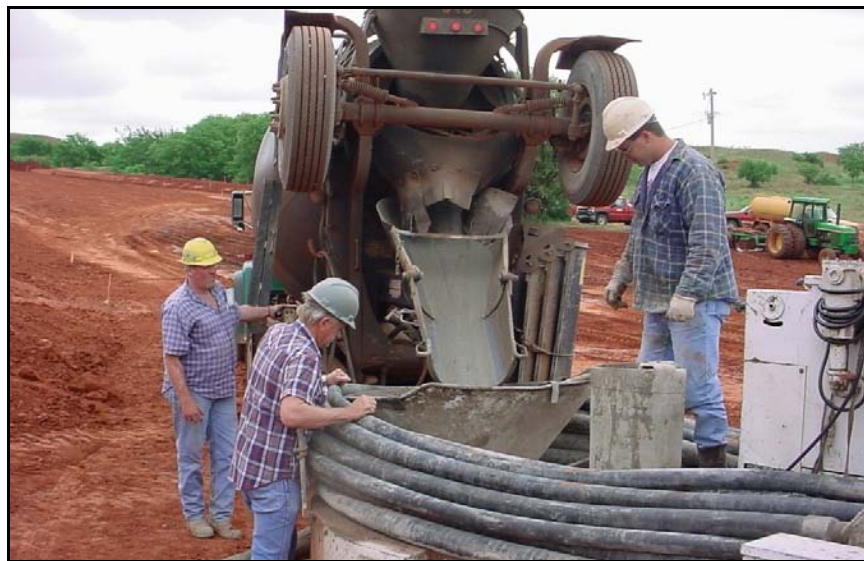
Figure 200.—Grout being delivered to the pumping truck.

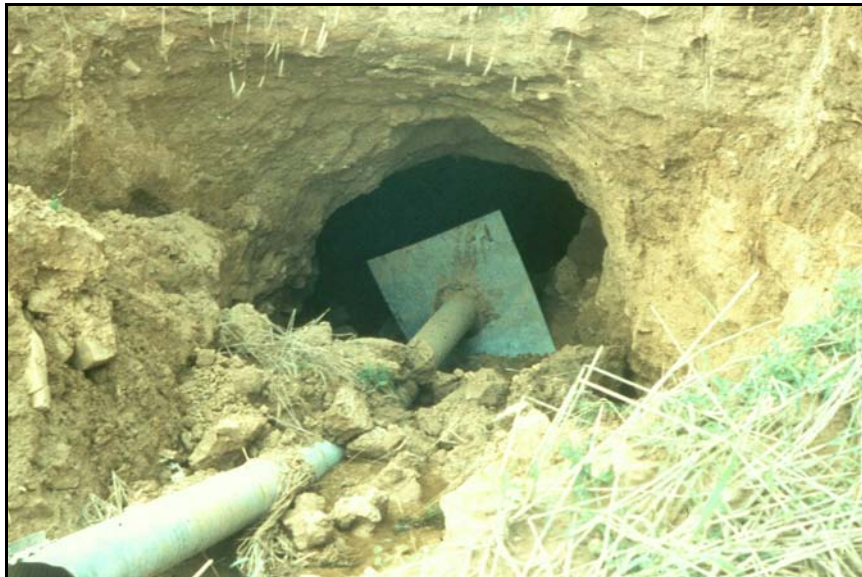
Figure A-2.—Internal erosion failure along a conduit with antiseep collars.

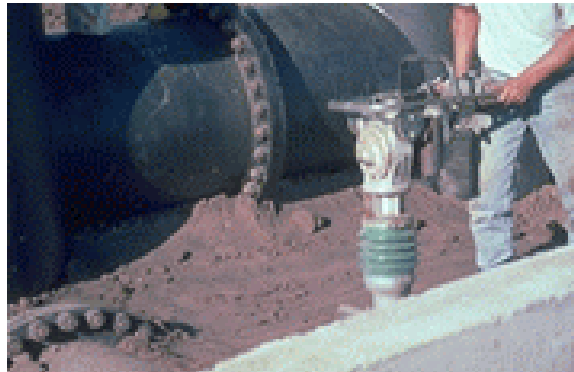
Figure B-4.—Initial construction. Note hand tampers being used to compact earthfill adjacent to outlet conduit.

The cause of the failure was likely the combination of the dispersive clay embankment material, hydraulic fracture, antiseep collars (figure B-3) around the conduit that required the use of hand tampers (figure B-4), “flowable” backfill for conduit support in lieu of a continuous concrete conduit support, and lack of a filter and drain around the outlet conduit in the downstream portion of the embankment dam. Cold air flowed through the conduit during the winter preceding the failure. This caused lenses of frozen material in the conduit’s backfill. These lenses may have provided a path for concentrated leakage when they were thawed by the initial flow of water in the conduit during the runoff.

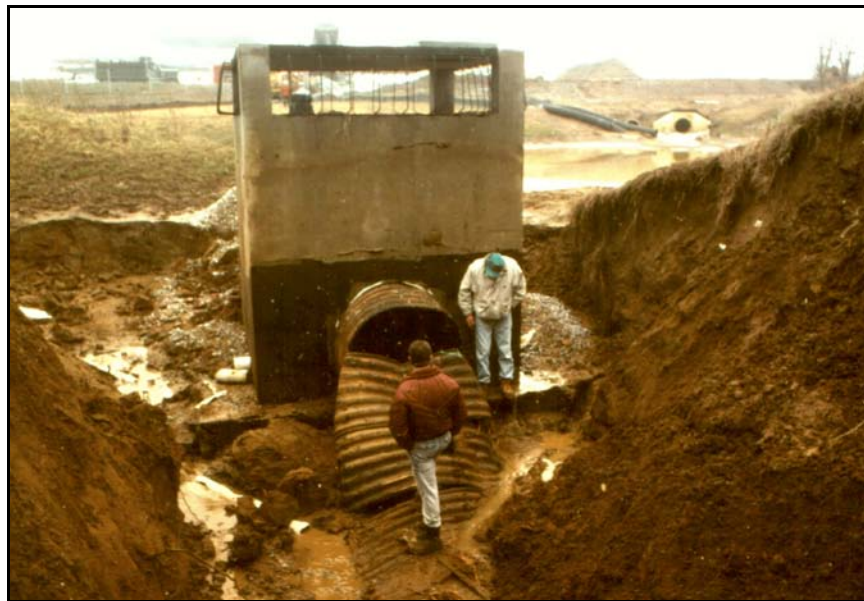
Figure B-5.—The upstream section of the 54-inch diameter CMP spillway conduit completely collapsed when the water level reached the elevation of the weirs on the inlet structure. Site personnel reported a “vortex” in the pool adjacent to the structure shortly before collapse.

In March 1993, a newly constructed embankment dam near Annapolis, Maryland, rapidly filled with water during a storm and failed, causing extensive environmental damage, but no loss of life or damage to downstream roadways. Figure B-5 shows the upstream section of the 54-inch diameter CMP spillway conduit, having completely collapsed when the water level reached the elevation of the weirs on the inlet structure.

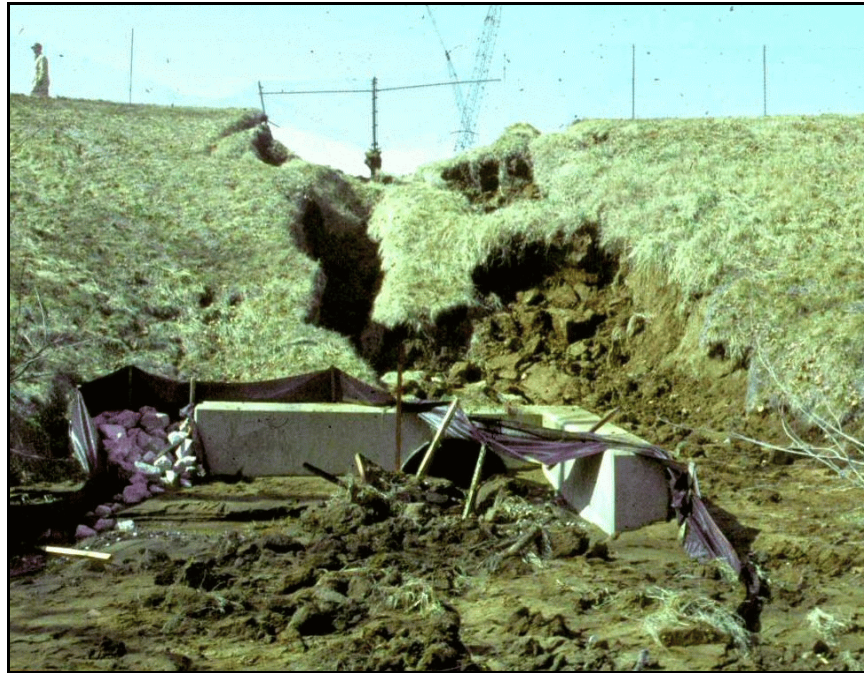
Figure B-6.—The downstream section of the CMP spillway remained partially intact, but deep troughs were visible directly above each side of the conduit.

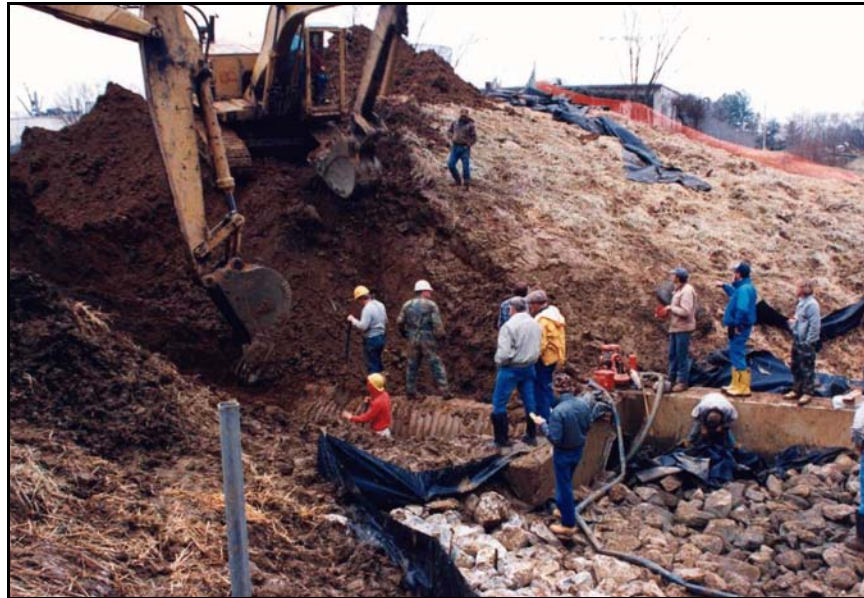
Figure B-7.—The spillway conduit and portions of the embankment soils were carefully removed and documented during a forensic investigation about 2 weeks after the failure.

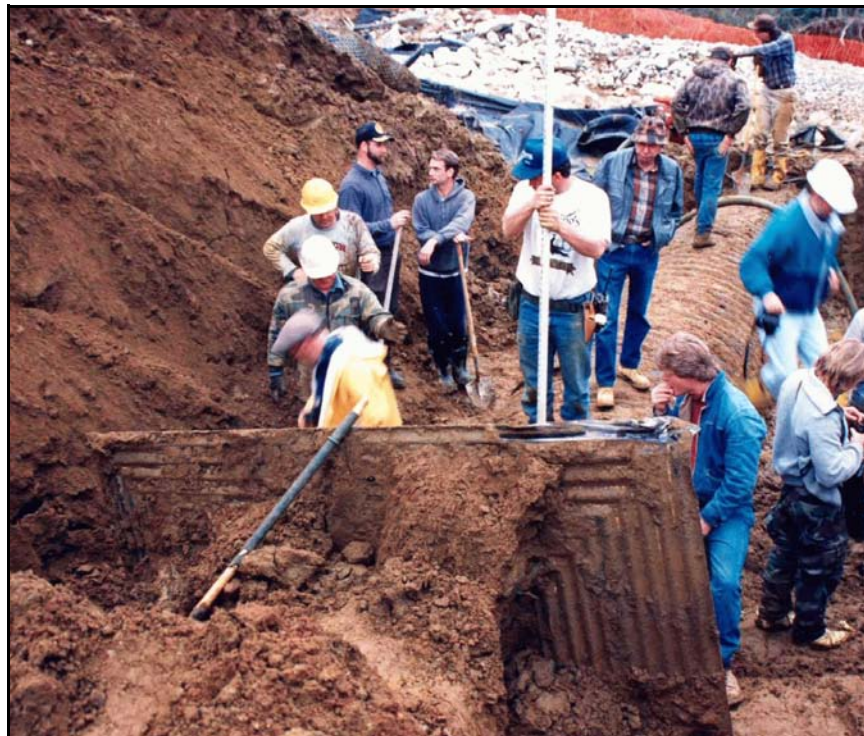
Figure B-8.—Starting at the downstream end of the conduit, two large excavators removed the majority of the earthfill under the watchful eyes of State and local officials, geotechnical engineers, surveyors, lawyers and the pipe manufacture.

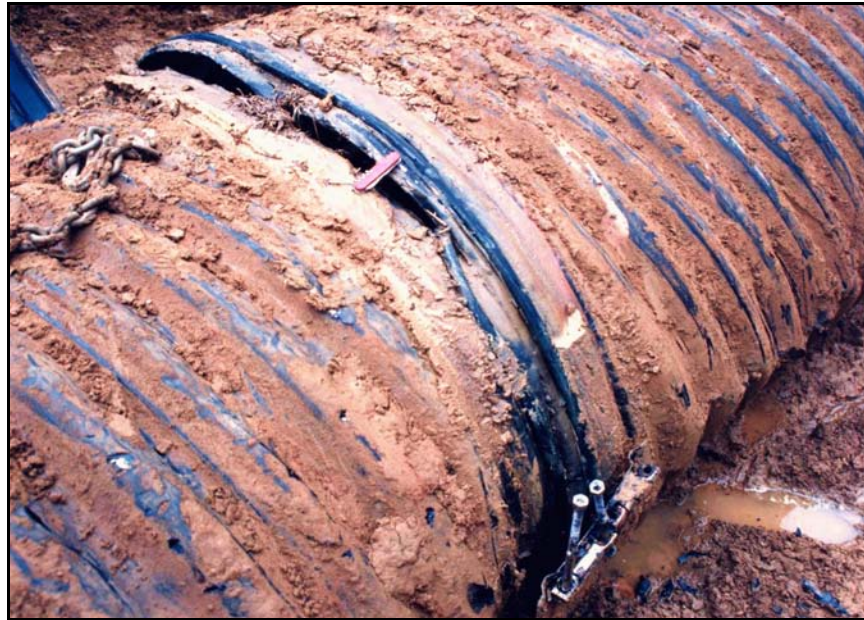
Figure B-9.—When the “hugger band” at the most downstream conduit joint was removed, the o-ring gasket was found to have been displaced. In addition, debris from the pool was found under the band, indicating that water may have flowed unrestricted along the outside of the conduit from the pool and into the joint.

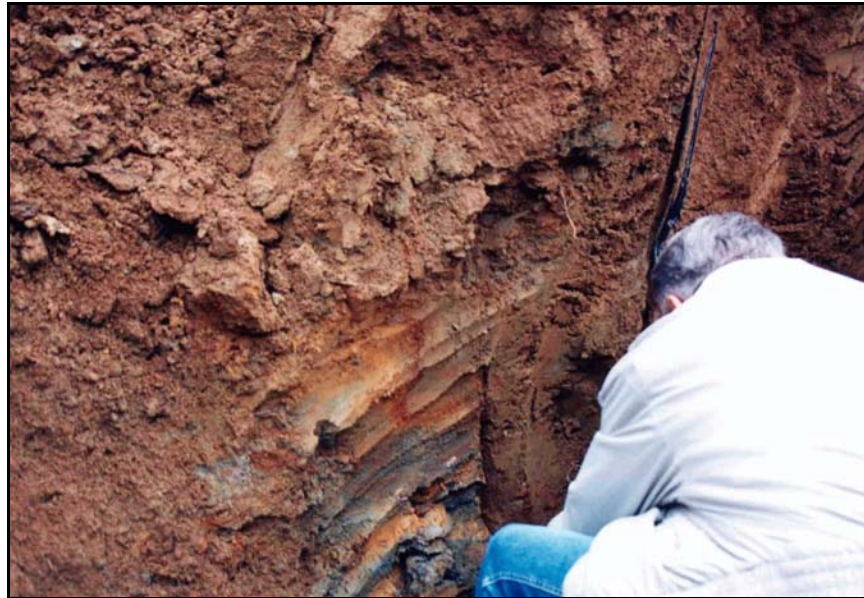
Figure B-10.—The presence of undisturbed foundation soils confirmed that the conduit was placed in a trench with nearly vertical sides, making it difficult to obtain good compaction of the fill soils under and along the CMP and around the antiseep collars.

The forensic investigation confirmed that the CMP was installed in a trench with near vertical sides. In addition, it appeared that the trench may have been overexcavated and backfilled with poorly compacted fill material, which was quickly eroded away by flow along the outside of the conduit and/or into open joints. Loss of soil support would have caused additional conduit deformation, further opening the joints, resulting in an ever-increasing cycle of leakage and loss of earthfill by internal erosion. Figure B-10 shows the presence of undisturbed foundation soils

that confirmed that the conduit was placed in a trench with nearly vertical sides, making it difficult to obtain good compaction of the fill soils under and along the CMP and around the antiseep collars.
