Technical Manual: Conduits through Embankment Dams

Best Practices for Design, Construction, Problem
Identification and Evaluation, Inspection,
Maintenance, Renovation, and Repair

Federal Emergency Management Agency

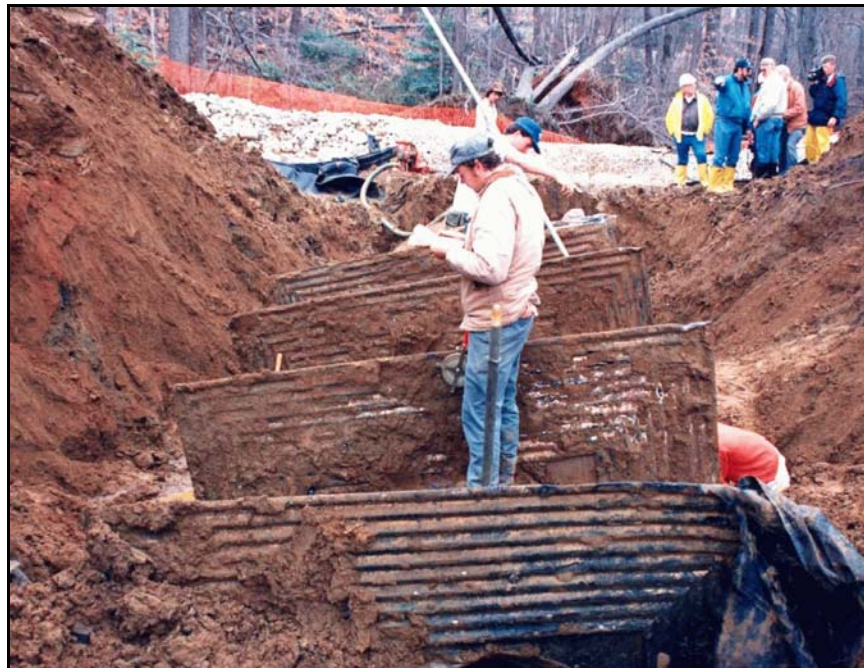
Figure B-11.—Seepage along the sides of the CMP resulted in loss of soil support, causing conduit and joint deformation.

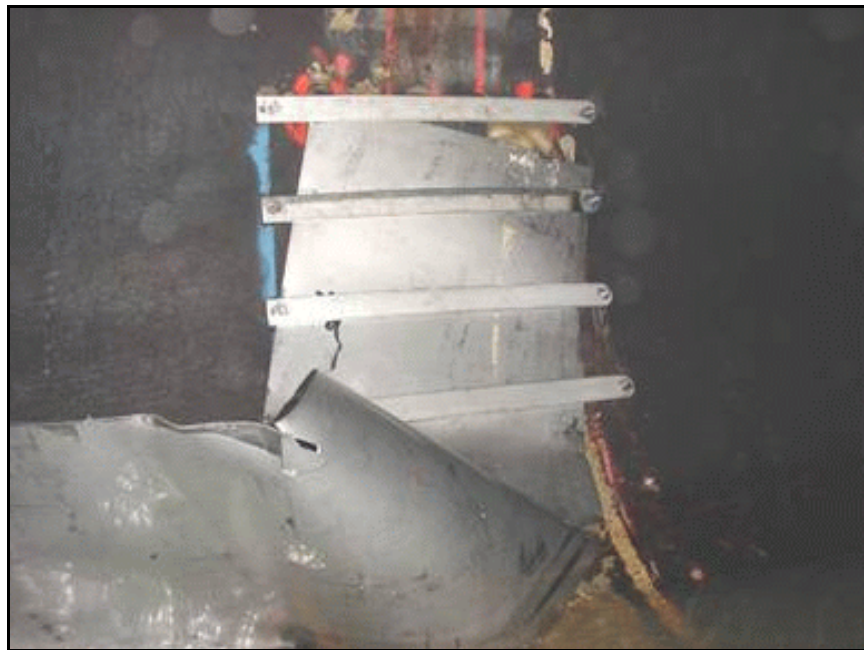
Figure B-15.—Damaged metal plate.

After installation, the project released 1,500 ft³/s for 2 weeks and then inspected the joint. The inspection team found the plate at one of the two repair joints displaced, bent, and torn (figure B-15).

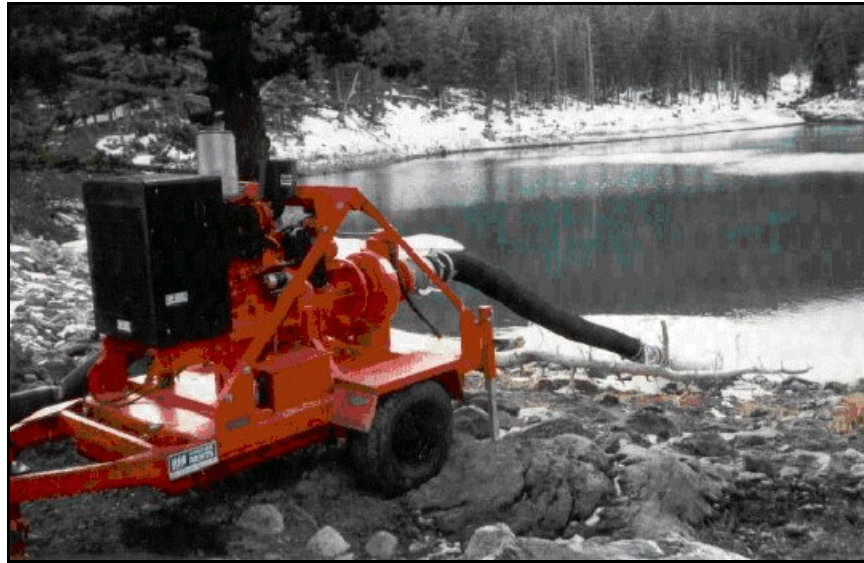
Figure B-17.—Portable pump used to initiate draining of the reservoir.

On November 15, 1996, a portable 3,000 gal/min pump (figure B-17) was delivered to the site. The pump was set up adjacent to the spillway and placed into operation. The pump was operated continuously for 3 days, and the water surface level of the reservoir was lowered to approximately 8 feet below the spillway crest. At this point, the excavation to breach the embankment dam was commenced. A Caterpillar 330 track-mounted excavator was used to perform the excavation. The area of the sinkhole and the upstream slope were first excavated as far into the reservoir as the excavator could reach, and then the embankment dam crest was benched down approximately 4 feet on either side of the breach. The breach was excavated on both sides at a slope of 1.5H:1V down to the water surface level. Rocks of varying sizes were placed in the bottom of the excavation and down the downstream slope of the embankment dam to help control erosion. Then, a small amount of the embankment dam was removed from the breach entrance, and water was allowed to flow through the breached section. Some minor slope erosion occurred, but no backcutting of the channel into the embankment dam was observed.

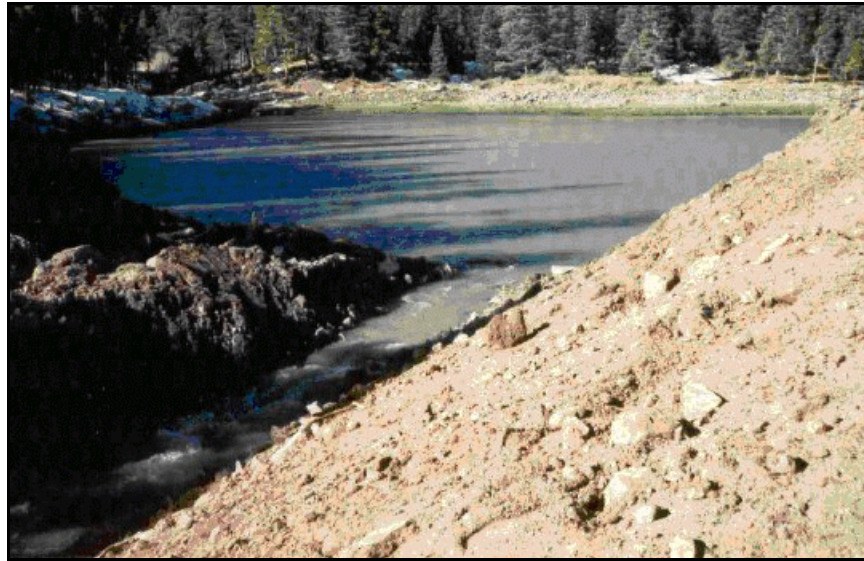
Figure B-18.—Initialization of the breach in the embankment dam near the left abutment.

The initial flow of water through the breach (figures B-18 and B-19) was allowed to stabilize and diminish, and then the process was repeated to remove another small portion of the embankment dam. The excavation of the embankment material was kept at a minimal amount to limit the quantity of water discharging through the breach section. This process was repeated, and each time the water flowing through the breach was allowed to flow out and stabilize before removing additional embankment material. The partial breaching of the embankment dam was completed over 2 days. The final dimensions of the breach obtained consisted of an 8-foot wide bottom, a 65-foot top width, a depth of 20 feet, and side slopes of 1.5H:1V. The bottom of the breach section was provided with rock riprap erosion protection. The embankment dam was not completely breached to allow for a small reservoir with a depth of 8 feet to remain for the purpose of controlling silt deposits in the reservoir and to maintain a fish habitat. With the partial breaching of the embankment dam, the dam was considered to no longer pose a safety hazard to the general public.

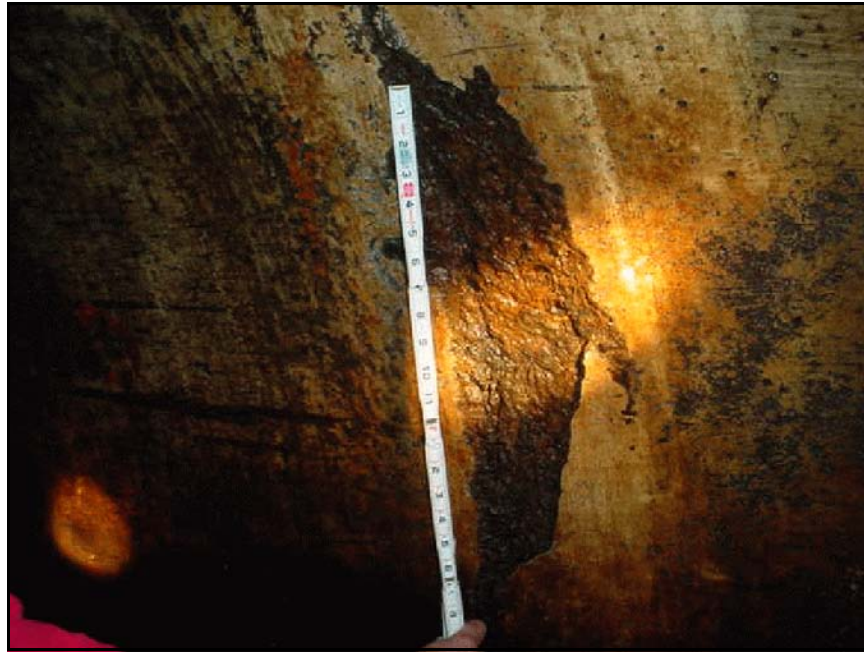
Figure B-20.—Large spall at the construction joint located at station 12+13.

Spalling had occurred at joints and other localized spots. Minor cracking, spalling, surface abrasion, and calcitic efflorescence were observed and mapped. Figures B-20 through B-23 are typical of these features. No major leakage was evident; however, minor seepage of water was observed in two locations but with no material being carried.

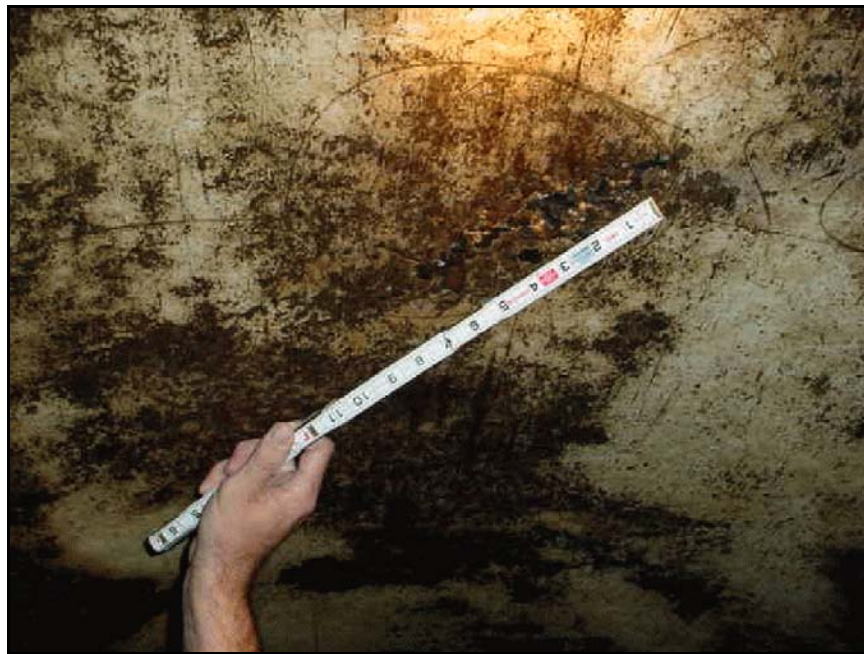
Figure B-21.—Exposed aggregate located at station 11+28.

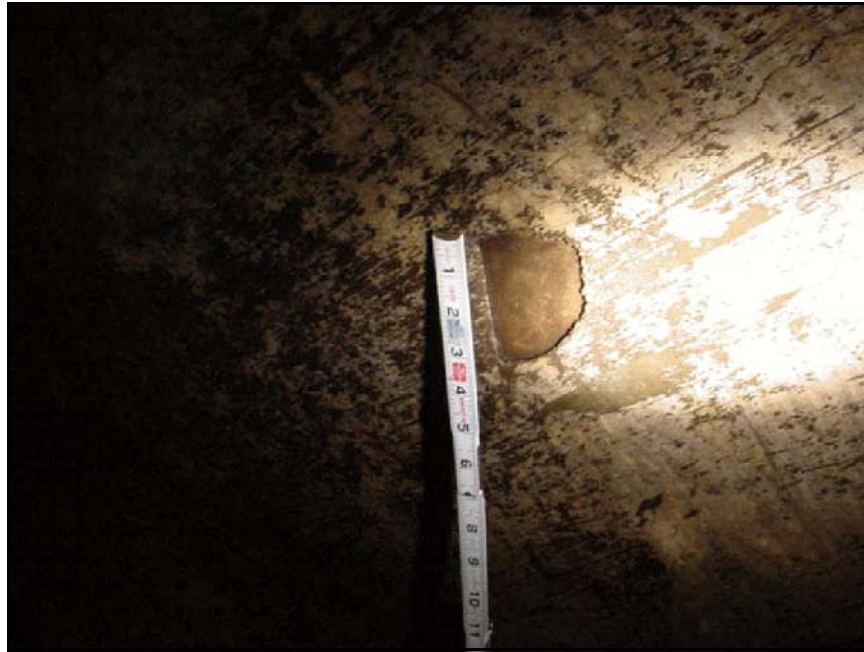
Figure B-22.—Popout located at station 10+79.

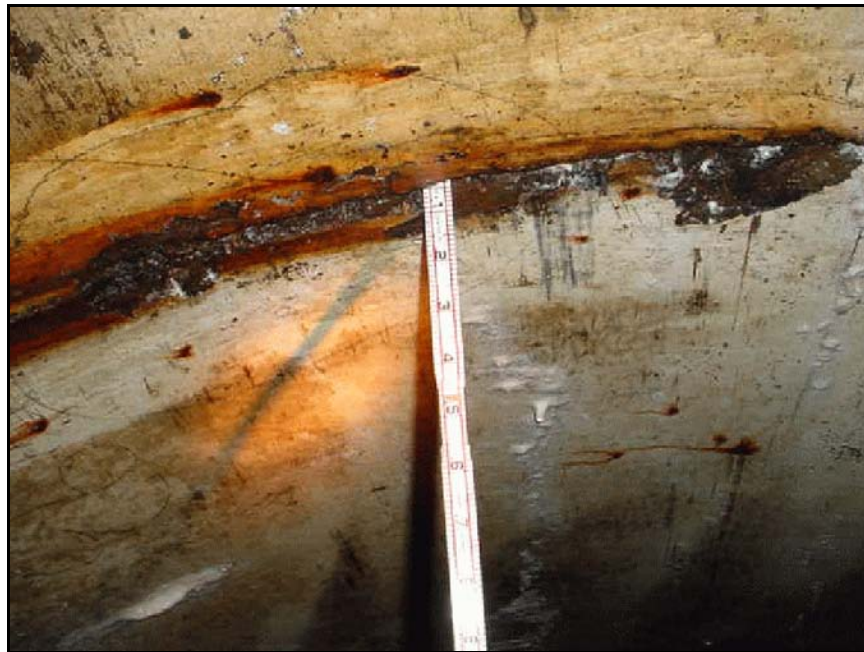
Figure B-23.—Spall at the construction joint located at station 4+93.

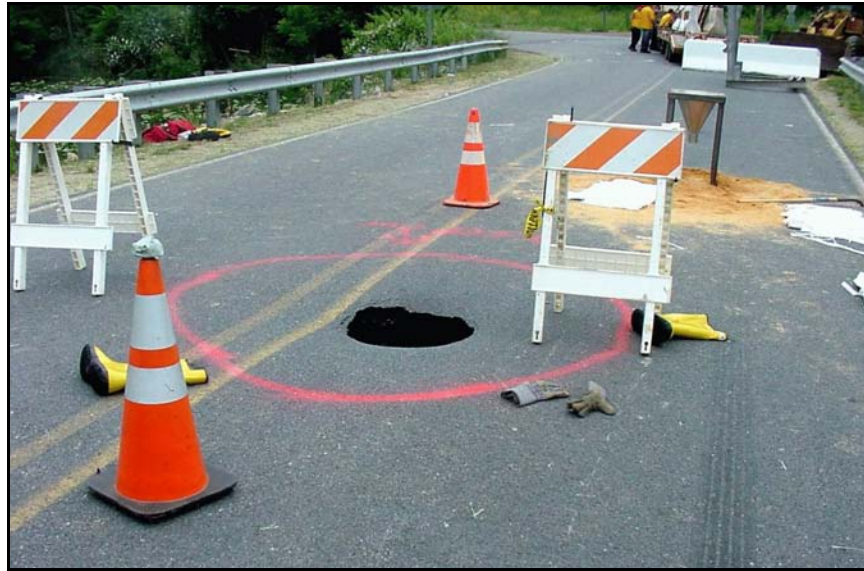
Figure B-26.—Less than 2 years later, an engineer inspecting the bridge over the spillway reported that seepage flow was visible from under the downstream end of the spillway. The seepage flow was clear, and no migration of soils was evident. A few months later, the roadway on the dam crest collapsed, and large quantities of sediment were observed in the pool below the dam.

However, within a few months, a sinkhole was noted in the pavement on the embankment dam crest (figure B-26). The seepage flow had significantly increased, and soil particles were observed moving downstream. The condition rapidly worsened, and the size of the sinkhole increased (figure B-27). Particles of the bentonite slurry cutoff wall were observed to be washing downstream from an area that appeared to be boiling (figure B-28). Attempts to create a sandbag weir around the boil to reduce leakage under the spillway conduit were unsuccessful, and the lake was drained.

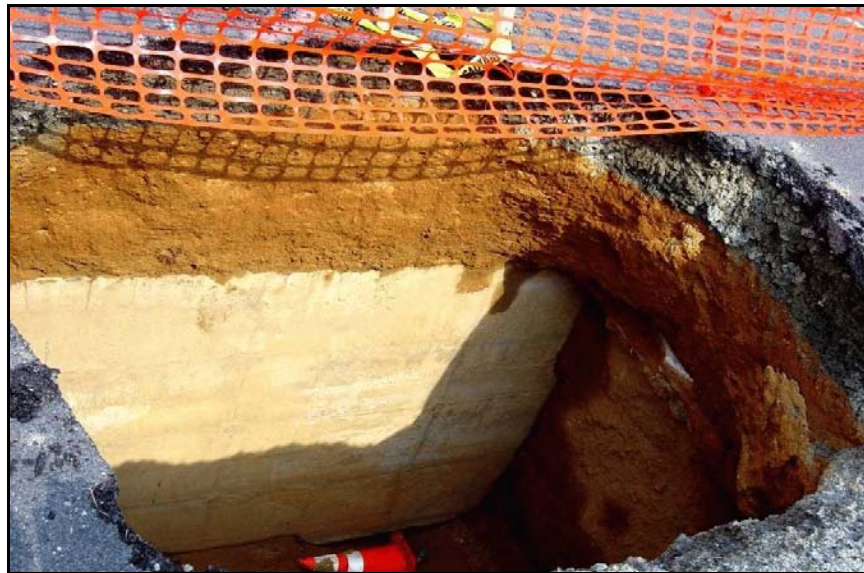
Figure B-27.—The road was closed immediately, and lake level was lowered. However, the sinkhole rapidly enlarged.

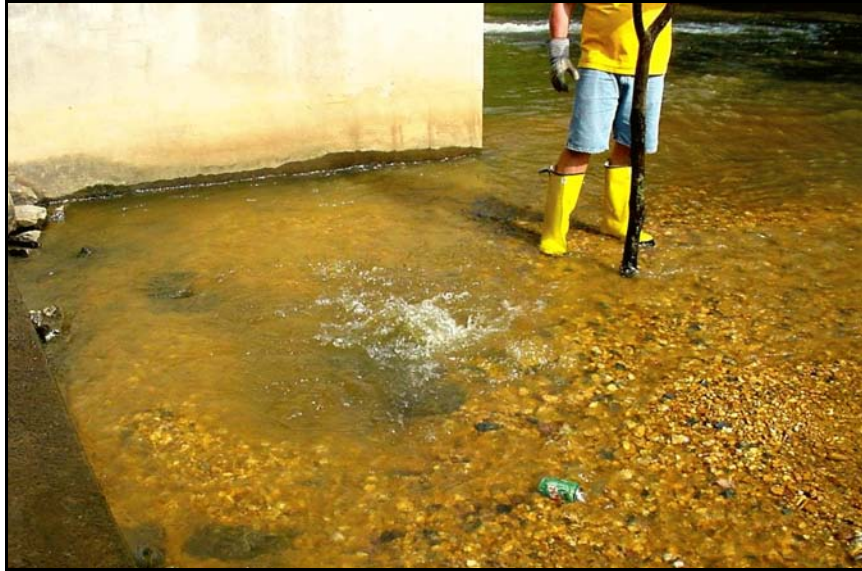
Figure B-28.—Seepage flow at the downstream end of the spillway appeared to be boiling. Attempts to create a sandbag weir around the boil to reduce leakage under the spillway were unsuccessful.

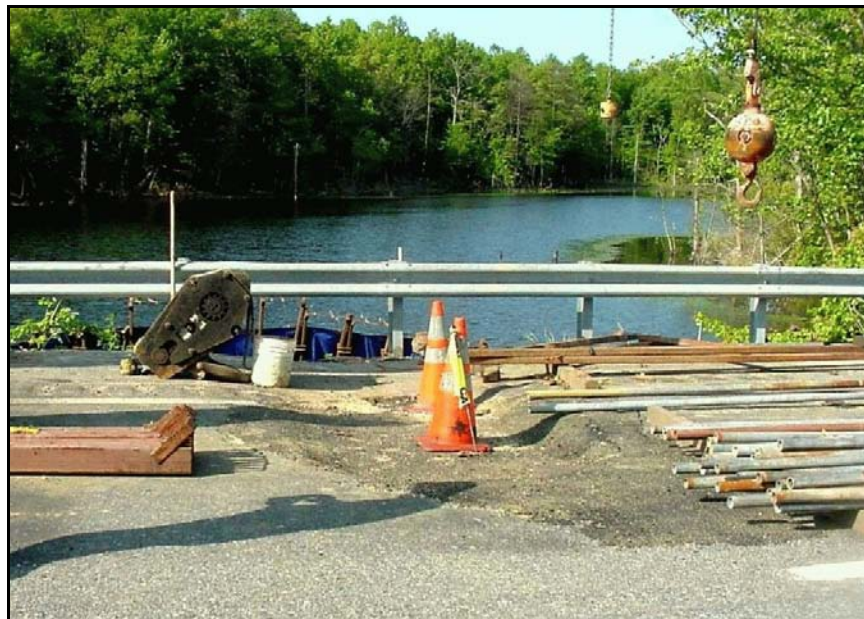
Figure B-29.—A sinkhole, which appeared in a heavily traveled roadway above a 20-year old CMP spillway, was filled with asphalt. Part of the roadway was closed when the asphalt patch subsided a few hours later.

In April 2003, a police officer traveling on State Highway 235 near Lexington Park, Maryland reported a large “pothole” in the roadway. A highway repair crew dispatched to the site promptly filled the 12-foot long, 1.5-foot deep hole with asphalt patching material, and the road remained open to traffic (figure B-29). However, one lane of the roadway was closed a few hours later when it was observed that the patched area had again subsided and a sinkhole was located directly above the spillway conduit.

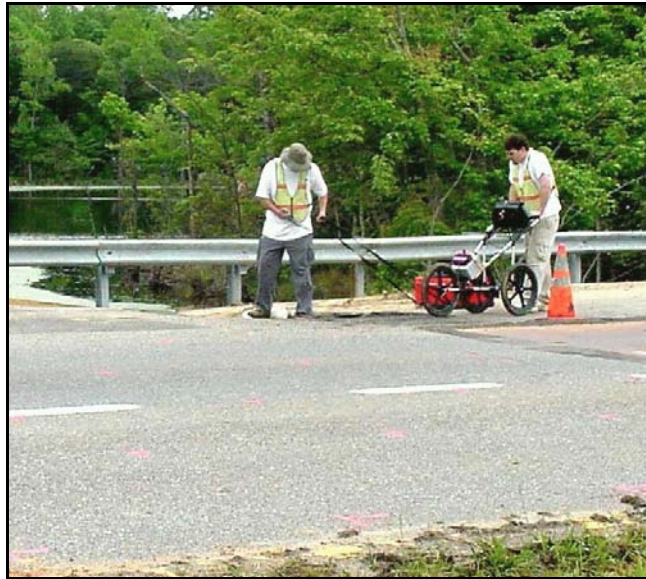
Figure B-30.—Ground penetrating radar investigations were performed from the embankment dam crest.

After the roadway collapsed in 2003, an inspection revealed extensive deterioration of the CMP and that substantial loss of embankment material had occurred. Ground penetrating radar (GPR) detected large voids in the embankment along the pipe, and a decision was made to construct a new spillway at a different location (figures B-30 and B-31). The failed CMP spillway and adjacent voids were filled with a stiff cement and flyash-based “compaction grout” (figure B-32). A specialty contractor performed the grouting and pumped the grout into the 24-inch diameter CMP using a trailer mounted, diesel powered, piston type concrete pump, specially mounted for grout injection work. The pipe fill mixture was a flowable, nonshrink, moderate strength (500-700 lb/in²) grout with the following specifications:

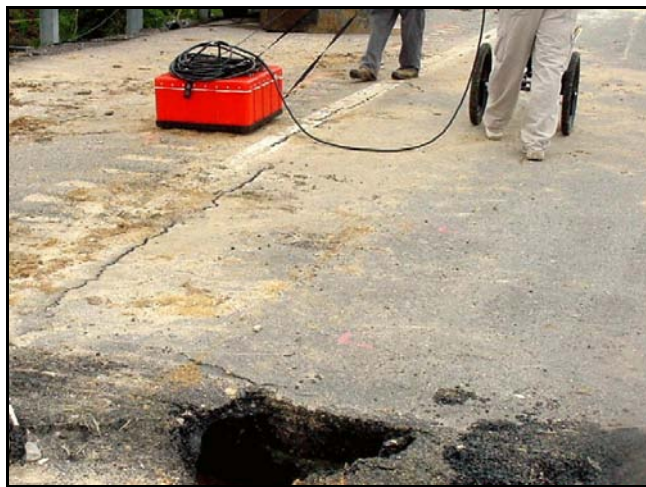
Figure B-31.—Ground penetrating radar identified the location of voids along the CMP.

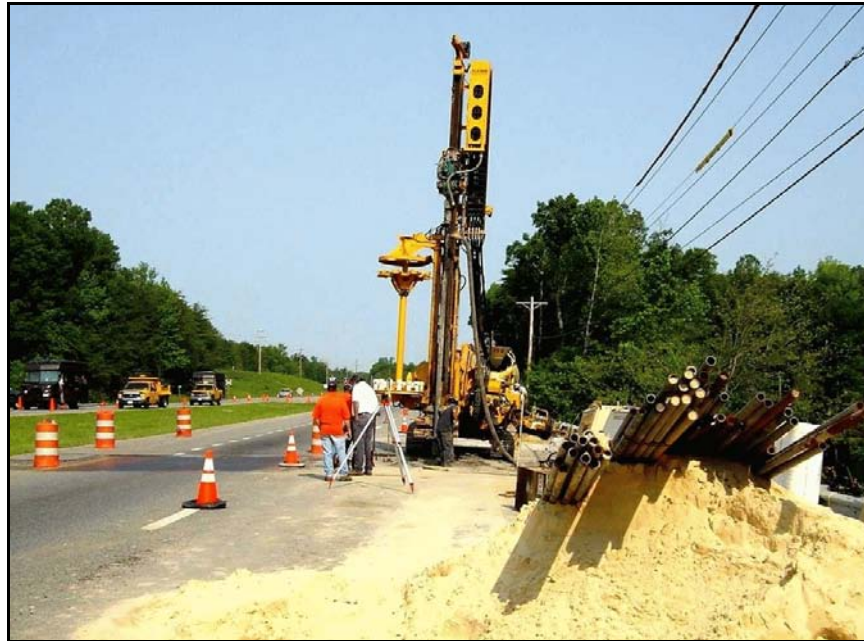
Figure B-32.—The failed CMP and voids were filled with a stiff compaction grout.

The compaction grouting to fill the voids in the embankment dam was performed from the roadway and median along the abandoned pipe alignment, with each grout pipe extending to approximately the pipe invert elevation. The grout-hole layout plan consisted of 128 compaction grout locations based on a 5-foot offset square grid throughout the anticipated treatment zone. The compaction grouting was performed utilizing a diesel powered track drill to install the grout casing through the pavement and fill soils to the invert elevation of the pipe. The grout was a blend of

concrete sand, type I Portland cement, flyash, and water proportional to provide a pumpable mix with about 500 lb/in² strength in 28 days. The compaction grout mixture specifications are as follows:

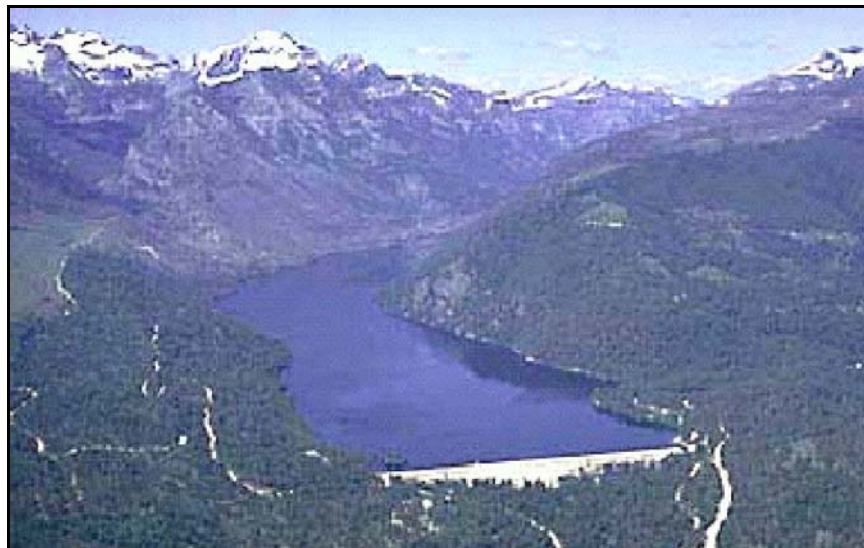
Figure B-33.—Aerial view of Como Dam, Montana.

Como Dam was constructed by semihydraulic fill method from 1908 to 1910. Como Dam has a crest length of 2,550 feet and a crest width of 25 feet. The structural height is 70 feet, and the base width is 400 feet. The spillway was constructed in 1923 and is located on the left abutment. The outlet works conduit through the embankment dam was a 6-foot inside diameter, 526-foot long concrete-encased redwood stave pipe. The wood staves in the pipe are 3 inches thick. Approximately half of the downstream conduit was relined in 1936 with $\frac{3}{8}$ -inch thick steel plate liner. Figure B-33 shows an aerial view of Como Dam.

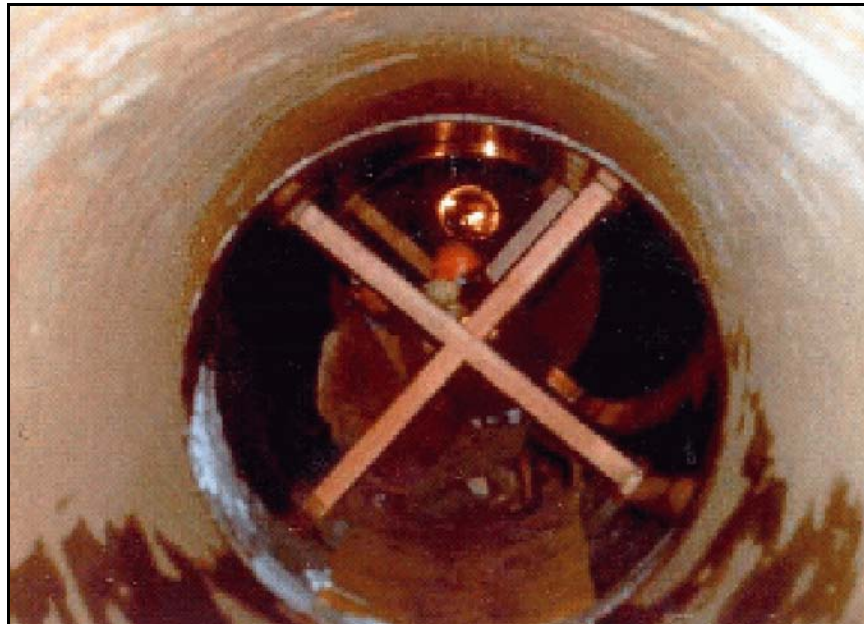
Figure B-34.—Installing the steel pipe slipliner within the existing outlet works conduit.

entire conduit with a steel pipe slipliner. This steel pipe slipliner would provide additional structural stability and a good flow surface, prevent seepage through the concrete, and could be placed in an expeditious manner to allow reservoir operation in the spring of 1993.

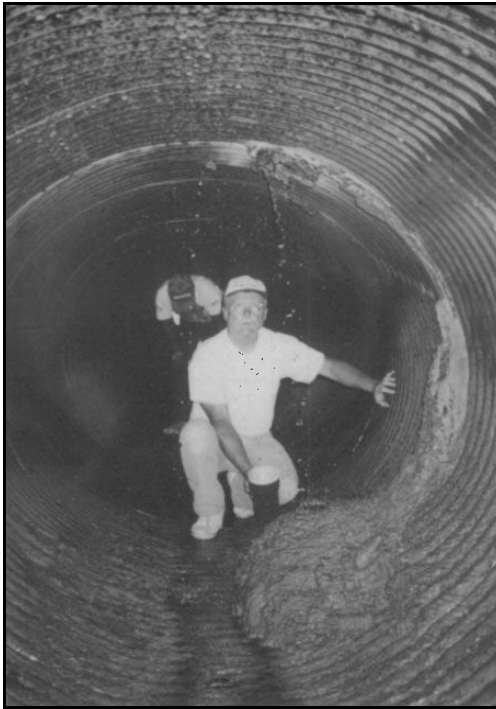
Figure B-36.—A man-entry inspection of this 60-inch CMP noted seepage and extensive loss of embankment soil at two locations.

Subsequent sloughing of the upstream slope damaged the upstream end of the CMP. An man-entry inspection of the pipe in 1993 noted that the pipe had ruptured, and seepage into the conduit was observed at two locations. At that time, the seepage flow was clear, and no soil loss was evident. However, by 1995 the seepage flow had increased, and soil deposits in the pipe indicated that internal erosion or backward erosion piping of embankment material was occurring, and failure of the embankment dam was a distinct possibility. Figure B-36 shows the man-entry inspection being performed. Due to the potential for loss of life if the embankment dam were to fail, the State dam safety agency directed the owner to hire a professional engineer to develop remedial plans to immediately repair the dam.

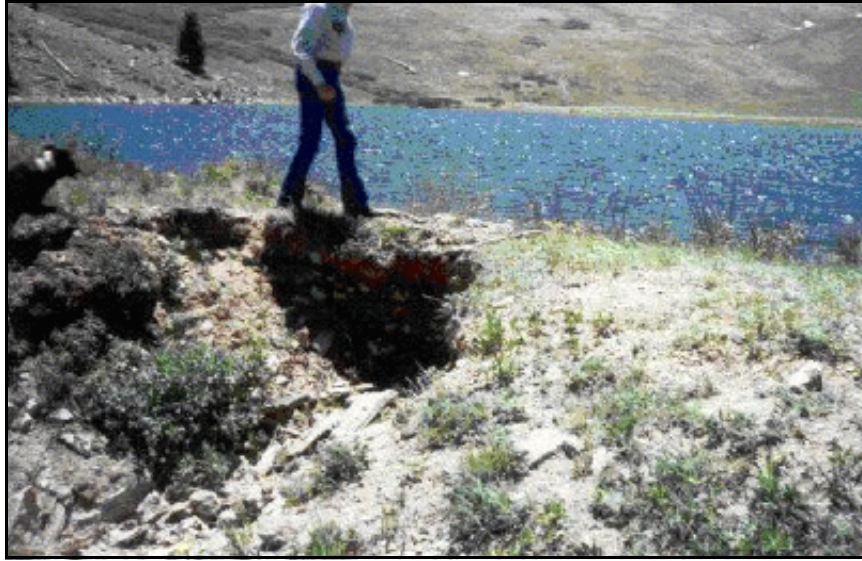
Figure B-37.—Erosion scarp on downstream slope of the embankment dam at the location of the overtopping of the dam crest.

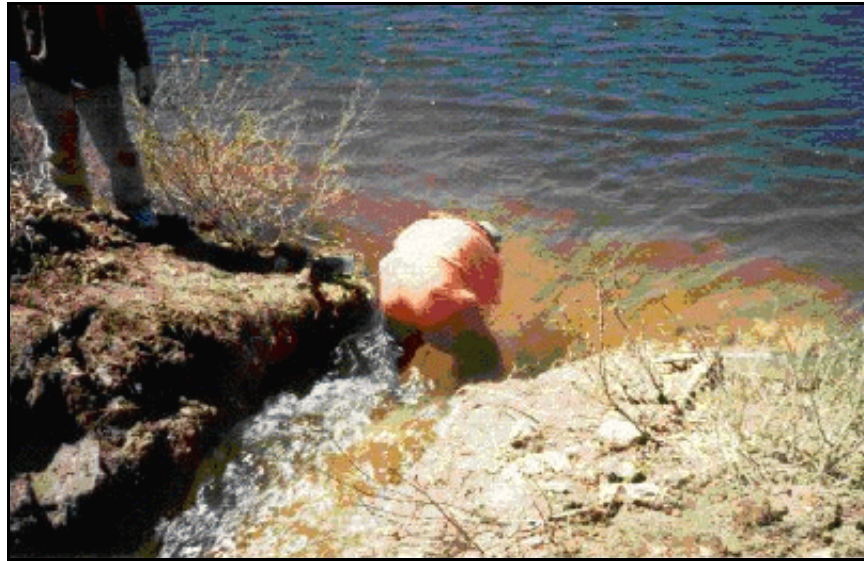
Figure B-40.—Deepening of the initial breach channel.

B-40). However, the control section, where the flow transitions from subcritical to supercritical flow, was located in the breach channel, where backcutting could occur and cause a large uncontrolled release. The reservoir basin upstream of the breach would have to be excavated in order to move the control section back into the reservoir. The inmates donned hip-waders and began the arduous task of excavating underwater, and after an hour's effort, the control section was safely located several feet back into the reservoir. Empire Dam was completely breached by July 2, and the reservoir drained in a very efficient and cost-effective manner.

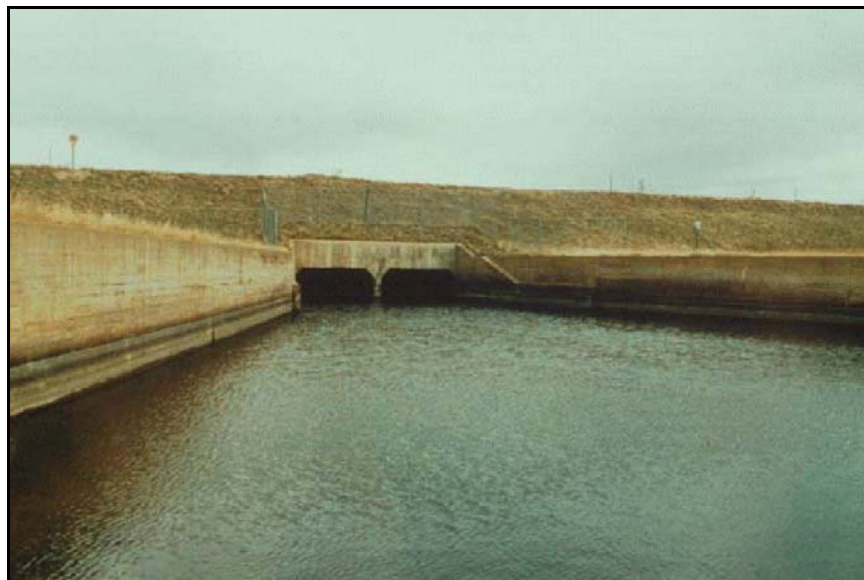
Figure B-43.— Lake Darling Dam outlet works discharge, circa 1990.

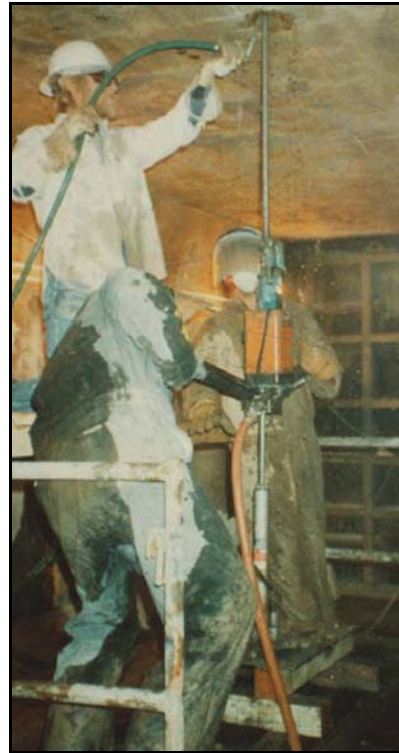
Figure B-45.—Grouting operations within the conduit.

Small voids were found beneath the conduit at a number of locations near observed cracks with seepage discharge. The lost grout was not found. Based on the additional information, final design and construction of corrective actions were initiated. The USACE was going to remove and replace the outlet works within 5 to 10 years as part of a comprehensive flood control project. The design of corrective actions took into consideration the limited planned life expectancy of the outlet. Corrective actions included in the rehabilitation design included both primary and secondary “lines of defense.” Primary lines of defense included (1) installation of six relief wells into the foundation soils to collect and safely discharge foundation seepage—these wells were installed about 15 feet downstream of the roller gates and discharged up through the floor of the conduit through a flap valve; and (2) sealing of all cracks in the conduit floors and walls with an elastic filler that would adhere to the concrete and expand and contract during seasonal changes in the width of the crack. The secondary lines of defense included (3) grouting around the base and exterior of the outlet conduits to seal existing voids and increase the effectiveness of the relief well system (see figure B-45); and (4) construction of a new floor with a filtered underdrain system.

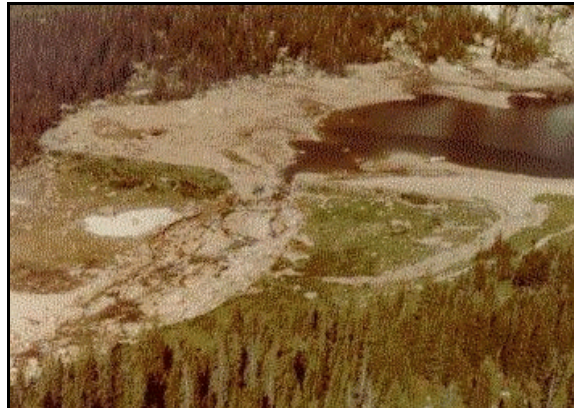
Figure B-46.—Aerial view of the breached Lawn Lake Dam and downstream floodplain.

At approximately 5:30 in the morning of July 15, 1982, Lawn Lake Dam failed. Estimates indicate that the breach of the embankment dam released 674 acre-feet of water, and the resulting dambreak flood had an estimated peak discharge of 18,000 ft³/s (USGS, 1982). The final breach dimensions through the embankment dam were surveyed to have a maximum depth of 28 feet, a top width of 97 feet, and a bottom width of 55 feet. The embankment dam materials exposed at the face of the breach showed the dam to have been constructed mainly of a silty and poorly graded sand with varying amounts of fine gravels and considerable amounts of organic materials. Figures B-46, B-47, and B-48 show the breached embankment dam. The embankment dam was not observed as it was failing.

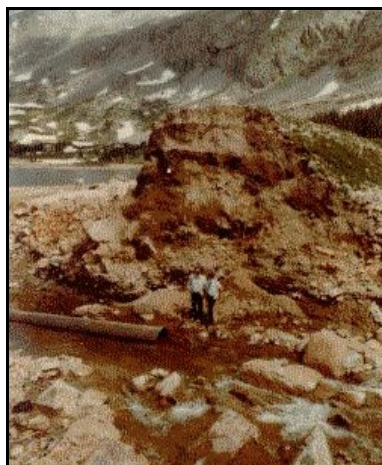
Figure B-48.—Left side of the breached Lawn Lake Dam.

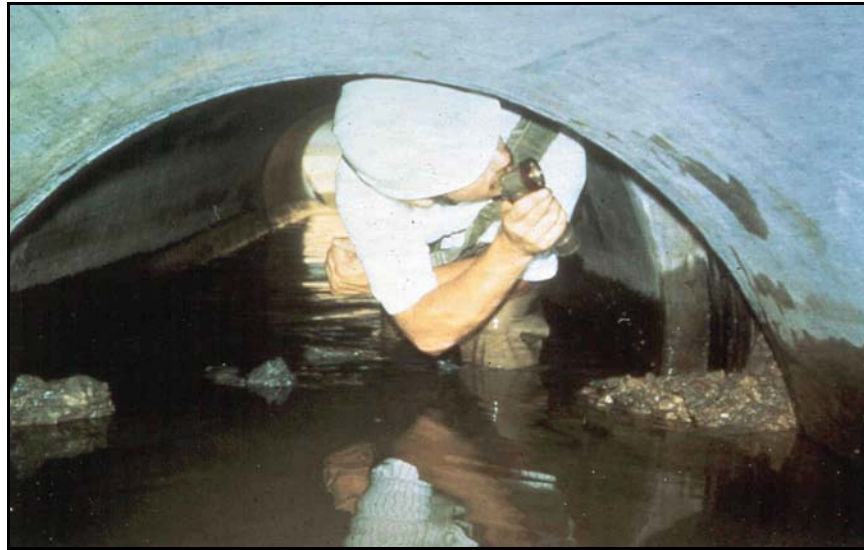
Figure B-49.—The pipe joints separated when foundation movement occurred during construction of the embankment dam.

The bottom of the pipe under the maximum earthfill height settled by about 1.5 feet, and the joints of one section of the pipe separated by more than 1 foot (figure B-49). The engineers investigating of the failure reported that the foundation soils under the

pipe, visible through the open joints, were soft, wet silts that resembled “stiff grease.” The engineer reported that no sands or gravels were encountered, and that the soil could be probed easily with a hand ruler to depths of 6 feet below the pipe. The report also indicated that the sheet metal shields on the outside of the joints appeared to support the embankment soils and minimized migration of soil into the open joints.

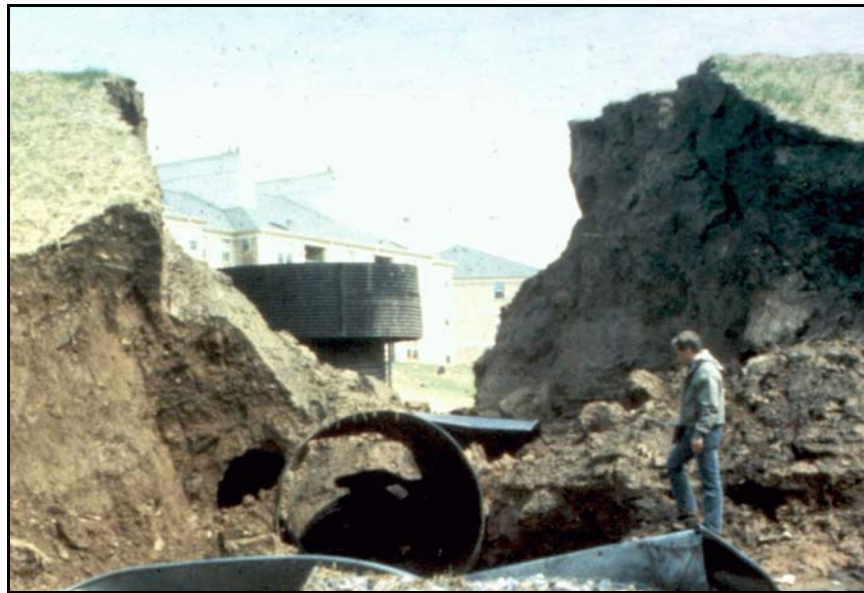
Figure B-51.—Loveton Farms Dam after failure as viewed from the downstream end of the 78-in diameter CMP spillway. Note that one of the antiseep collars, which were about 14 feet square, is visible in the breach.

The embankment dam failed less than a year after it was completed, when a relatively small storm filled the pool to the top of the riser. Failure was attributed to internal erosion of embankment fill along the outside of the pipe (figures B-50 and 51). The original spillway pipe was likely placed in a vertically sided trench excavated through the nearly completed embankment dam. This construction technique is not recommended, as it makes compaction of the soil under the sides of pipe very difficult.

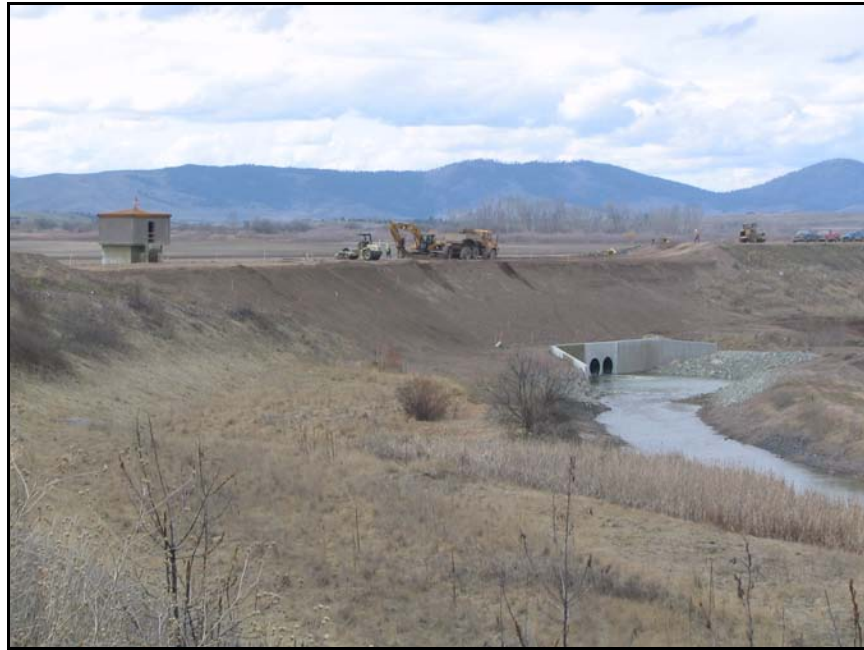
Figure B-58.—Pablo Dam nearing completion.

The construction of a new outlet works began in November 2004 and was completed in the by the spring of 2005. The major aspects of the work included:

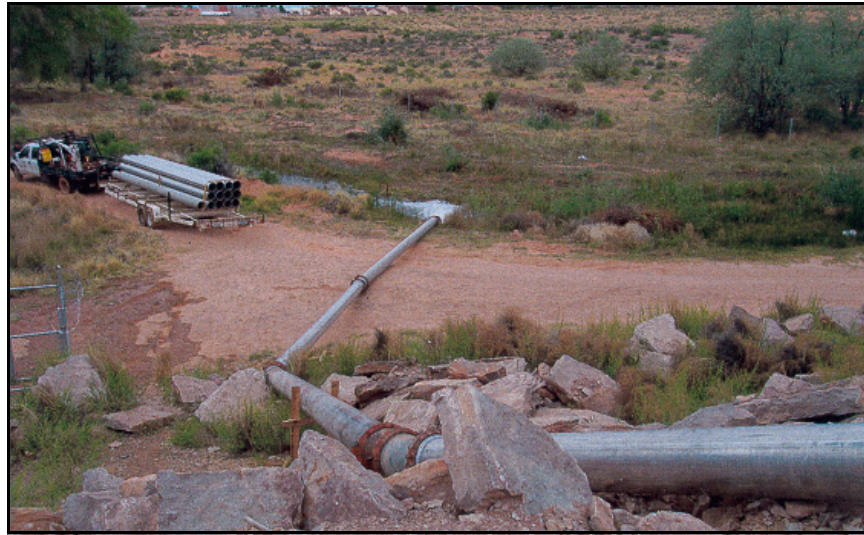
Figure B-61.—Siphon constructed over to crest of the embankment dam for discharging irrigation releases.

A contractor was mobilized to lower the reservoir level to elevation 4880.0 using high capacity, low head pumps (12-inch diameter). The reservoir drawdown was limited to 1 foot per day. After the reservoir was lowered to the desired elevation, a siphon was installed to provide downstream irrigation releases. Figure B-61 shows the siphon discharge irrigation releases. Based on the deteriorated condition of the conduit, the BIA decided to abandon the outlet works by grouting it closed. The

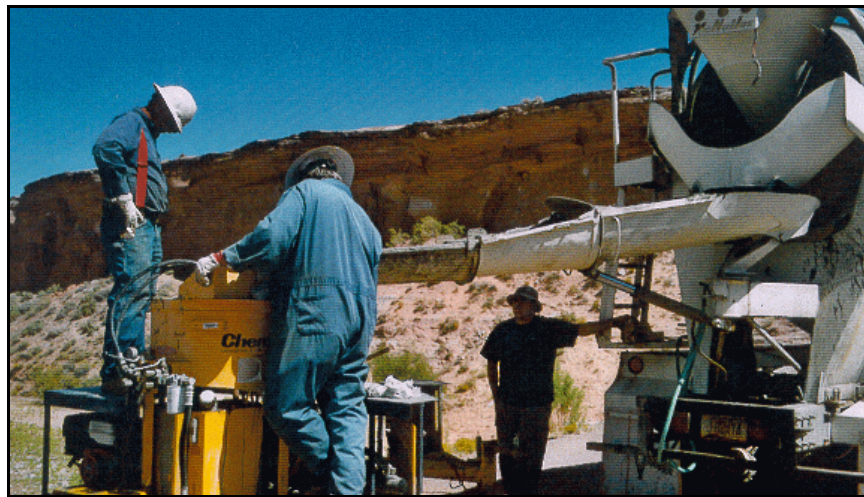
Figure B-62.—Grout mix being conveyed directly into the grout mixer from the transit mixer truck.

Bureau of Reclamation’s Farmington Construction office accomplished the grouting using three 1½-inch diameter PVC schedule 40 pipes. The upstream end was plugged by an inflatable bladder. The downstream end was plugged using a burlap pig sealed with redi-mix dry-pack. The burlap pig acted as a filter to prevent grout leakage, and the dry-pack held the pig in place. Two grout plants were brought onsite. The grout mixers had a volume of 45 gallons each. The plants were powered by gasoline engine over a hydraulic system and were found to be very adequate for the grouting operations. Figure B-62 shows the grout plant used. Type II cement

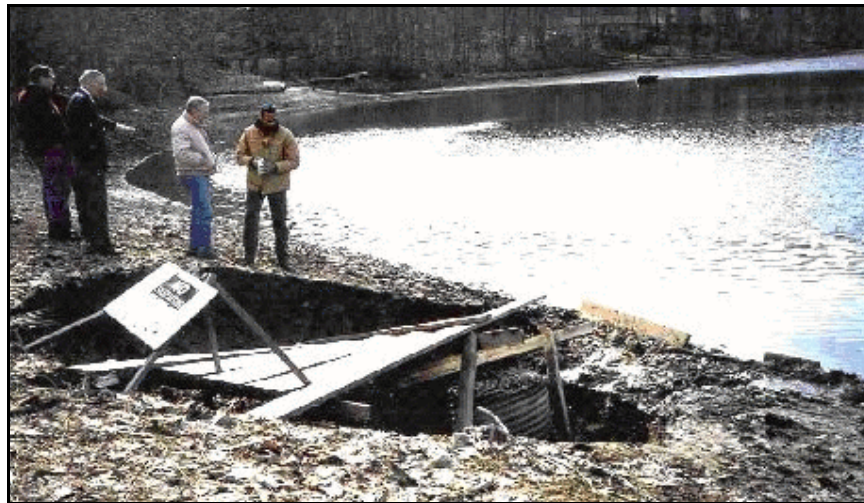
Figure B-67.—When the 35-year old corrugated metal pipe riser collapsed, a large portion of the low hazard embankment dam was washed away. This left a void about 30 feet in diameter and 10 feet deep around the original riser.

Rolling Green Community Lake Dam failed in February 1999. Constructed in 1965, the 22-foot high, low hazard embankment dam contained a 24-inch diameter CMP spillway. The spillway riser had been gradually deteriorating, and the owner had attempted repairs at the top of the riser by use of a larger CMP sleeve and concrete grout. However, no repairs to the lower portion of the riser were attempted, and the base of the riser collapsed on February 6, 1999. A large portion of the embankment dam was washed away, leaving a void about 30 feet in diameter and 10 feet deep around the original riser location (figure B-67).

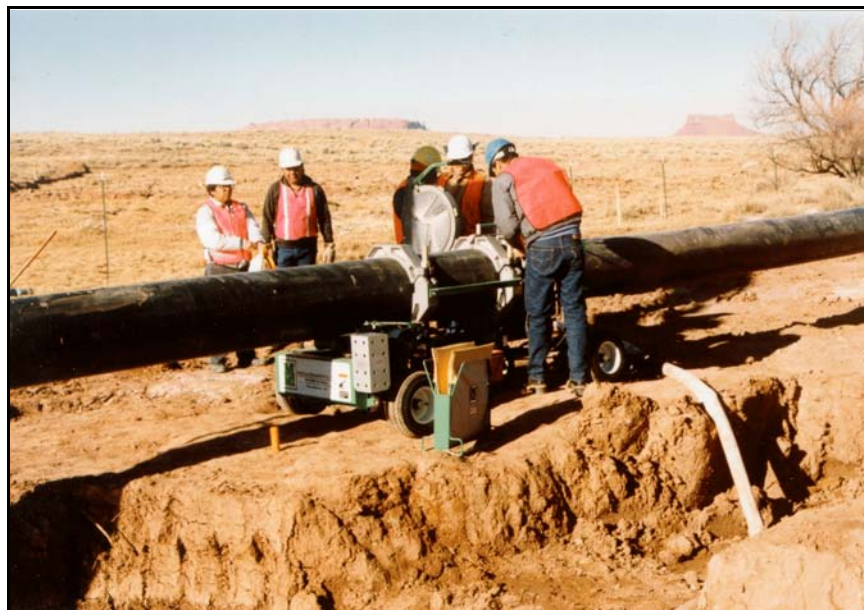
Figure B-68.—Heat fusion of an HDPE pipe joint.

Reclamation designed a modification, to address this dam safety deficiency, which consisted of an 18-inch O.D. HDPE pipe that was sliplined (figures B-68 and B-69) and then grouted into both the upstream and downstream CMP conduits. The HDPE pipe was designed to withstand external loads, disregarding any additional

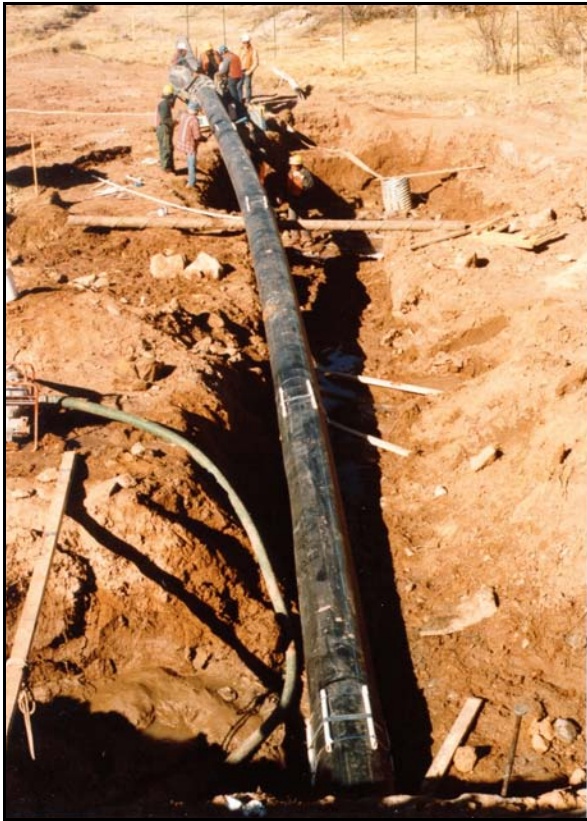
Figure B-69.—Inserting the HDPE slipliner into the existing CMP conduit.

support from the existing CMP. The design called for the HDPE pipe to withstand embankment fill loads of 38.2 feet, hydrostatic loads to 37 feet and a construction surcharge H-20 live load with a minimum of 5 feet cover. The HDPE pipe was also designed to withstand the loads associated with grouting. Installation of the liner was completed in the summer of 1994. The outlet works has operated without any liner-related incidents since that time. CCTV inspection of the slipliner was performed in May 2001, and the liner was found to be in good condition.

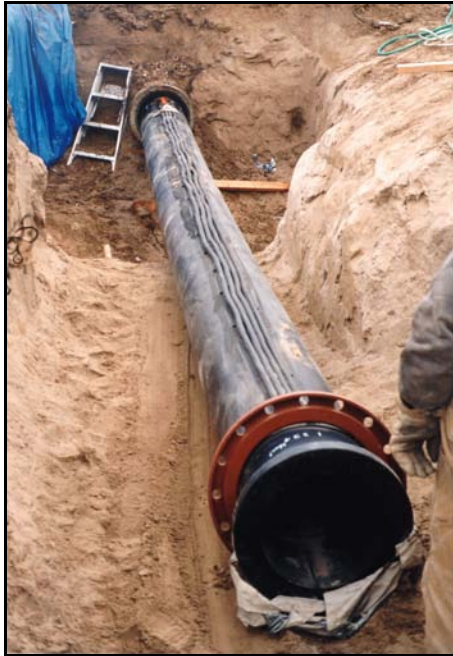
Figure B-75.—HDPE slipliner being installed at Turtle (Twin) Lake Dam. Note the HDPE grout lines welded onto top of new liner. The end flange was used to attach the two different sized liners together.

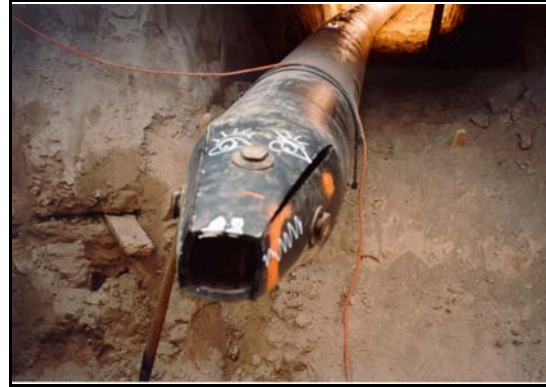
Figure B-76.—Upstream end of the HDPE slipliner modified to act as a pulling head.

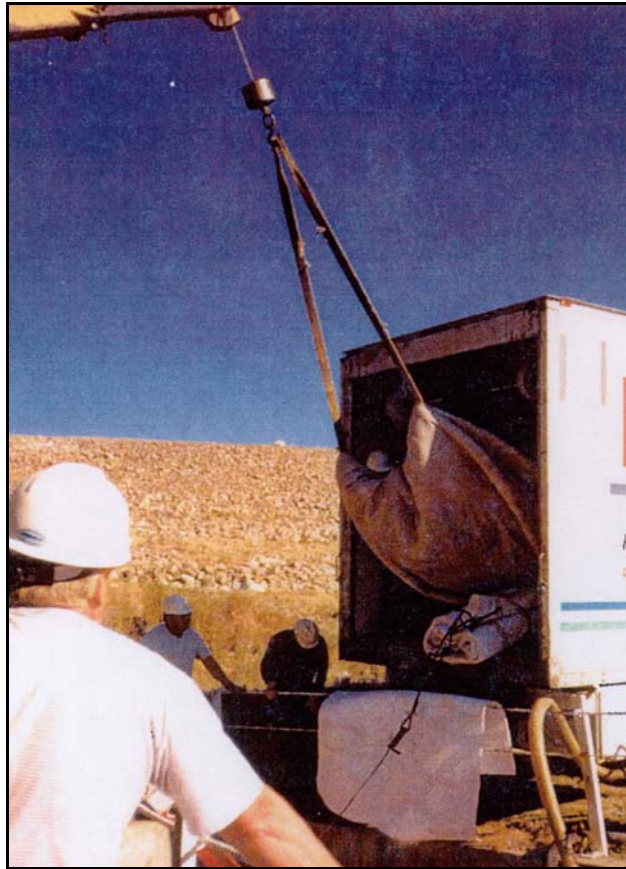
Figure B-80.—Lowering of the CIPP liner into the stilling basin, so it can be winched up the tunnel.
