Technical Manual for Dam Owners

Impacts of Plants on Earthen Dams

FEMA 534 / September 2005

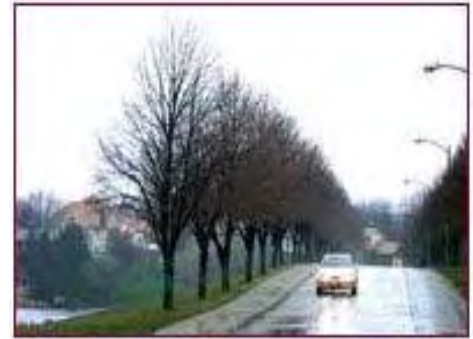
Figure 2. Example dam with problematic trees in Nebraska.

Of the 48 states that responded to the above seven questions (Alabama and Delaware did not reply), all state dam safety officials indicated that they consider trees and plant growth on dams to be a safety problem. One eastern state dam safety engineer goes so far to say that trees are probably the major problem that he has to deal with. He notes further that most of the trouble occurs because owners (and some engineers) do not recognize trees as problems and become complacent as trees slowly grow into serious problems. Both state and federal officials agree that trees have no place on dams. Federal agencies like the Corps of Engineers, U. S. Bureau of Reclamation, and TVA, which own, operate and maintain their own dams, do not allow trees to grow on their structures. Figure 2 shows a problem dam in Nebraska where tree roots have been reported to penetrate the chimney drain and thus affect the

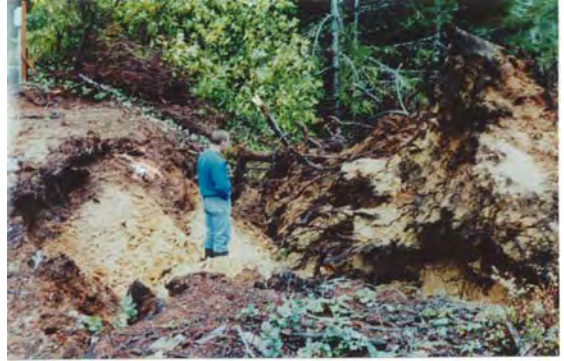
Figure 5. Serious damage by uprooted tree to embankment stability at a dam in Oregon.

- Uprooted trees that produce large voids and reduced freeboard; and/or reduced x-section for maintaining stability as shown in Figure 5.

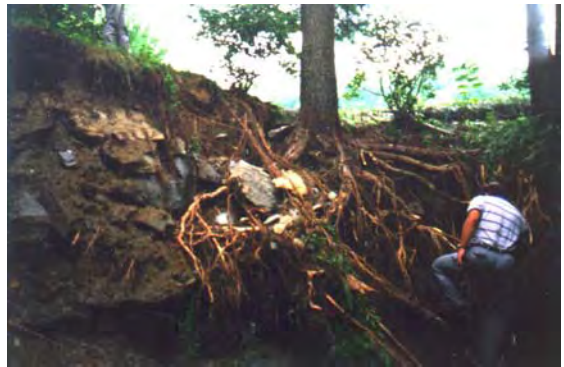
Figure 6. Tree root induced scouring on crest and downstream face of Coffey dam in Kansas.

- Inducing local turbulence and scouring around trees in emergency spillways and during overtopping as shown in Figure 6.

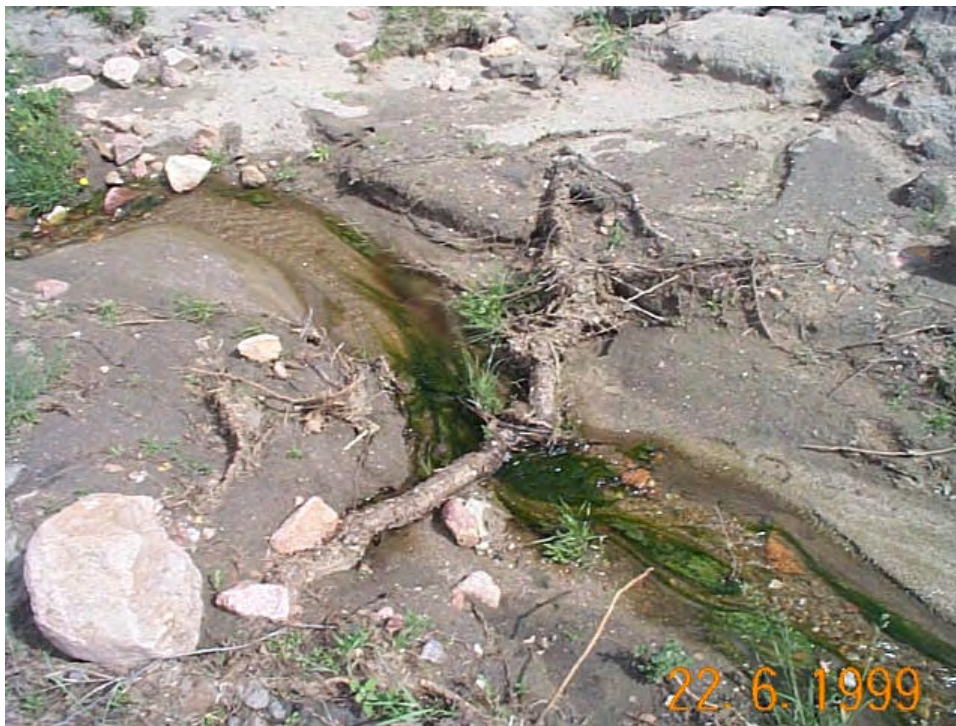
Figure 9. Large pine tree root located in the channel of the breach opening of a failed Air Force Academy waste lagoon pond dam (David Eyre, Senior Civil Engineer, Air Force Academy, Colorado, 1999).

safety problems. The most recent documented dam failure due to tree root penetration occurred in May 1999 at an unnamed Air Force Academy dam near Colorado Springs. Here, an approximately 13-ft. high dam with a pond capacity of less than 5 acre-feet of horse stable waste water failed, releasing its contents and injuring a horse in a stable located about 100 yards downstream. The failure occurred after more than 7 inches of rain had fallen in the previous 72 hours. The dam had several pine trees on its crest and faces, and the breach opening exposed an extensive, deep root system. Roots up to 4 inches in diameter were found in the breach area. Figure 9 shows an example of a large root exposed in the bottom of the channel at the breach. The dam had not overtopped, and the failure was attributed to internal erosion of the decomposed granite embankment material along the roots. A tree had been located directly over the breach.

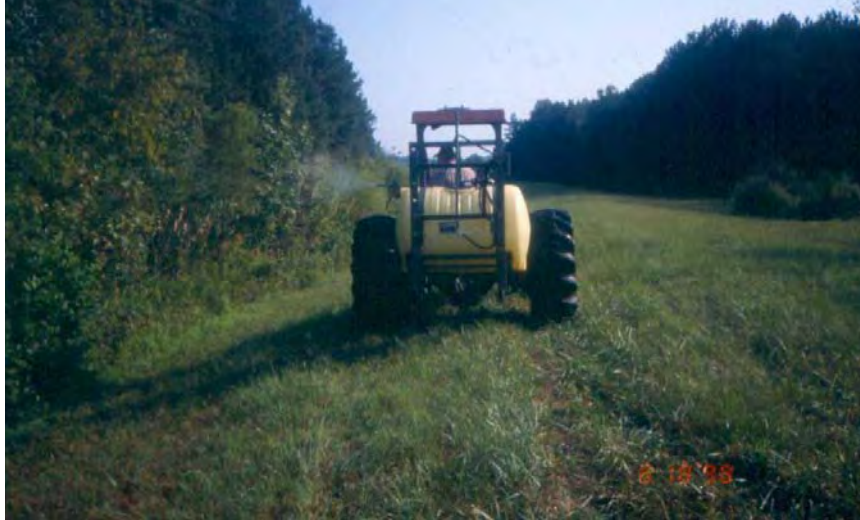
Figure 5f. Tractor spraying application on dam.

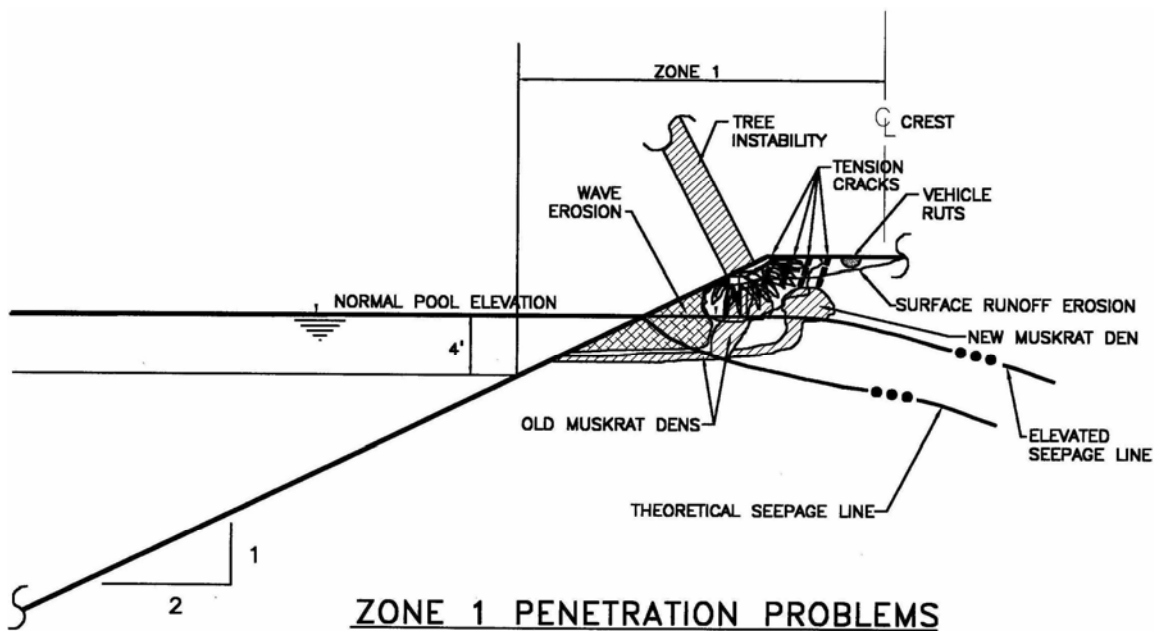
Figure 2 illustrates potential problems that can occur in Zone 1 with respect to tree and woody vegetation growth on earthen dams. This illustration also depicts the occurrence of wave erosion, vehicle access, and surface runoff erosion. Potential problems illustrated include instability of relatively large trees on the upstream slope and dam crest, and alteration of the seepage line as a result of wave erosion.

Dam remediation design techniques necessary to address potential problems illustrated in Figure 2 are illustrated in Figures 3 and 4. Dam remediation construction typically requires lowering of the normal pool elevation and/or complete drawdown of the retained reservoir. This is particularly true for dam remediation construction in Zone 1. The normal pool elevation should be lowered as far ahead of the scheduled dam remediation construction as practicable.
